# Strain Induced in Cracked Utility Poles and Damage to Dwellings from the Dec 26, 2003, Bam Earthquake

## Abstract

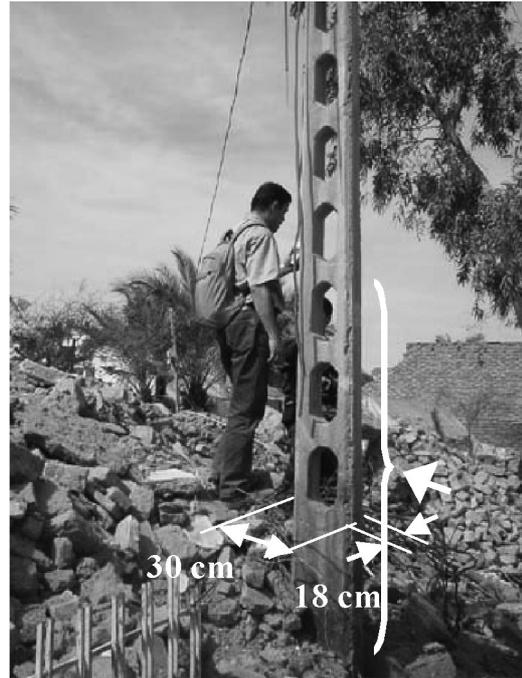
dimensions from area to area, but a thin pole with holes for climbing were the most widely used in the city (Fig. 4(a)), and thus, were chosen as the target.

(a) 8 m pole with holes and embedment depth of 2 m.

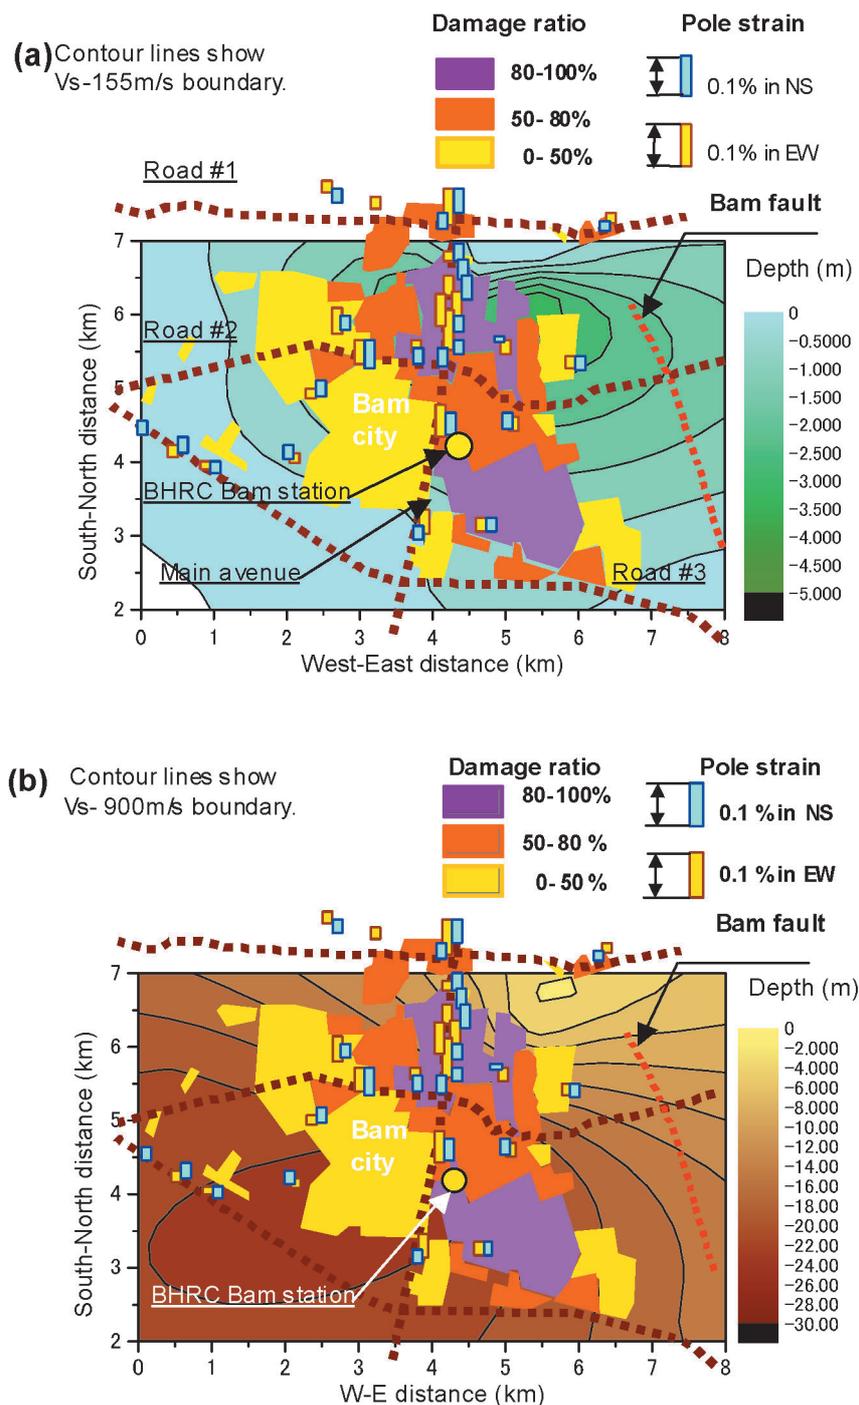
Fig. 8 b Strains remaining in poles: (Damage ratio provided by NCC of Iran, 2004).

were used in both the city and its suburbs. The poles were then divided into several tens of clusters in such a way that each cluster included at least one crossing in it. Because the poles in one cluster line up at least two roads intersecting each other, both north-south (NS) and east-west (EW) average strains were obtained cluster-wise. Figs. 8 (a) and 8 (b) show the distribution of remaining average strains in the city. Contour lines in Figs. 8 (a) and (b) show inferred layer boundaries of shear wave velocities  $V_s=155\text{ m/s}$  and  $V_s=900\text{ m/s}$ , respectively (see Fig. 3), and colored zones show percentages of damage to dwellings mapped by the National Cartographic Center of Iran (2004). In general, strains are large along the main avenue that runs through the city from north to south. Damage was also severe along this avenue

(Fig. 9 a), and it faded quickly as we got some street blocks away from the avenue (Fig. 9 b). Some severe damage to dwellings was also found along Road #2, which used to be an old river trace, and goes through the city from East to West (Fig. 9 c). The strain distribution thus seems to be consistent with the overall damage distribution pattern. However, cali-

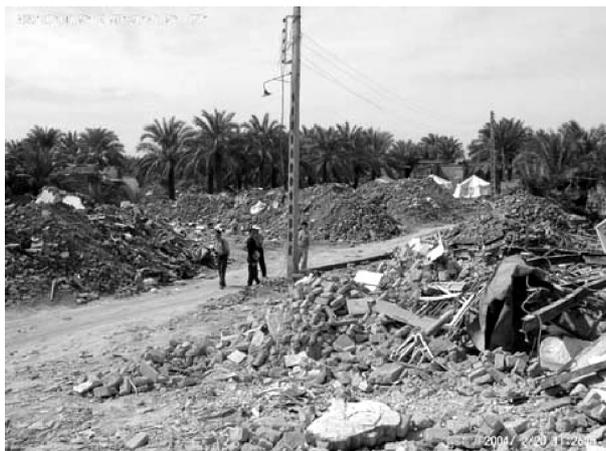
(a) Near the main avenue.  
N29°07'00.5" E58°21'41.5" 77°.

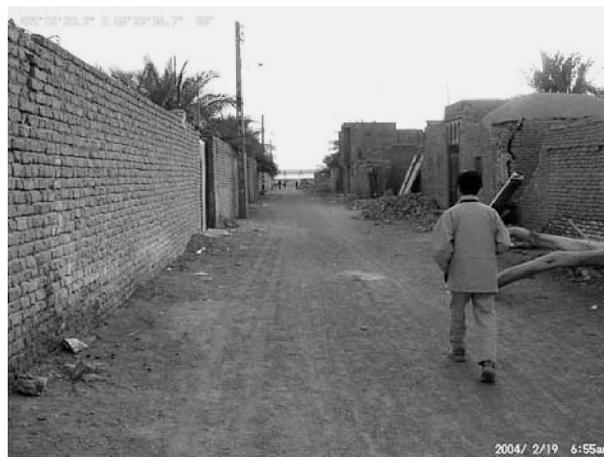
(b) East of the city.  
N29°06'23.3" E58°22'36.7" 88°.

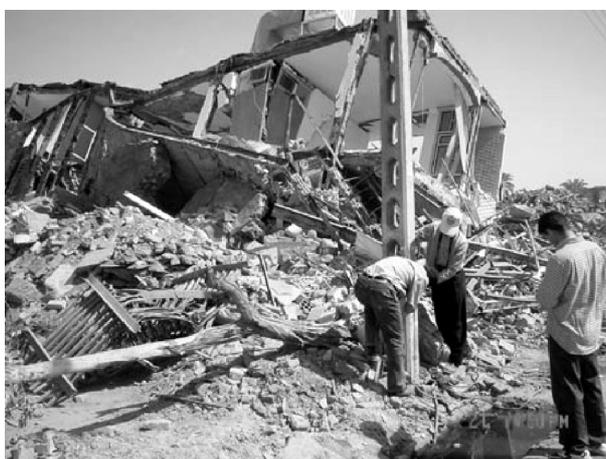
(c) Along the Street #2  
N29°06'24.6" E58°21'13.1" 74°.

suburbs. Clusters of poles with relatively large strains were found mostly along (1) the main avenue that runs through the city from north to south and (2) along Road #2, which used to be an old river trace, and goes through the city from East to West (Fig. 9 c). Dwellings along these roads were the most seriously damaged. In general, the distribution of cracked poles seems to have a good correlation with damage distribution, which again showed the high seismic vulnerability of adobe and unreinforced masonry structures.
