Seismic Behavior of Local Soil and Foundations in Bam City During the 2003 Bam Earthquake in Iran

Abstract

Key words: site investigation, sounding, masonry, earthquake

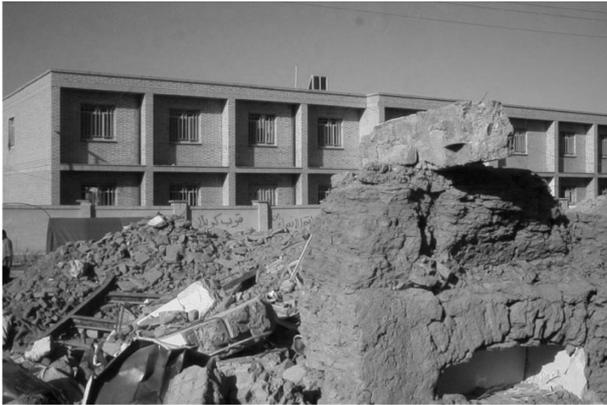
The IIEES array 5 is the first of 4 sites where Swedish soundings were conducted. This site is located in the northern part of the city (Fig. 3) and the extent of damage to buildings was significant. It is, however, noteworthy that a few buildings survived the quake without suffering damage among many other damaged neighboring buildings (Photo 3).

Photo 3. Damaged and undamaged buildings around the site of IIEES array 5.

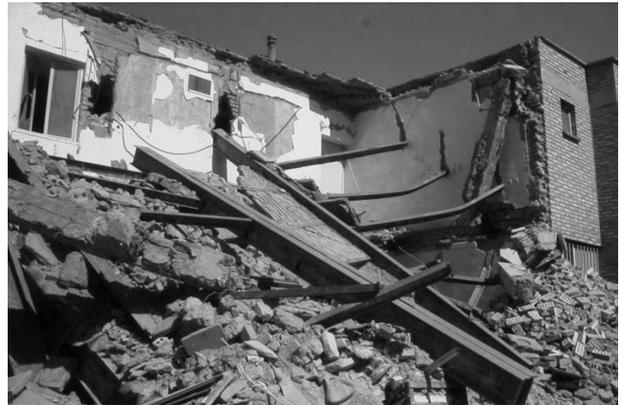
Photo 4. Damaged masonry building near site of IIEES array 6.

This site is located at the center of the city and many buildings were destroyed by the earthquake (Photo 4). It is again noteworthy that there was 1 house that suffered little damage in this area (Photo

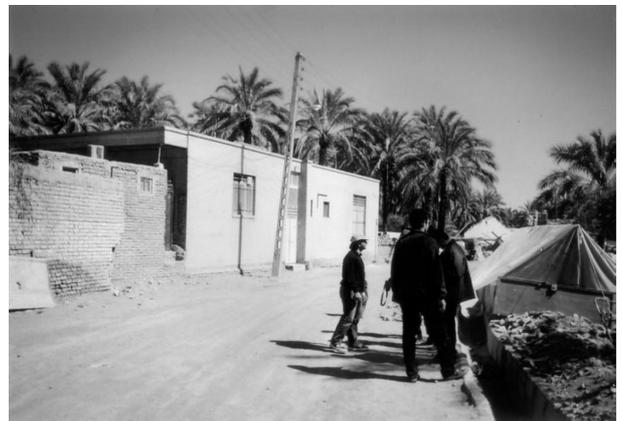
Photo 5. Undamaged house near the site of array 6.

5). Upon visiting this house, its owner said that it had been built by a local contractor who was renowned for the good quality of construction. Fig. 7 compares

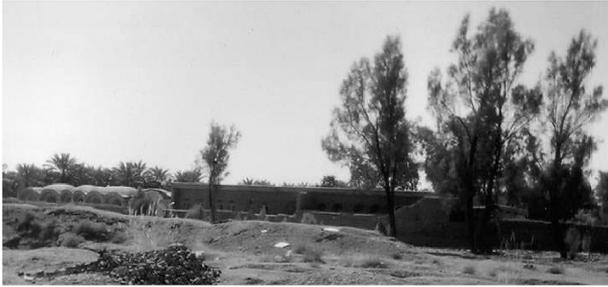
Photo 6. Relatively light damage around site of IIEES array 7.

less significant (Photo 6) than in the north and central parts of the city, as demonstrated above. Swedish sounding at this site was conducted in a large excavated pit (Photo 7 a), which was approximately 3 meters deep. It was expected that this decision would save time needed to penetrate the top hard soil and more efficiently study subsoil conditions.

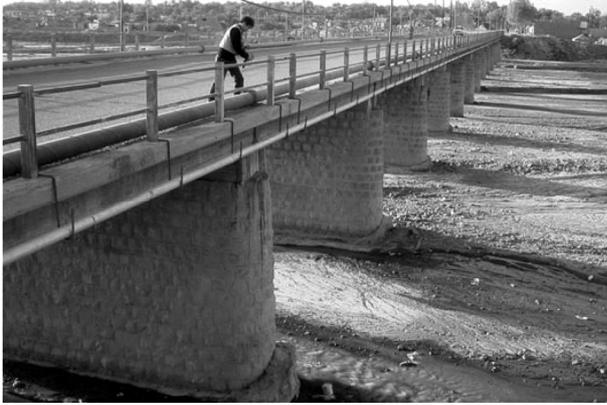
There are 2 major bridges in the Bam City area. They are the Esfikan and Khaje-Askar Bridges crossing the Posht-e-Rud (Posht River). The Esfikan Bridge is located at the north end of the city (Fig. 3), while the Khaje-Askar Bridge is to the west. Photos 9 and 10 show the appearance of the bridges during the investigation. There is evidently no significant damage to or deformation of these bridges, and road traffic was not suspended. In more detail, Photo 11 shows the situation of the Esfikan Bridge at the top of the pier. Noteworthy is the fact that the lateral displacement is only a few centimeters, and that the function of the bridge was maintained, in spite of the lack of any aseismic measures, during the earthquake. The good performance of the bridges during the quake is in contrast with the complete destruc-

Photo 9. Appearance of Esfikan bridge after the earthquake.

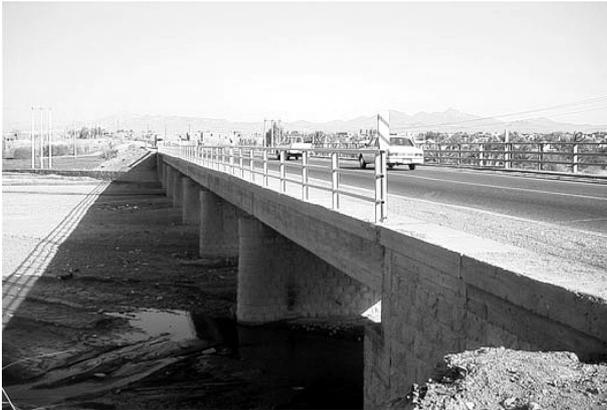
Photo 10. Appearance of Khaje-Askar bridge after the earthquake.

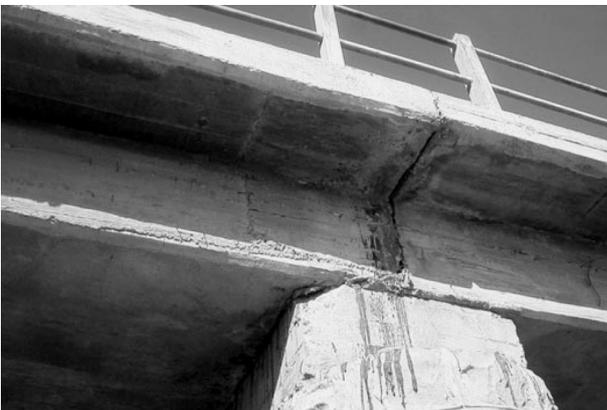
Photo 11. Minor displacement of Esfikan bridge at the top of pier.

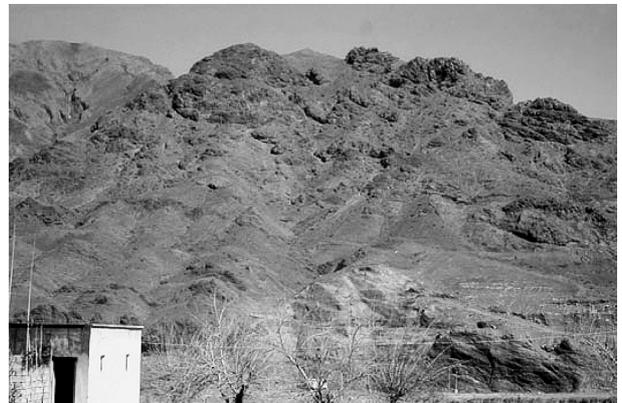
A visit was made to the site of Narmoshir Dam, whose construction was to start 25 km south east of Bam city. Located in a mountainous area, the dam site experienced “strong and long earthquake tremors” according to the chief engineer of dam construction. No seismometer was installed there. The present investigation did not find seismic slope instability in this area, with the exception of a minor rock fall (Photo 13) from the excavation site of the rockfill dam. This situation is again in clear contrast with

Photo 13. Rock fall near Narmoshir Dam under construction.

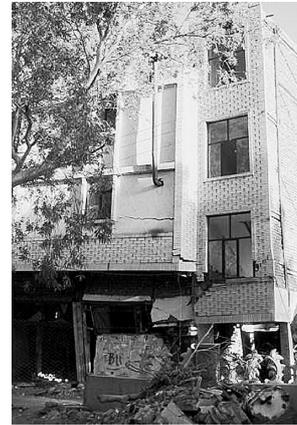
First, the bank building in Photo 14 had no appearance of damage. On the opposite side of the street, there was a building in Photo 15 whose first floor was severely distorted. As has been pointed out, thus, there are buildings in all parts of the city which survived the quake. Conversely, many nearby buildings and houses were severely affected by the same earthquake motion. Because the distance between damaged and undamaged buildings was small, the globally inclined geology in the city (Fig. 10) cannot account for the difference in damage. A more detailed inspection of Photo 15 reveals that the foundation did not deform. This may imply that the foundation and the subsoil had sufficient resistance to the seismically-induced inertia force, while the first floor did not.

Photo 15. Damaged building in front of bank in Photo 13.

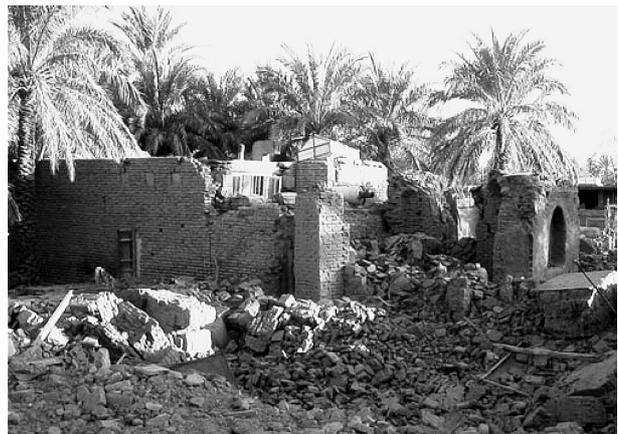
Second, Photo 16 shows a completely destroyed adobe house. Adobe is a form of masonry made from local soil, which is mixed with water and sun-baked. Because it is easily available without any special raw material or manufacturing process required, adobe is widely used in Central Asia, which has an arid cli-

mate, and in South America. It is important that the base of the wall of this house did not distort, although the upper part totally collapsed. This again suggests that the damage was caused not by weak

Photo 16. Foundation of destroyed adobe house.

foundation and soil, but the low strength of the superstructure.

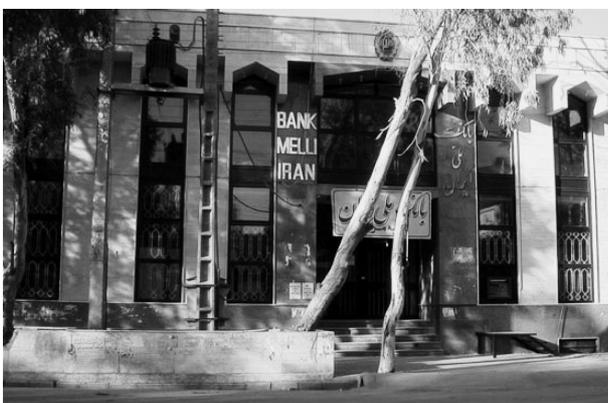
Photo 14. Undamaged bank building in western Bam.

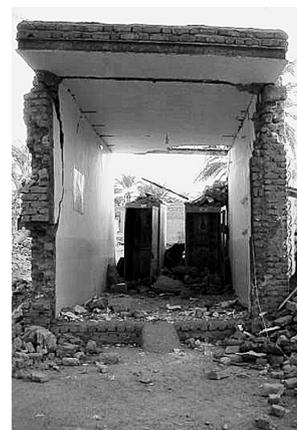
Photo 17. Damage of to masonry structure.

Photo 17 further indicates the form of damage to the masonry structure in which the front wall was lost. It can be seen that the base of the side walls did not deform, showing that the foundation was not responsible for this damage.

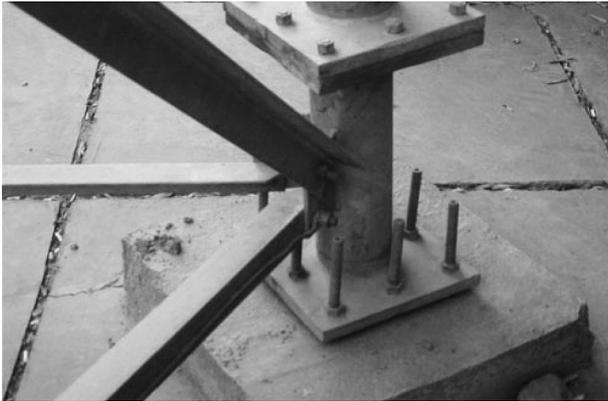
Photo 18. Foundation of communication transmission tower.

Finally, Photo 18 shows the footing of a microwave transmission tower. Apparently, there is no distortion. This is in strong contrast with the substantial damage to masonry houses and buildings in the same part of the city.

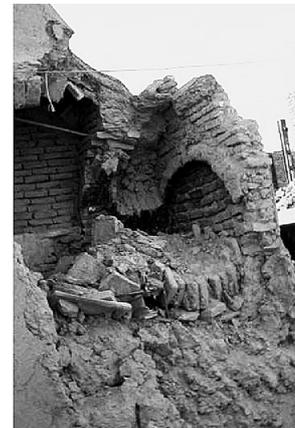
Photo 19. Exceptional seismic damage to adobe house in Kerman City.

Iran. Due to the 150 km distance from Bam city, the magnitude of tremors in Kerman was much weaker than in the Bam city. Therefore, most adobe houses in this city received no seismic damage. There was, however, an exceptional case, as shown in Photo 19, in which a wall of an adobe house fell down due to

the Bam earthquake. This example suggests that some adobe and local masonry houses might have extremely low seismic resistance.

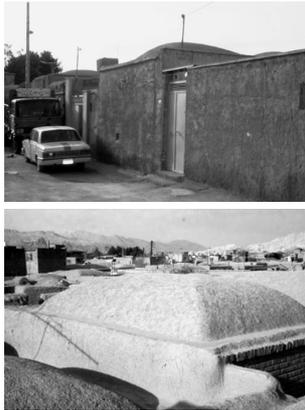
Photo 20. Intact adobe house in Kerman City.

Photo 20 shows an adobe house visited by the authors. Although the surface is covered with beautiful tiles, the internal structure is made of adobe. This visit was intended to examine any possibility of structurally improving the seismic resistance of existing houses. The improvement measure in mind was replacing heavy top roofs with lighter materials. The owner of this house stated during the visit that his family was scared now by earthquakes and slept under a table, which could provide good shelter. He also mentioned that the top roof had new mud added once every 4 years, and its present thickness was about 40 cm.

As shown in Photo 20 (b), the top roof is massive and replacement with a lighter material seemed to be very difficult, if not impossible, for ordinary families. Consequently, it is suggested by the authors that public support should be introduced for retrofitting existing houses, or that furniture that could provide shelter during strong tremors should be made available at reasonable costs.

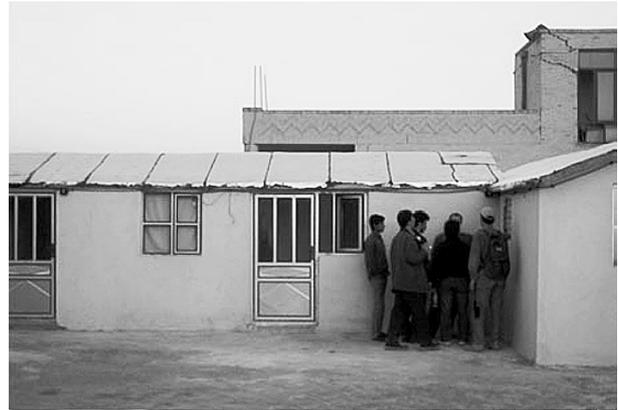
Photo 21. EPS temporary house for evacuation in Bam.

Photo 21 illustrates a new attempt to use EPS for the above-mentioned purposes. Large EPS plates were reinforced with steel so that their structural integrity could be maintained. Due to its good thermal insulation, this EPS house can provide good

Another problem associated with EPS houses is their external appearance; see Photo 21. Because the economy of Bam city relies considerably on its historical environment and tourism, the appearance of EPS houses, which might make it difficult for tourists to enjoy the environment, is not welcome. There is a need for decorative EPS blocks to be developed.
