Building Damage around Bam Seismological Observatory Following the Bam, Iran Earthquake of Dec. 26, 2003

Yasushi Sanada^{1)*}, Ali Niousha²⁾, Masaki Maeda³⁾, Toshimi Kabeyasawa¹⁾ and Mohammad Reza Ghayamghamian⁴⁾

Abstract

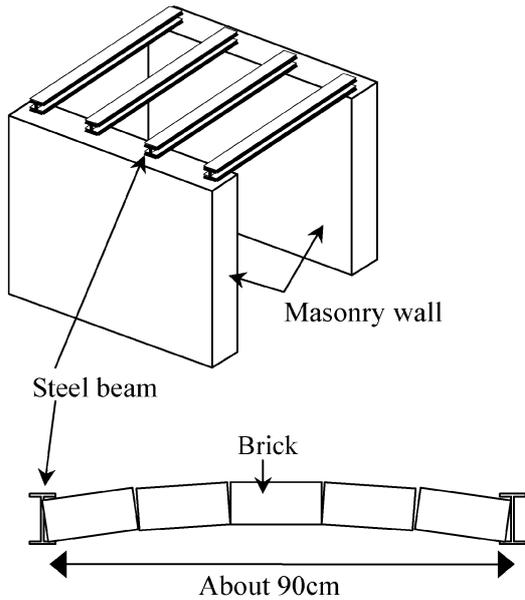
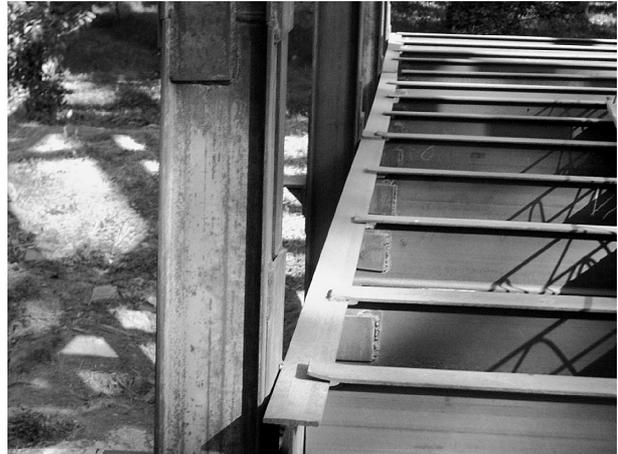
Fig. 1. Commonly used jack arch slab (left: wall supporting; right: girder supporting).

The common slab in the buildings was of the brick jack arch type (Fig. 1). The system consists of parallel I-shape steel beams at intervals of about 90 cm. These beams support the brick arches, which are covered and leveled off with gypsum plaster at the bottom and mortar and tiling at the top.

These slabs are heavy and behave like a flexible diaphragm unless detailing is considered. Slabs constructed in this way are usually not tied together or to supporting walls or girders. Therefore, these kinds of slabs have caused many building failures and an unusually high death toll in many recent earthquakes in Iran.

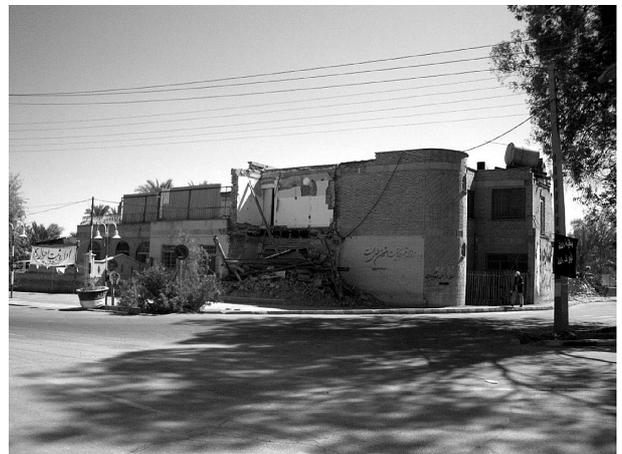
The Governor's Building is a 2-story SM building with reinforced concrete horizontal ties, as shown in Photo 1. This building has an irregular plan. The wall arrangement is illustrated in Fig. 9. The damage level, classified by EMS-98, was Grade 4 due to the partially collapses of NW- and SW-sections as shown in Photo 2. The location of the seismograph is

Photo 1. North view of Governor's Building.

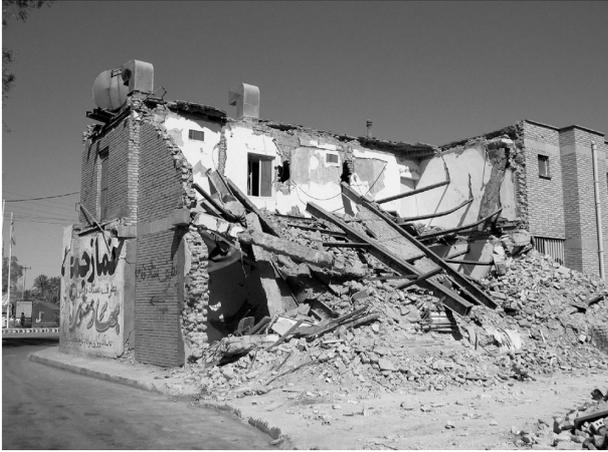
Photo 2. Collapse at the south west section.

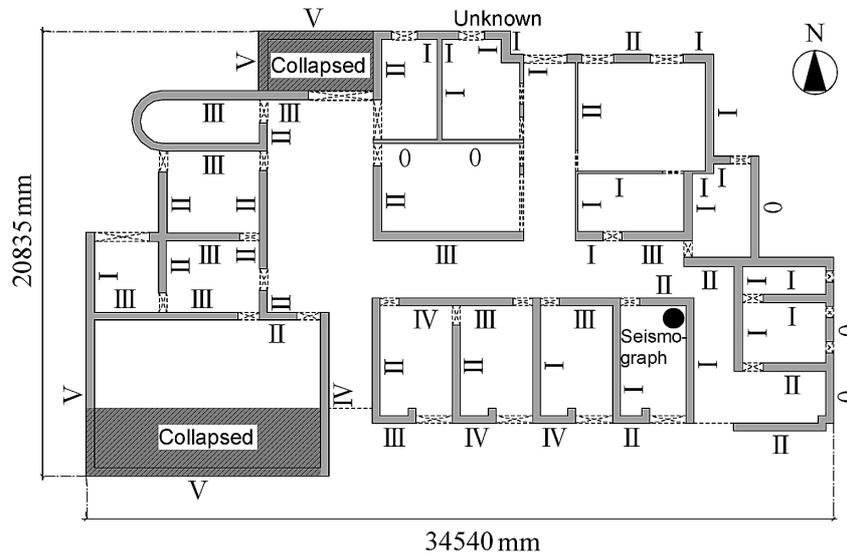
also illustrated in Fig. 9, which shows that the seismograph was placed far from both collapsed areas. The wall ratios (=the sum of the first floor wall sectional area/the first floor area) were 6.4% to 6.8% in the NS direction and 5.8% to 6.7% in the EW direction, considering those with and without the collapsed area.

Moreover, the damage levels and the maximum crack widths of all masonry walls in the first story, except an inaccessible one, were measured in the Governor's Building according to the criteria shown in Table 2. The damage levels of walls are also shown in Fig. 9 and the distribution of wall damage level in each direction is shown in Fig. 10. The

Fig. 9. First floor plan and damage levels of masonry walls of Governor's Building.

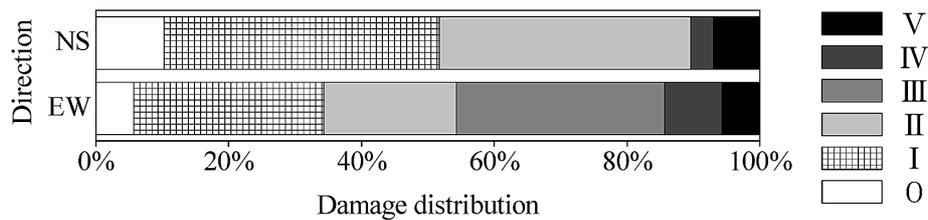
Fig. 10. Distributions of the wall damage level in Governor's Building.

average damage level of all walls in the EW direction of 2.3 is larger than that in the NS direction of 1.7, which means the directivity of the input motions, estimated by the wall ratios (NS \approx EW) and damage levels (NS<EW), corresponds to that of actually recorded data (NS<EW).

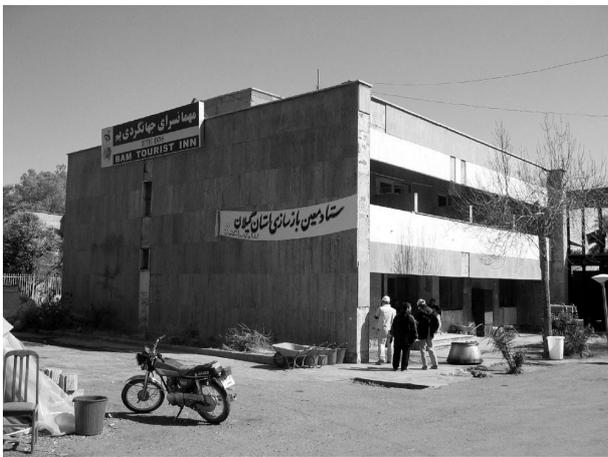
Bam Tourist Inn, used as hotel and restaurant, is a 2-story SM building as shown in Photo 3. The plan of this building is relatively regular (Fig. 11). The damage level, classified by EMS-98, was as low as

Photo 3. South west view of Bam Tourist Inn.

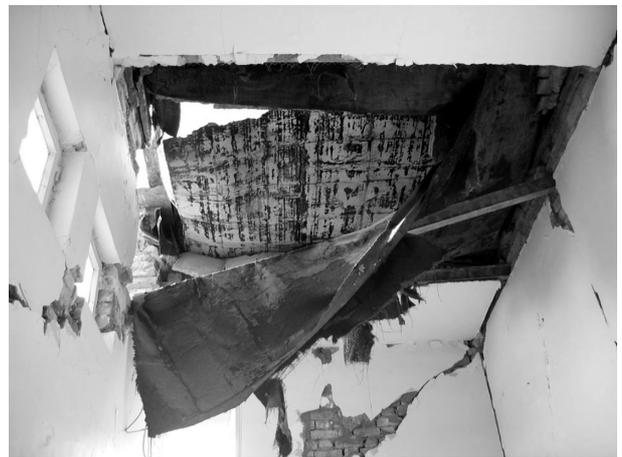
Grade 2 as estimated from Photo 3, however, the roof of the penthouse collapsed as shown in Photo 4. The wall ratio in the NS direction was 9.4%, which was much larger than that of the Governor's Building, and that in the EW direction was 5.5%. The damage levels of walls except inaccessible ones, which were evaluated from the definition in Table 2, are illustrated in Fig. 11. Fig. 12 shows the distribution of wall damage level in each direction. The average damage level of walls in the NS direction of 1.3 was a little smaller than that in the EW direction of 2.3,

Photo 4. Falling down of the roof of penthouse.

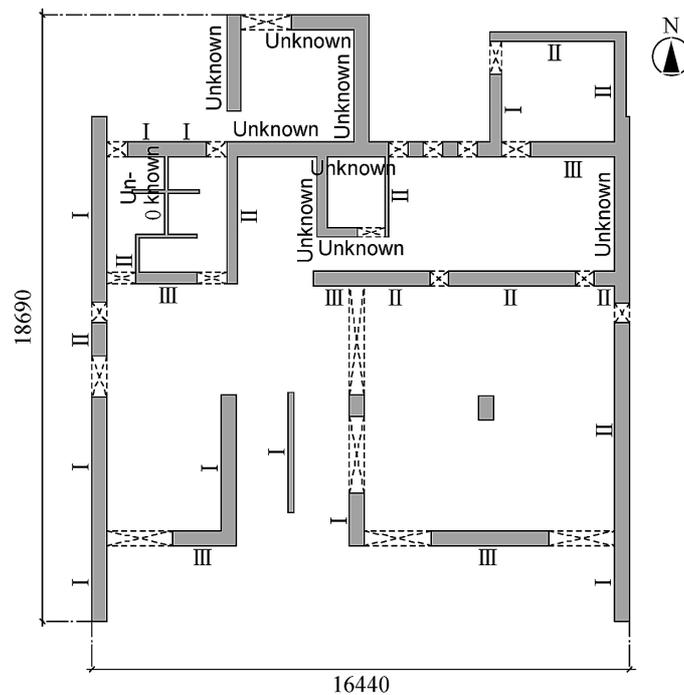
Fig. 11. First floor plan and damage levels of masonry walls of Bam Tourist Inn.

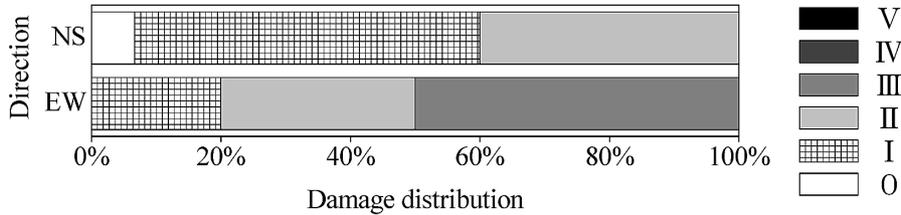
Fig. 12. Distributions of the wall damage level in Bam Tourist Inn.

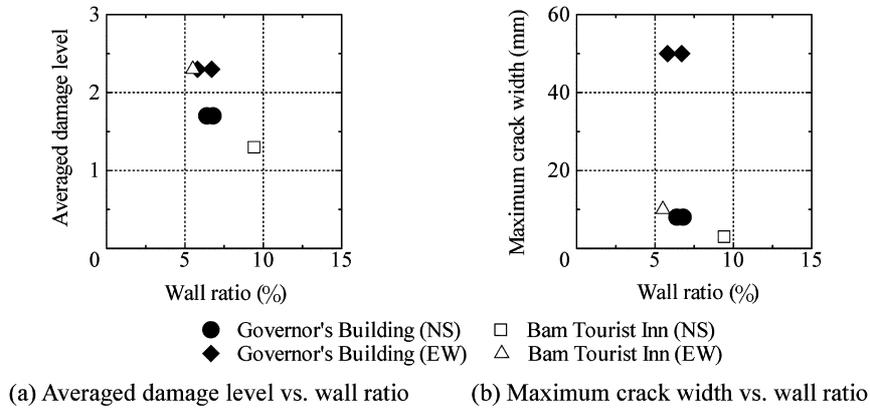
Figure 13 shows the relationships between wall ratio and average damage level, and correlation between the wall ratio and the maximum crack width, respectively. It can be concluded from Fig. 13 (a) that the average damage levels were larger in the case of a smaller wall ratio. The maximum crack widths were also larger in the case of a smaller wall ratio among the NS direction of Governor’s Building and both directions of Bam Tourist Inn, as shown in Fig. 13 (b). However, the maximum crack width in the EW direction of the Governor’s Building was much higher than those in the other cases. This may be caused by torsional responses due to the horizontal irregularity of Governor’s Building, because larger crack widths were observed in the outside walls. The building damage cannot be clarified in detail based only on the wall ratio as mentioned here, however, it can be concluded that the wall ratio is considered to be one of the reliable indexes for evaluating the seismic performance of unreinforced masonry buildings.

Fig. 13. Relationships between the wall ratio and the wall damage level.

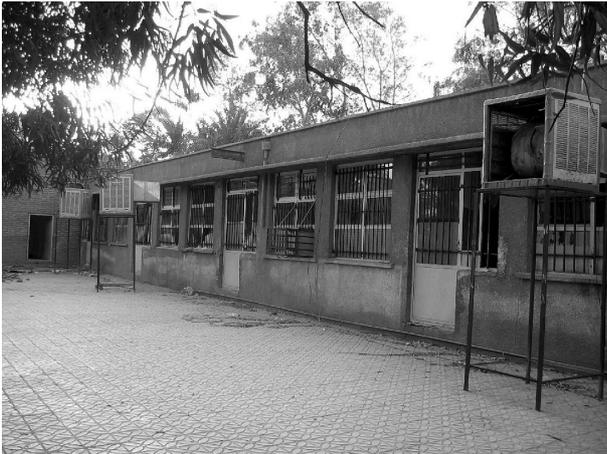
17 Shariwar High-School is located a few hundred meters west of the Governor’s Building and consists of 3 SM buildings. The 2 single-story buildings escaped severe damage, as shown in Photo 5, although minor cracks were found in brick walls. On the other hand, the 2-story building had partially collapsed (Photo 6). This building consists of intermediate steel frame and exterior brick walls. The floor slab system is a jack arch type, mentioned earlier. The floor plan of the collapsed part is shown

Photo 5. Single-story school building (slight damage).

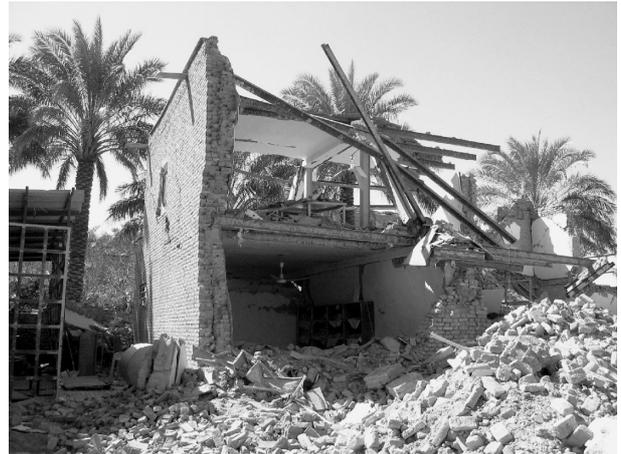
Photo 6. Collapsed two-story school building.

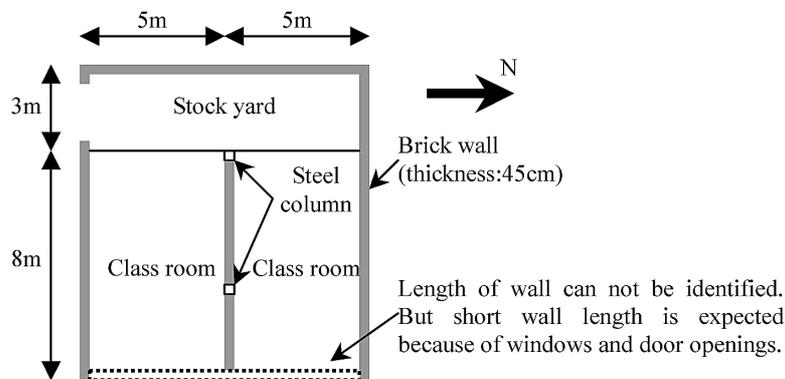
Fig. 14. Floor plan of collapsed part of two-story school building.

in Fig. 14. The roof and floor slab fell off due to the collapse of an east exterior brick wall.

The wall area ratio of the first story obtained is 4.1% in the NS direction and 11.0% in the EW direction. Note that the value in NS was calculated assuming that the area of collapsed east exterior wall is 0, not only because thickness and length of the collapsed wall could not be identified, but also because a very short wall length may be expected due to the existence of windows and doors. The wall area ratio in the NS direction of 4.1%, in which severe damage occurred, is less than values of the 2 buildings mentioned before.

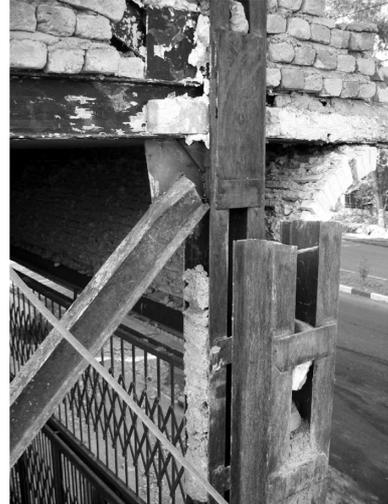
In the first story, fractures of welding joints and buckling of steel braces were observed (Photo 8 and 9). As a result, the brick walls had collapsed. Damage to the brick wall on the second story (Photo 10) was also observed. No remarkable structural damage to the steel columns in NS direction was found, although bricks had fallen off the facade of the building.

Photo 8. Fracture of welded joint of a steel brace.

cm², (2) angle of steel brace is 45 degrees, (3) unit weight of the building for each floor is 800 kgf/m², and (4) floor area is 5.7 m × 16 m = 91.2 m². These assumptions give a base shear coefficient, *C*, of 0.33. This base shear coefficient is lower than the approximated values for both the Governor's building and Bam Tourist Inn, in spite a higher than minimum requirement of 0.19. This may be one reason why this building suffered severe damage. Other reasons may be poor quality of welding (Fig. 8 and 9) and unconfined brick walls.

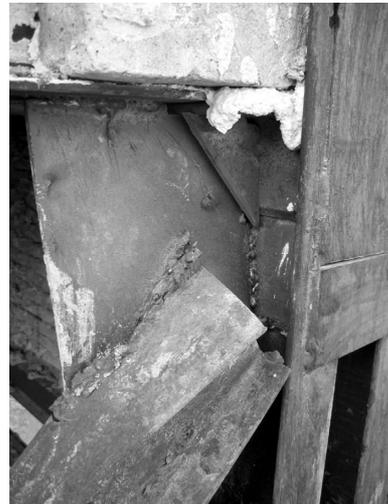
Photo 9. Close-up of Photo 8.

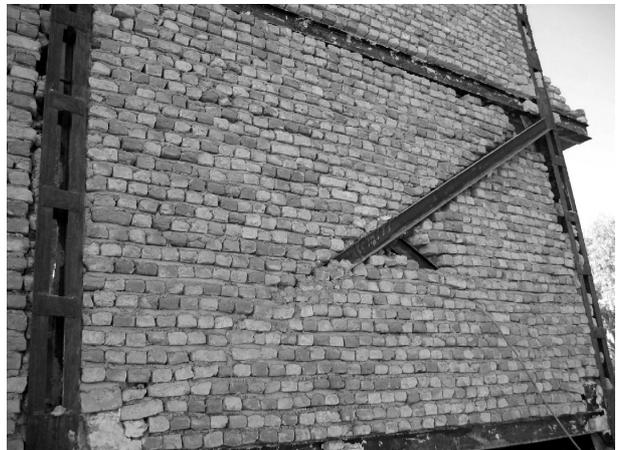
Photo 10. Buckling of steel brace and damage to brick wall.
