# 境川橋震害圖

## ELEVATION & PLAN OF SAKAIGAWA

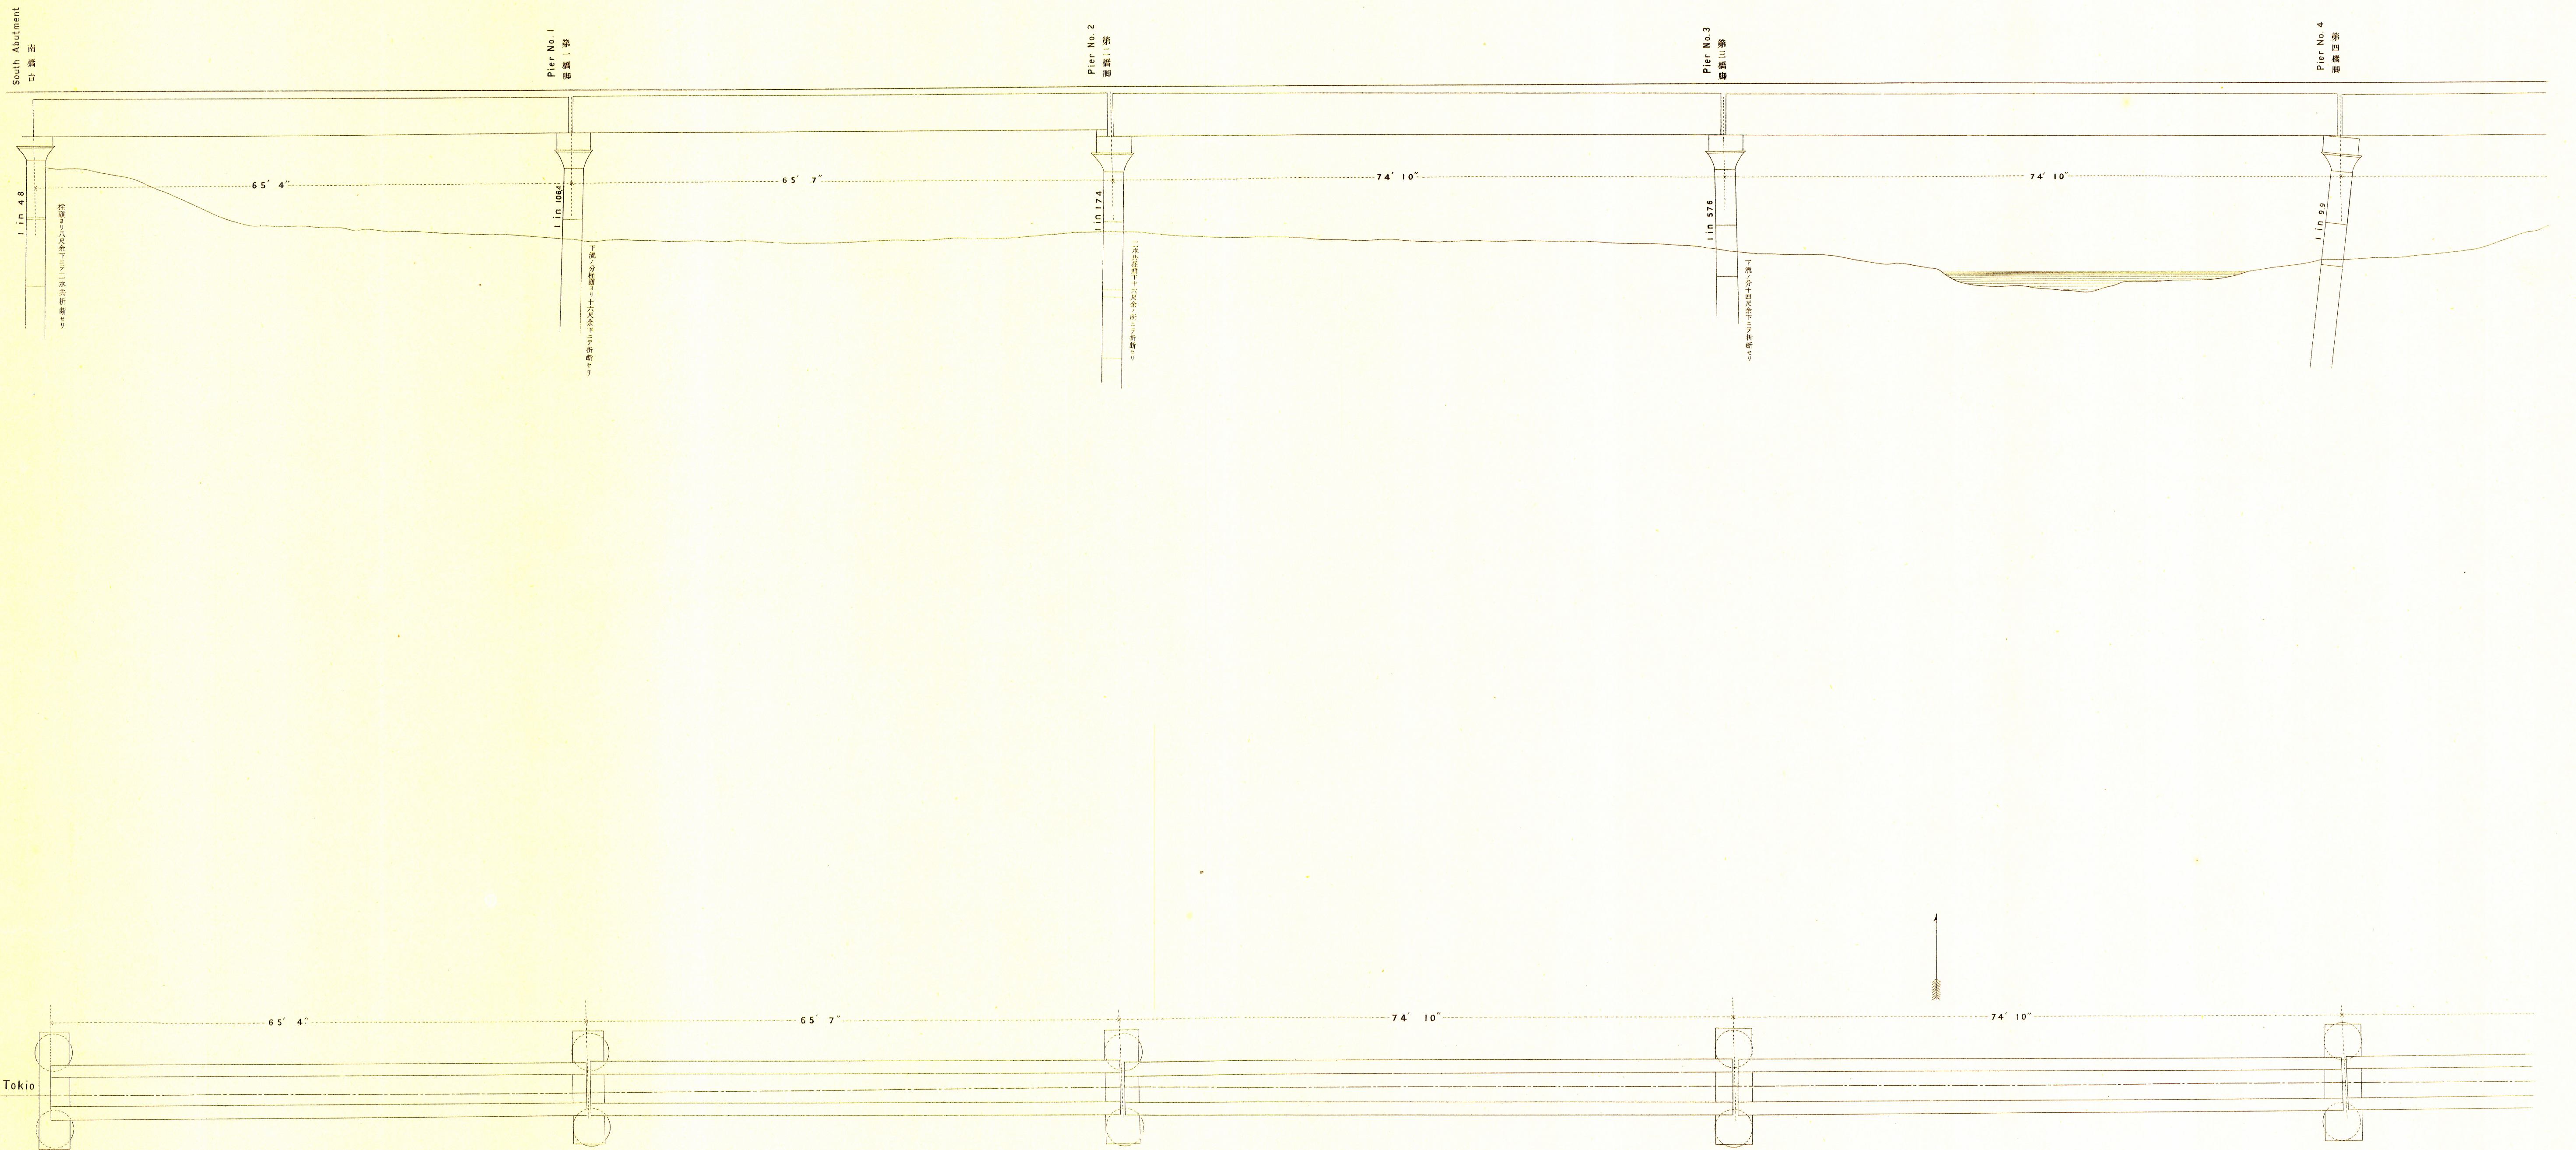
境川橋震害圖(其一)

Showing the condition after the earthquake disaster of Oct. 28th,  
All the piers, each consisting of a couple of cast iron screw piles, 2'6" in diameter and filled with concrete, broken
