**共同利用実施報告書(研究実績報告書)**  
(特定共同研究(A)、特定共同研究(C))

1. 課題番号 2014-A-01 (※1703)

和文: 地表地震断層および活断層の地表計上・変位量データにもとづく直下型地震の規模・頻度予測手法の高度化・LiDAR 等の高解像度 DEM を用いた検討

3. 研究代表者所属・氏名 名古屋大学・減災連携研究センター・鈴木康弘

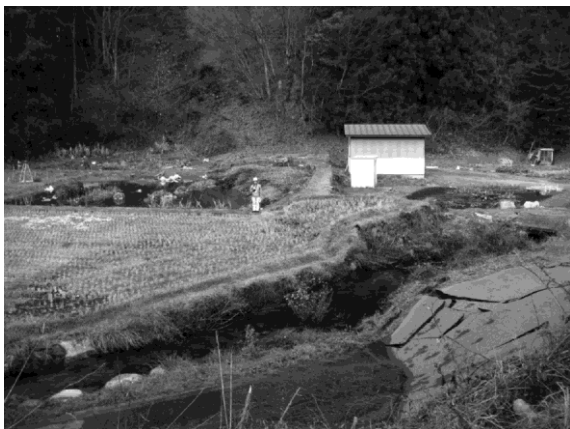
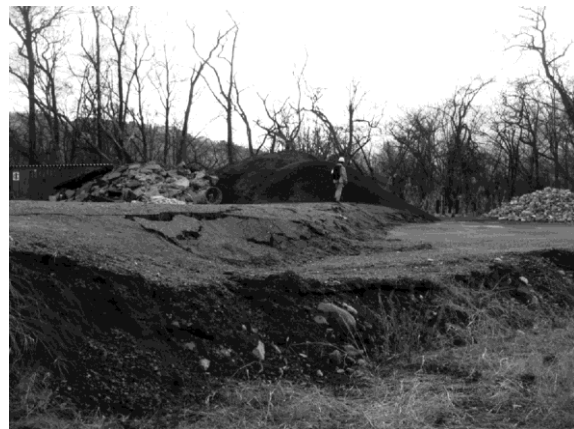
Photo 1. (Left) Coseismic west-facing fault scarp observed at the Shiojima site (located in Figure 1). Note person for scale. The maximum height of the scarp is ca. 0.9 m. Horizontal shortening is also identified. (Right) The southern extension of the fault scarp. Revised after Hirouchi et al. (2014).

地表地震断層の北端は，城山から北東の姫川方向へ数百 m 出現した．一方松川左岸には，約 300m に渡って最も明瞭な地震断層が出現し，その変位量は東側隆起約 90cm であった．また東方の菅沢では，西側隆起の逆向き断層が認められた．

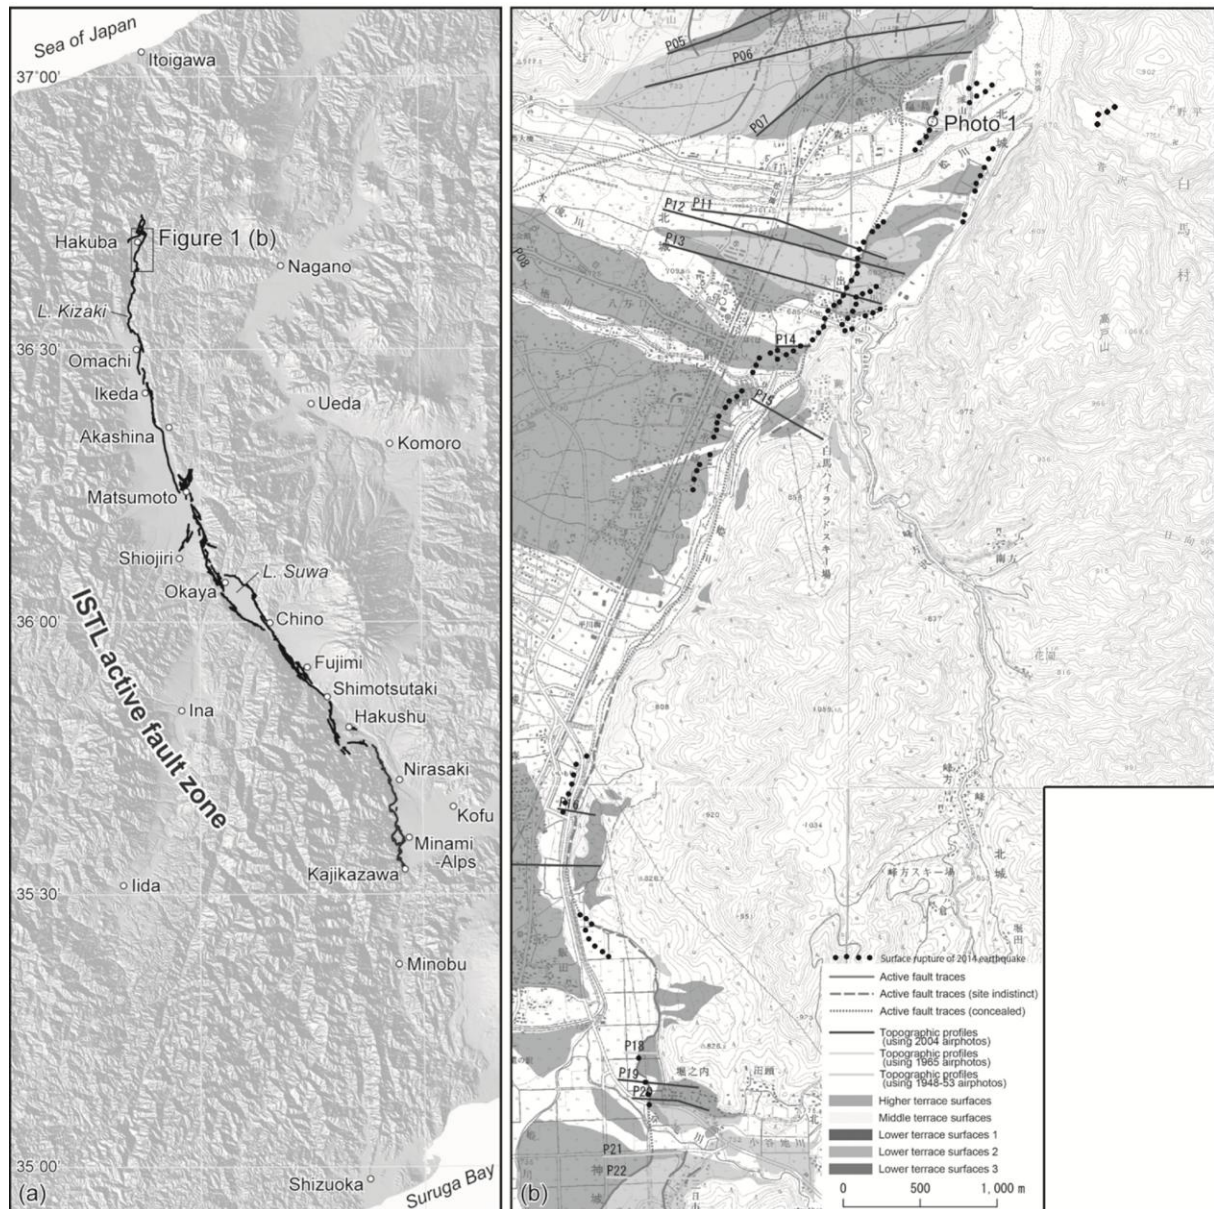
Figure 1. (a) Index map of the ISTL active fault zone. The shaded relief map is based on 50-m-grid DEM issued by GSI of Japan. (b) Tectonic geomorphological map of the northern part of the Kamishiro fault (Research Group for ISTL Tectonic Landforms, 2007). The web-GIS based active fault information is available at <http://danso.env.nagoya-u.ac.jp/istl-gis/> (in Japanese).

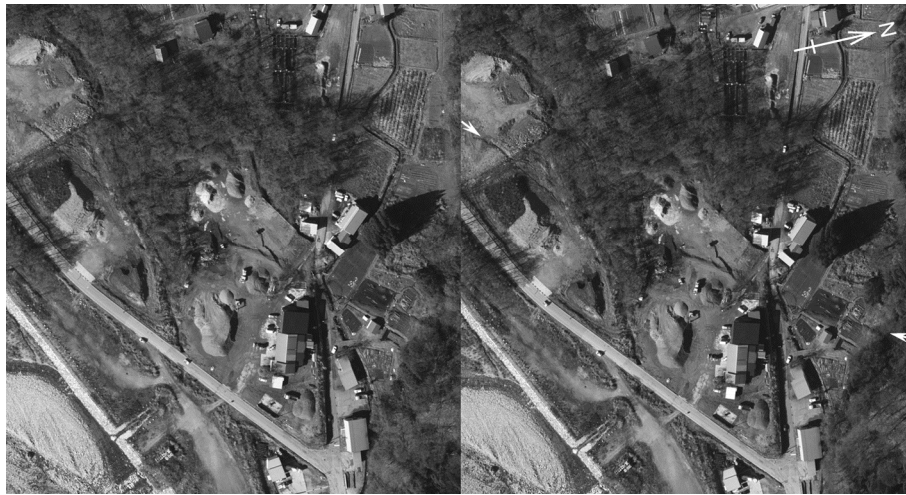
Figure 1. A post-earthquake stereo-pair airphoto of the Shiojima site.

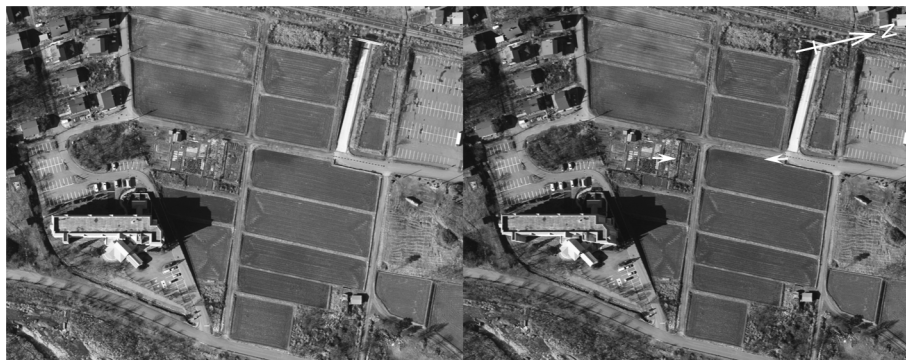
Figure 2. A post-earthquake stereo-pair airphoto of the Hakuba-cho site.

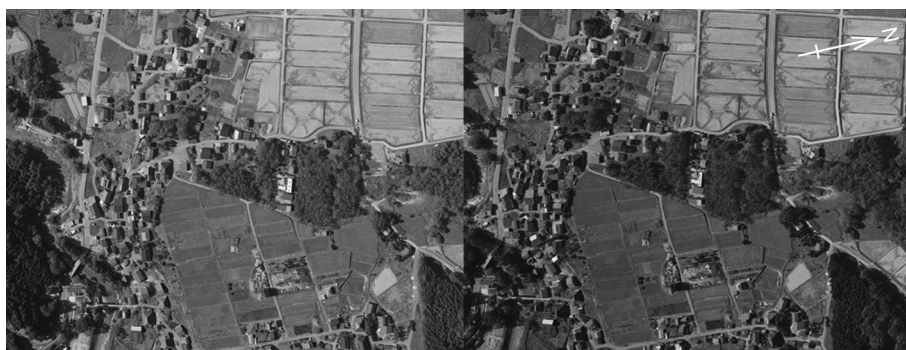
Figure 3. An example of stereo-pair airphotos taken in 2004, showing the Oide site.

1) Oide: Obvious surface rupture stretched north to south along the active fault trace at Oide. The southern half of surface rupture at Oide doesn't seem to match with the active fault trace. However, a few small tectonic landforms exist on the lower terrace, and was overlooked. The active fault line should have been traced considering such small landforms. 2) Nodaira: This area was on the outside of the study area in Matsuta et al. (2006) and Research Group for ISTL Tectonic Landforms (2007). In this reexamination the pre-existing tectonic landforms were observed in the area. The M terrace (50–100 ka) is cut by the fault. The west-side-up fault extends northeastward and it is considered to be a back-thrust faulting associated with the main fault. Surface ruptures clearly appeared along these pre-existing fault traces. 3) Kamishiro: Some tectonic landforms along the piedmont line and back-thrust fault scarps were newly mapped at Kamishiro. Obvious surface ruptures appeared along some traces. In Mikkaichiba, surface rupture was observed along the back-thrust fault scarp that had been mapped on our earlier active fault map (Katsube et al., 2014). 4) Shiojima: The remarkable coseismic east-side-up fault scarp appeared in the 2014 earthquake. The maximum height of the scarp is about 0.9 m. In a little of northeast of the coseismic scarp, there are the tectonic landforms on the M terrace (50–100 ka). We found the pre-existing east-side-up small - less than 1 m - fault scarp on the alluvial lowland through the detailed re-interpretation of aerial photographs. The coseismic east-side-up fault scarp appeared in the same location.

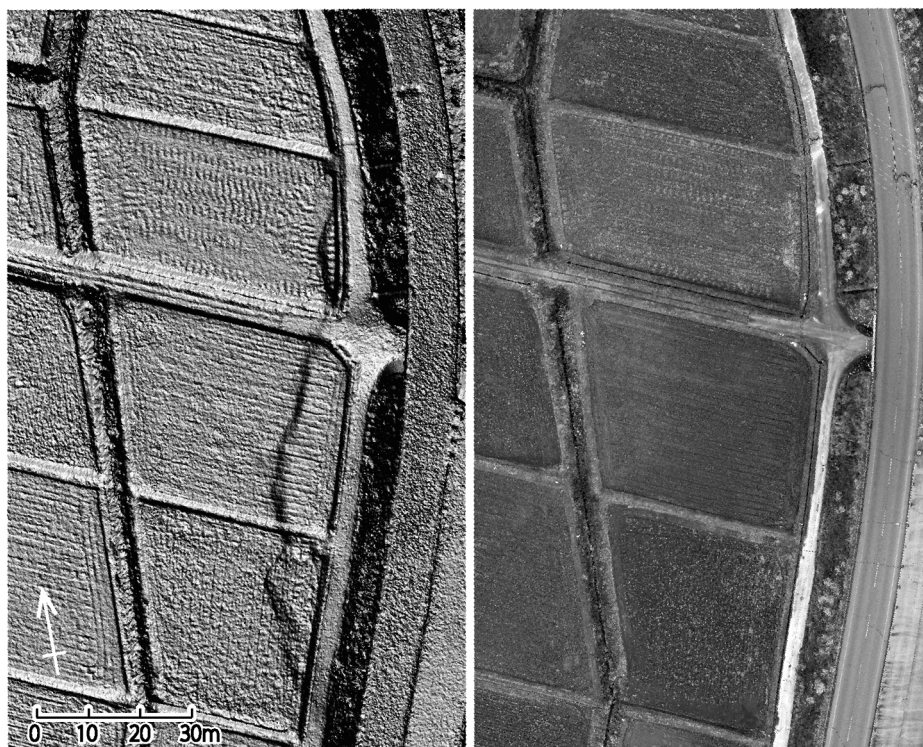
As a result, we were able to create a DSM of a resolution of a few centimeters (Figure 1). The shaded

diagram of the DSM indicates the following: 1) Surface rupture has propagated in an intricately bent and branched manner. 2) Small-scale deformation and deformation along several meters of width have taken place. Subsequently, this DSM was compared with the cross-sectional survey and measurements carried out by the auto-level and LiDAR, and it was confirmed that the DSM is characterized by fine topographic changes. However, an error of about 10 cm could have been present depending on the location.

Figure 1. An example of DSM and orthophotograph of the Iimori site.

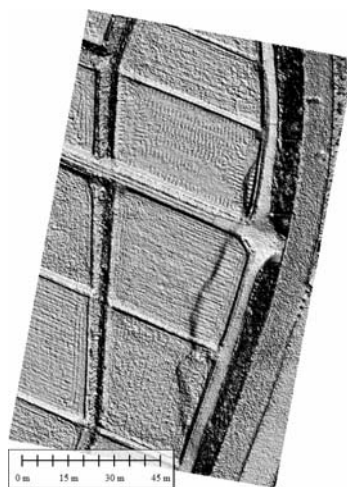
SfM-MVS は, 対象物を多方向から撮影した写真を用い, イメージマッチングの技術を応用することにより大量の 3 次元点群データを生成して 3D モデルを作成する技術である. 本研究において撮影した写真と GCP を用いて SfM-MVS ソフトウェア (Photo Scan Pro) により解析し, 解像度約 5 cm の DSM (図 1) と解像度 2.5 cm のオルソ画像を作成した.

隔で断面計測を行い, 鉛直変位量を計測した. 変位量は単に崖の比高 (見かけの変位量) を計測するのではなく, 背後のたわみなどの地形を考慮する必要がある. 計測の結果, 鉛直変位量は見かけの変位量よりも過小評価される場所と過大評価される場所が確認された.

←図 1. UAV による写真から作成された DSM の陰影図. 水田内に明瞭な変位地形が認められる.

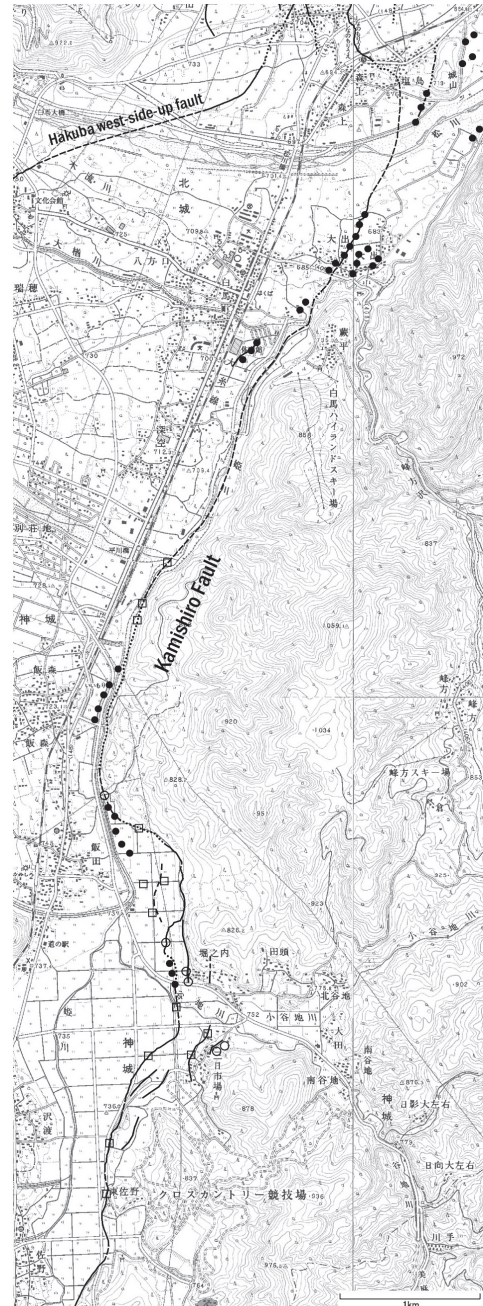
白馬村堀之内地区に甚大な被害が集中した。家屋倒壊率は3割を超えたことから、震度7相当と見られる。その原因は、逆断層直近の上盤側で発生した強震動にある可能性が高い。神城盆地の地盤が軟弱であることを理由にする意見も多々あるが、堀之内地区は上盤側(隆起側)で段丘化しているため、地盤がとくに軟弱だとは言えない。堀之内地区周辺の活断層は複数あり、少なくとも数列は今回の地震時にずれを生じた。集落内に逆向き(西側隆起)の副次的な断層も認められ、堀之内地区は複雑な変形帯に位置する。歴史記録によれば、1714 年の信濃小谷地震の際にも堀之内地区の被害は甚大であった。そのことから約 300 年ごとにこの程度の地震が繰り返しているのではないかという意見もあり、今後の課題である。

黒線：活断層、●：地震断層、○：産総研による地震断層、□：地盤変状  
(鈴木ほか,2015,科学 より)
