Collapse Mechanism of Adobe and Masonry Structures During the 2003 Iran Bam Earthquake

Abstract

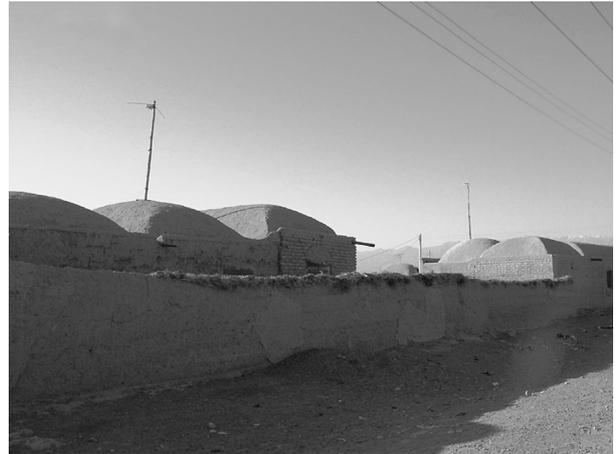
Photo 1. Undamaged adobe buildings (suburbs of Bam city).

Photo 1 shows a village near Bam in which the adobe buildings were not damaged. The beautiful buildings mostly have arched roofs.

To support this arched roof, a building has thick, massive side walls. On the other hand, photo 2 and photo 3 show a collapsed adobe building and a heavily damaged non-reinforced masonry building, respectively, in Bam city. In the collapsed adobe building, adobe bricks filled the rooms and left almost no

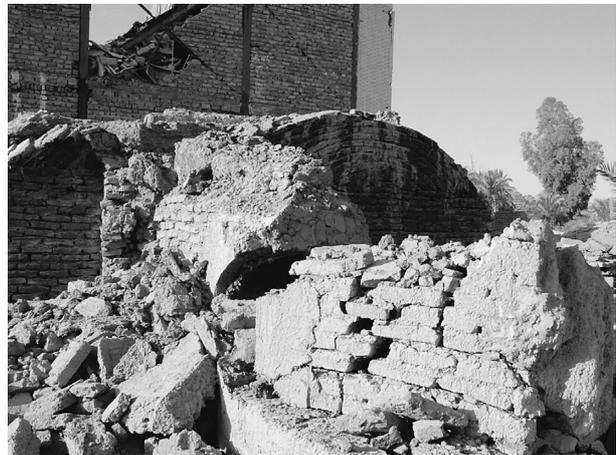
Photo 2. Collapsed adobe building (Bam City).

space for the trapped inhabitants.

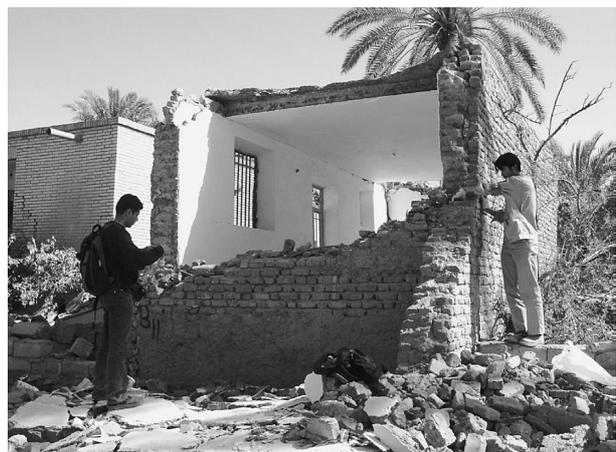
Photo 3. Severe damage to non-reinforced masonry building.

Moreover, in the masonry buildings, the damage ratio of non-reinforced masonry buildings was obviously more than that for confined masonry buildings. A high collapse rate was observed when a large amount of sand was used in the mortar between the bricks.

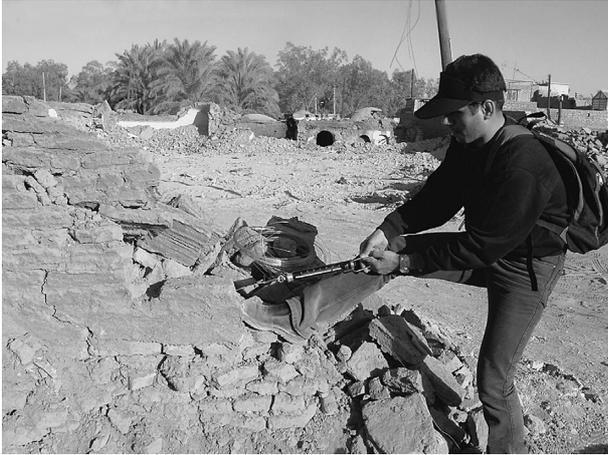
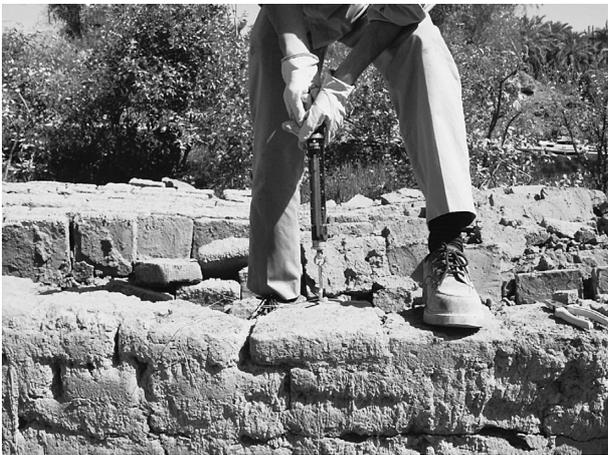
Photo 4. Measuring shear strength of mortar of sun-dried bricks.

Photo 5. Measuring tension strength of mortar of sun-dried bricks.

Photos 4 and 5 show the situation of the simple

shear and tension test carried out on sun-dried bricks. Bonding strength was defined as the force measured by the spring scale pulling the wire winding the sample when adhesion was lost.
