2011年東北地方太平洋沖地震の津波高調査

Field Surveys of Tsunami Heights from the 2011 off the Pacific Coast of Tohoku, Japan Earthquake

We report the results of field surveys conducted by the Earthquake Research Institute, to measure tsunami heights from the 2011 off the Pacific coast of Tohoku, Japan Earthquake (M 9.0), on March 11. Measurements were taken at 296 points on the Sanriku coasts of Aomori, Iwate, and Miyagi Prefectures, and the Pacific coasts of Ibaraki and Chiba Prefectures. The data are included in the results of the 2011 Tohoku Earthquake Tsunami Joint Survey Group. We did not cover the Sendai plain in the southern Miyagi Prefecture because other parties extensively measure there, nor Fukushima Prefecture because of the accident of the Fukushima Dai-ichi nuclear power plant. The twelve surveys first sought traces indicating tsunami runup or inundation heights. Reliability was classified into A (most reliable based on clear physical evidence and eyewitness accounts), B (mostly based on natural traces), and C (least reliable based on equivocal evidence). Most physical evidence obtained after June was not significant; therefore, reliance was mostly placed on eyewitness accounts. Loc

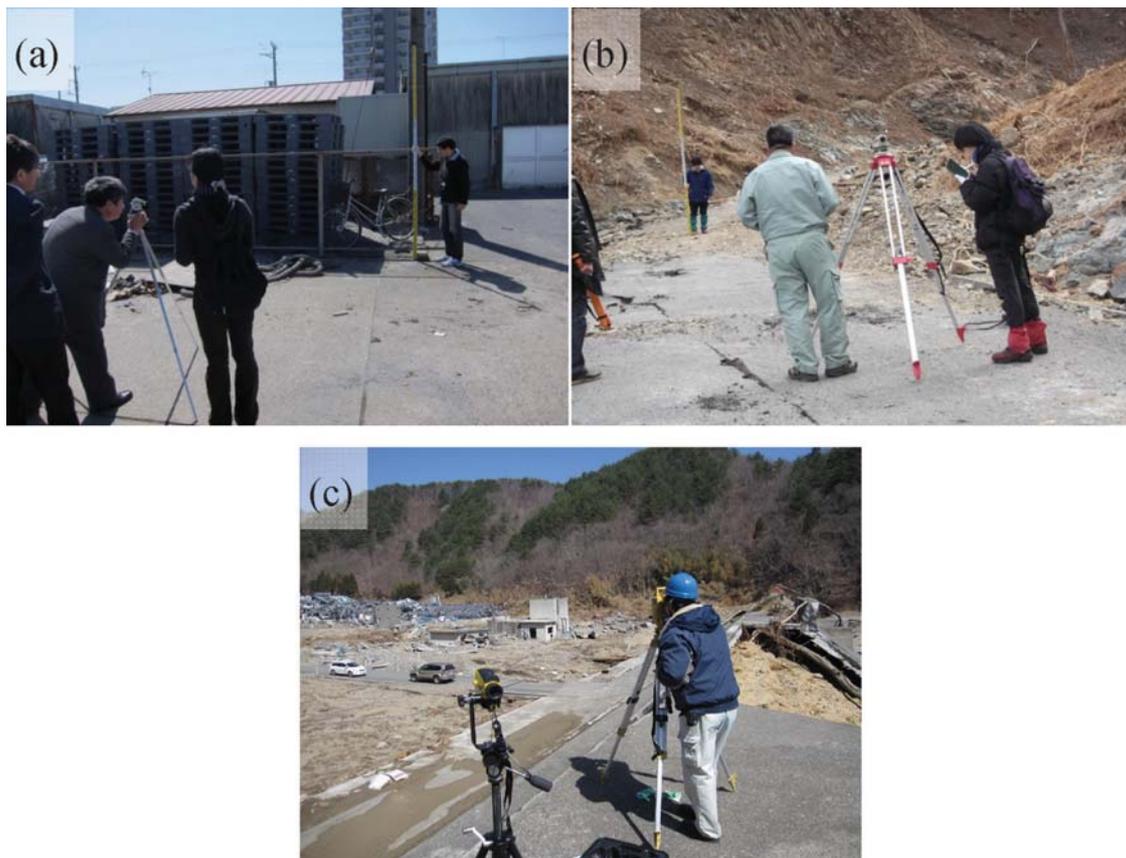
Fig. 2. Instruments used in the survey: (a) level tracon (b) auto-level (c) total-station (right) and laser range finder "Tru Pulse 360" (left).

津波痕跡の位置と標高を測定した。位置の測定には、携帯型GPS端末を利用した。その測定精度は、捕捉できた人工衛星の数にもよるが、通常20m以下であることから、緯度・経度の1秒程度の精度はある。標高については、測定時の海面あるいは水準点などの基準点から、レベルトラコン(牛方商会製レベルトラコンLS-25; 図2a)、オートレベル(ニコントリプル製オートレベルAC-2s; 図2b)、あるいはトータルステーション(TOPCON製Pulse Total Station GPT-3005WF、及びLeica Geosystems製TCRP1205+R1000; 図2c右)によって測定した。レーザー測距計(Laser Technology, Inc.製Tru Pulse360)(図2c左)を併用して、測定値の確認を行った。レベルトラコンやオートレベルを用いて尺取り式に測定を繰り返した場合、距離が長くなると誤差が増え、その測定精度は場合によっては0.1m以上になる。一方でトータルステーションを用いた場合、見晴らしの良い場所に設置することで海面と調査地点を同位置か

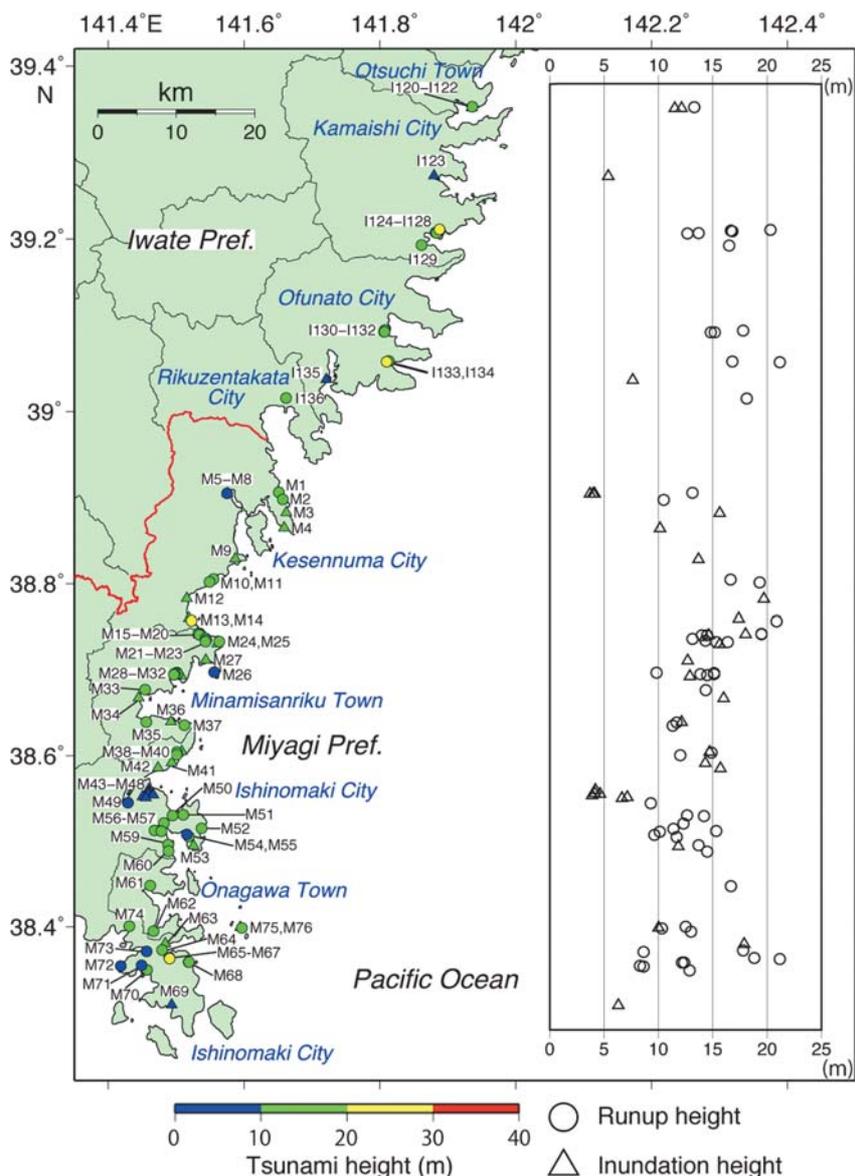
Fig. 4. Distribution of tsunami heights in the southern part of Iwate Prefecture (Otsuchi Town, Kamaishi City, Ofunato City, and Rikuzentakada City) and Miyagi Prefecture (Kesenuma City, Minamisanriku Town, Ishinomaki City, and Onagawa Town). The symbols and their meanings are the same as in Fig. 3.

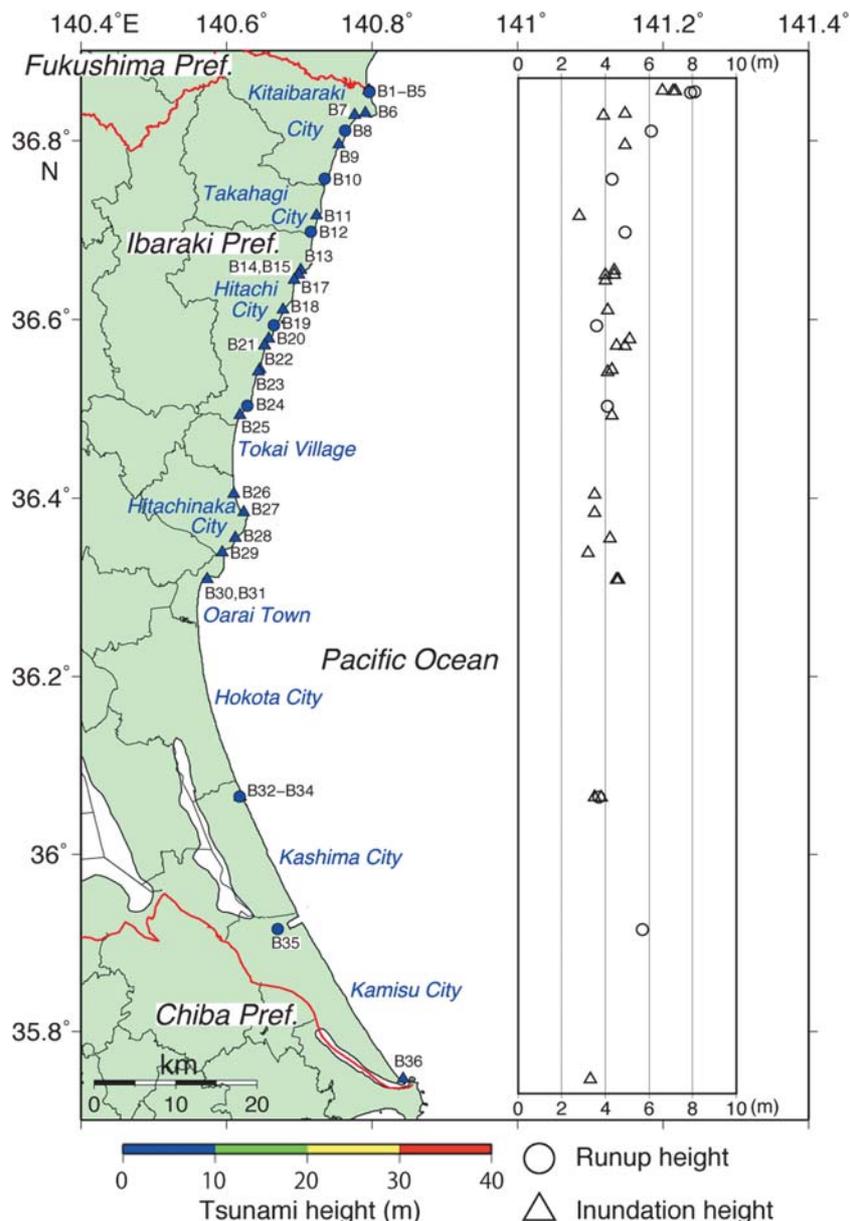
Fig. 5. Distribution of tsunami heights in Ibaraki Prefecture (Kitaibaraki City, Takahagi City, Hitachi City, Hitachinaka City, Oarai Town, Kashima City, and Kamisu City). The symbols and their meanings are the same as in Fig. 3.

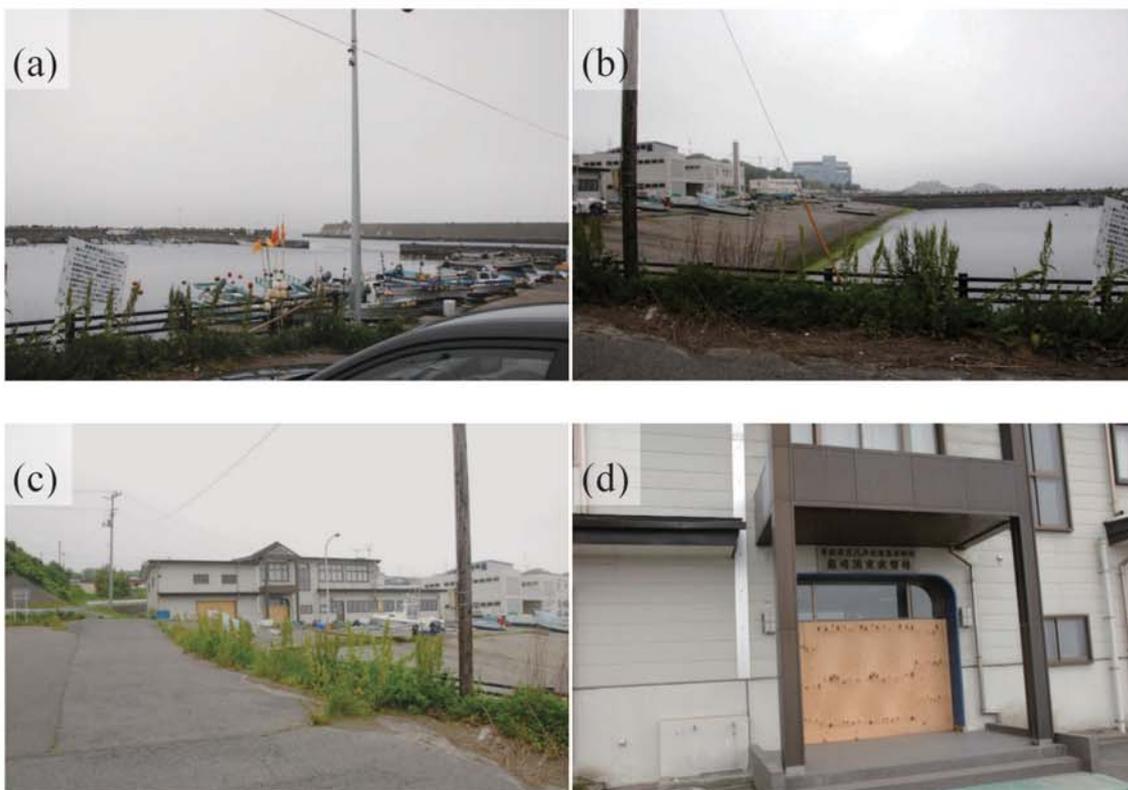
東約2kmに位置する。港内には1辺約130mの正方形の水域があり、この南東角に青森県立八戸水産高等学校の栽培漁業実習場がある。このガラス戸の正面玄関は上端の一部を除いて破損しており、このガラス戸上端の框（かまち）まで浸水したことが証言から得られた。これに基づき測定された浸水高は、6.1mであった（A1、図A2d）。

Fig. A2. (a)-(c) Damage at Ebisuhama district of Hachinohe Fishing Port. (d) Tsunami trace survey point at the laboratory of Hachinohe Fisheries High School (A1).

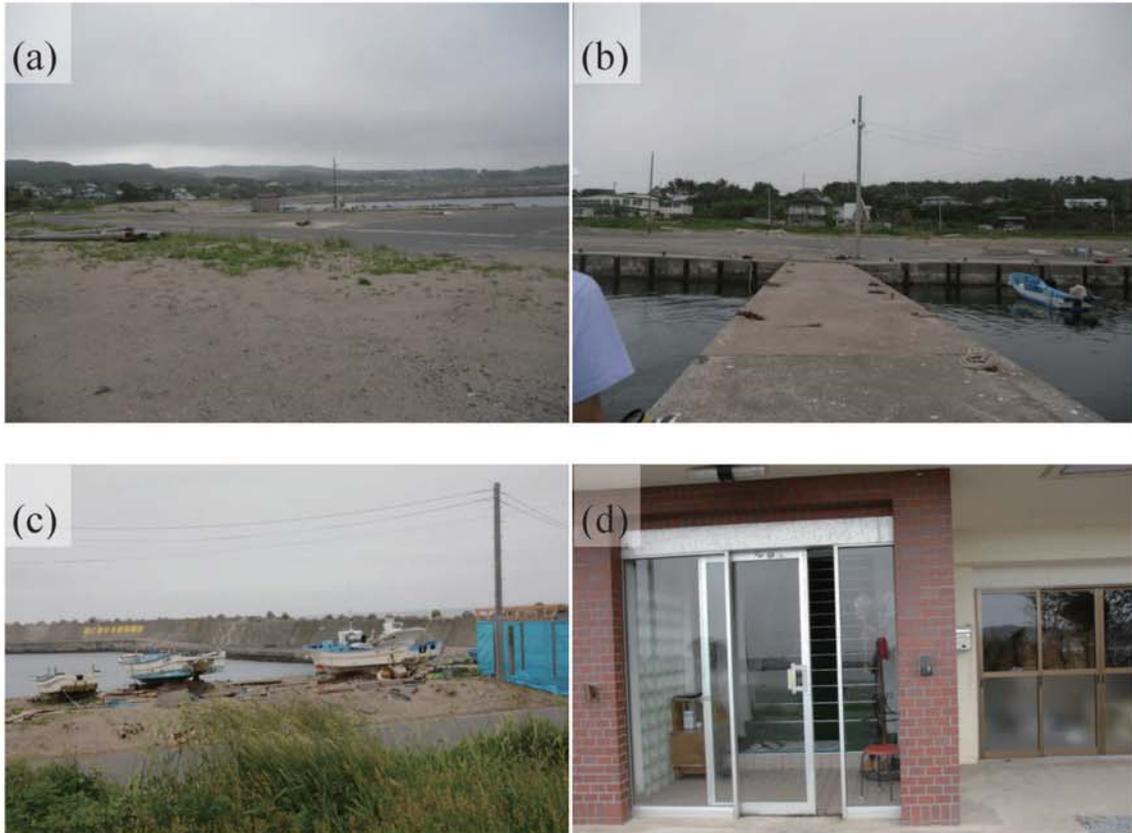
Fig. A4. (a)-(c) Damage at Tanesashi Fishing Port. (d) Tsunami trace survey point at the door header of Mr. Fukuda's house (A2).

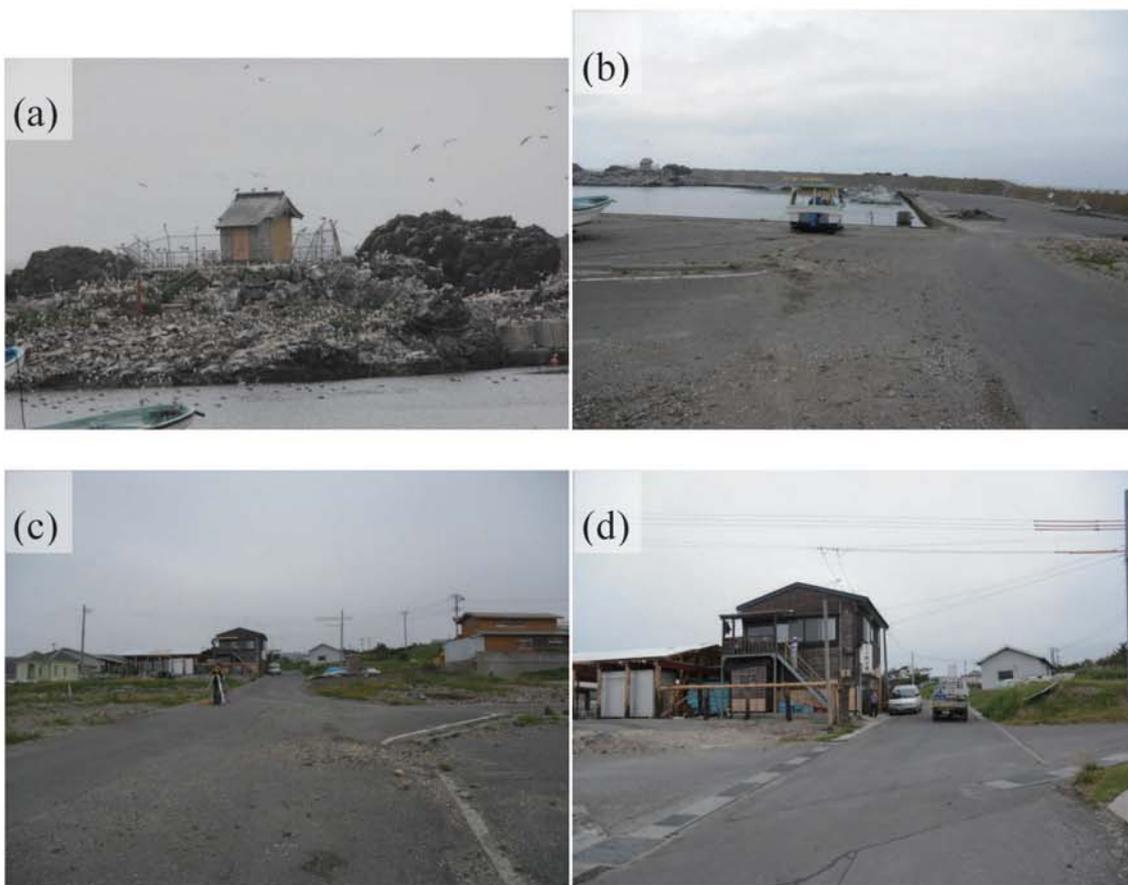
Fig. A6. (a)-(c) Damage at Daisakutai (Okuki Fishing Port). (d) Tsunami trace survey point at the wall of Japanese-style bar Hamagoya (A3)

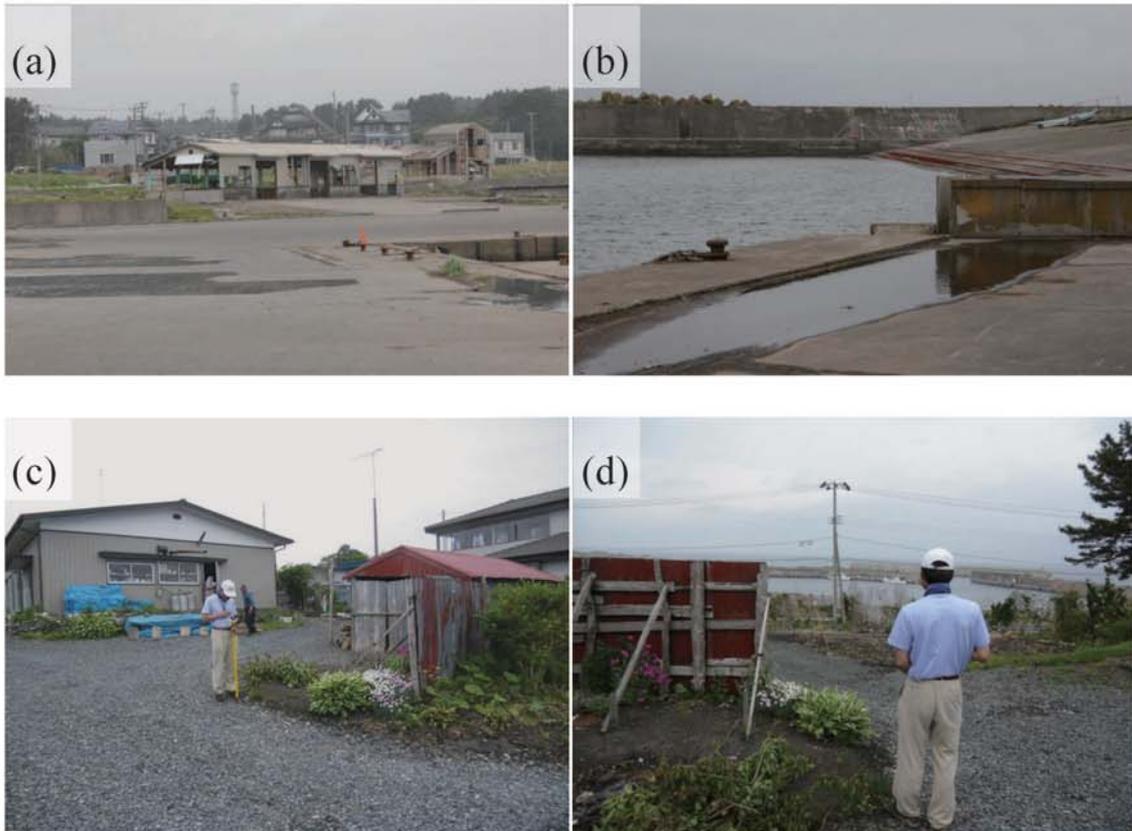
Fig. A8. (a)-(b) Damage at Oja (Oja Fishing Port). (c)-(d) Tsunami trace survey point at the slope in front of Mr. Tetsuzo Tanaka's house (A4).

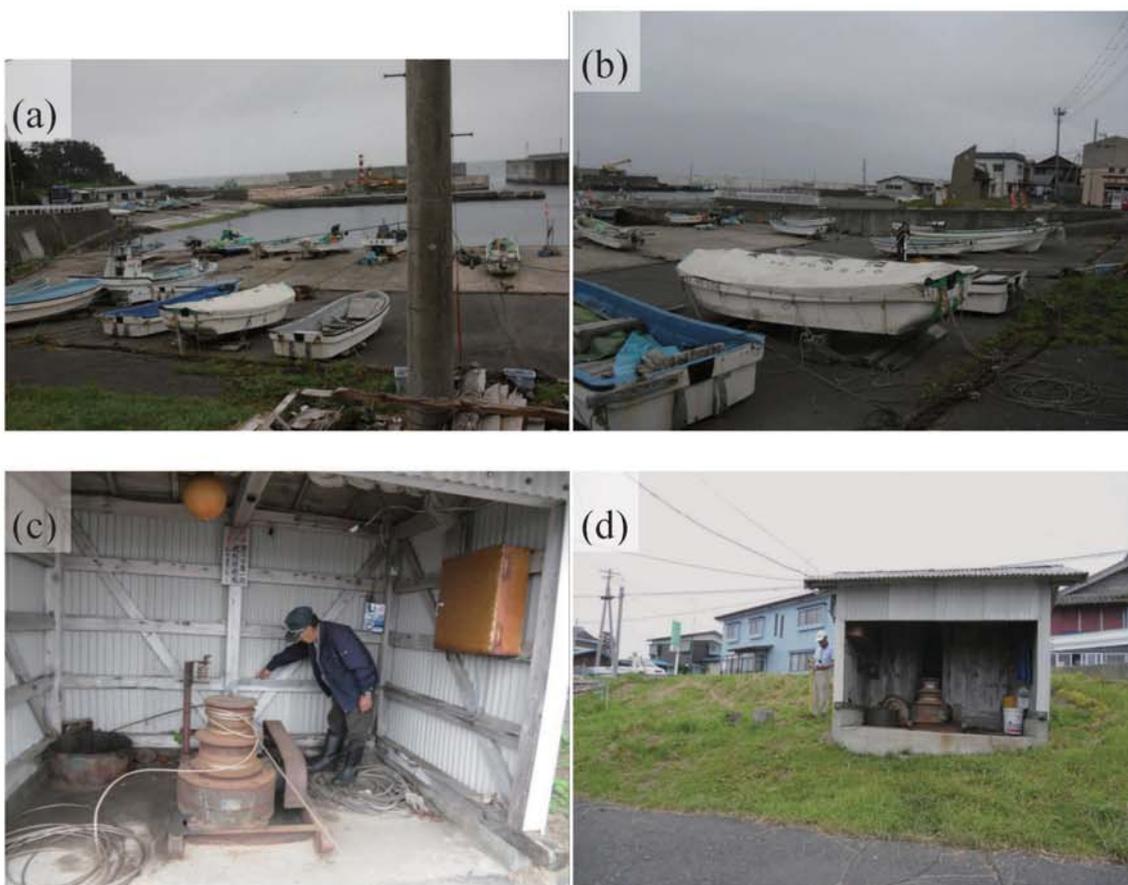
Fig. A10. (a)-(b) Kominato Fishing Port. (c) Inundation height in the winch lodge. (d) Tsunami trace survey point at the slope (A5).

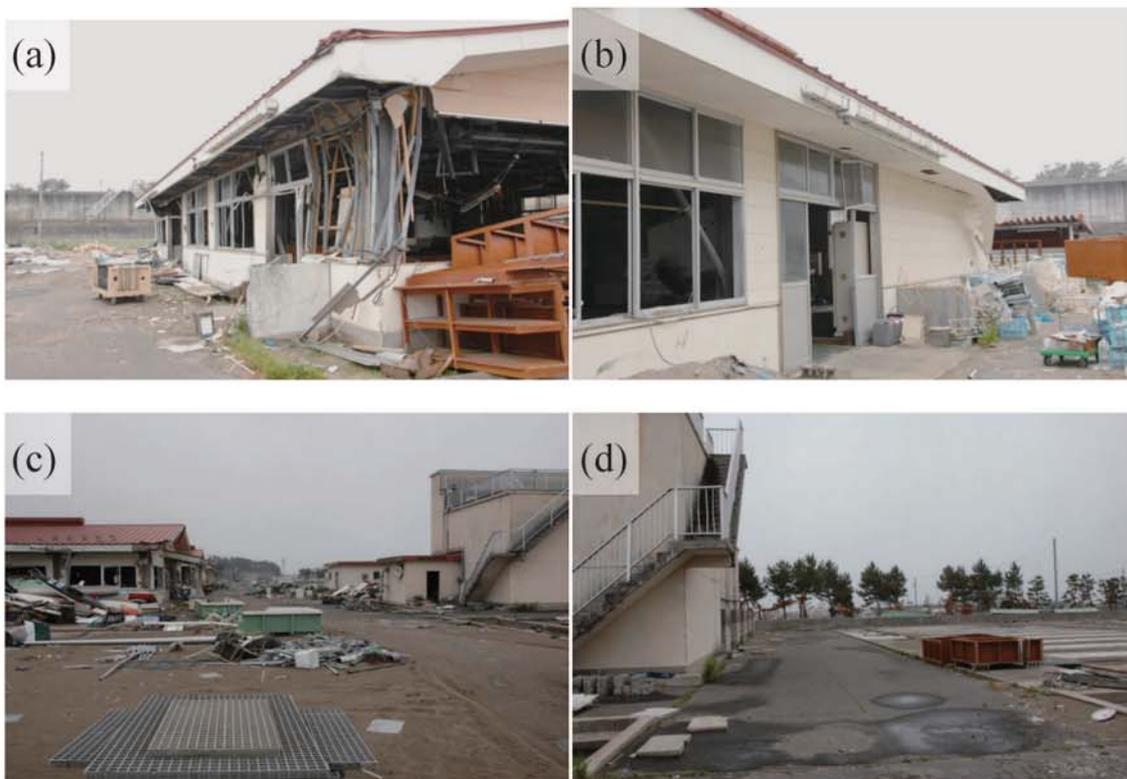
ち、最も大きな作業場がある建物では、1階天井まで浸水した痕跡が認められ、また天井面の蛍光灯に破損が見られた(図 A14a)。この建物に隣接した冷凍倉庫の外部では、階段の手すり作業場1階天井とはほぼ同じ高さで破損しており、これに基づき測定された浸水高は、6.8mであった(図 A14d)。

Fig. A14. (a)-(c) Damage at Taneichi Fishing Port. (d) Tsunami trace survey point at the step (I2).

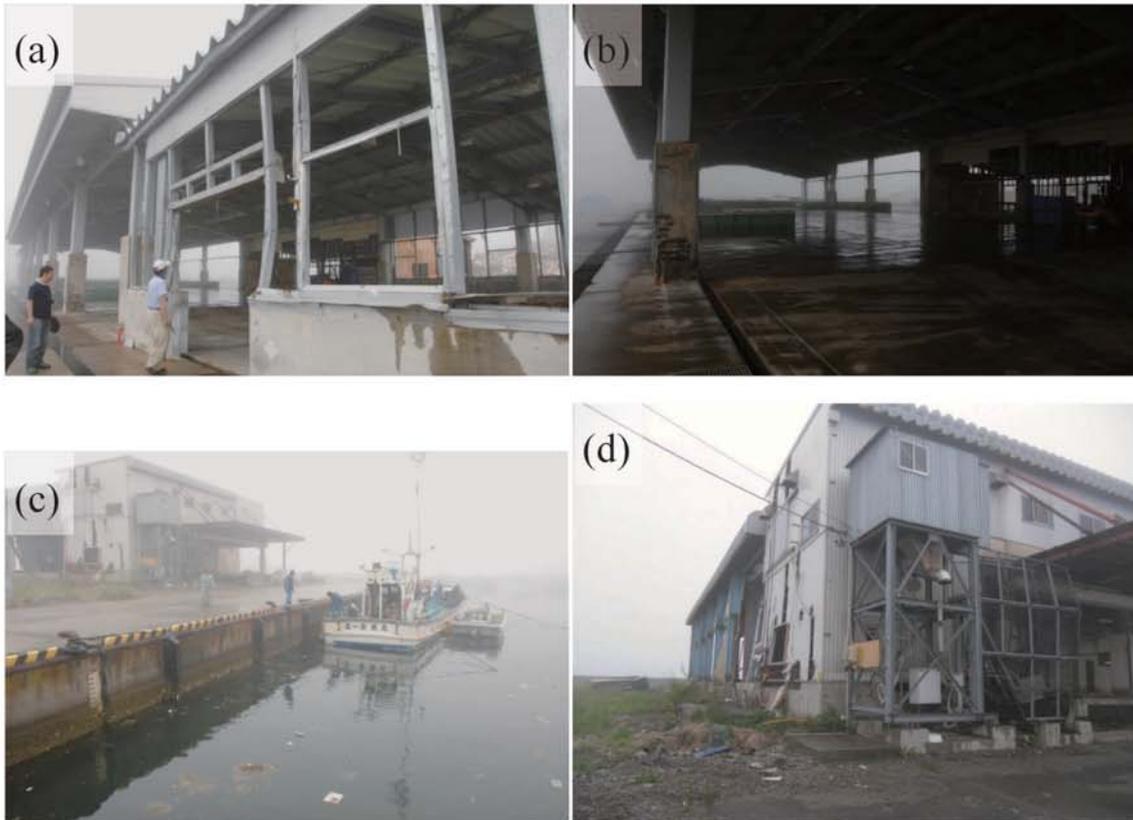
種市(八木港)(津波高;図 A15, 被害状況ならびに津波痕跡調査地点;図 A16)は大型船舶の停泊が可能な北港と、漁船の停泊に供される南港からなる。北港の漁業市場ビル内部の電気設備には浸水した形跡が認められた。この屋舎の壁面は頂上から約0.5m下まで破損して

Fig. A16. (a)-(c) Damage at Yagi Port. (d) Tsunami trace survey point at a damaged wall of the fish market (I3).

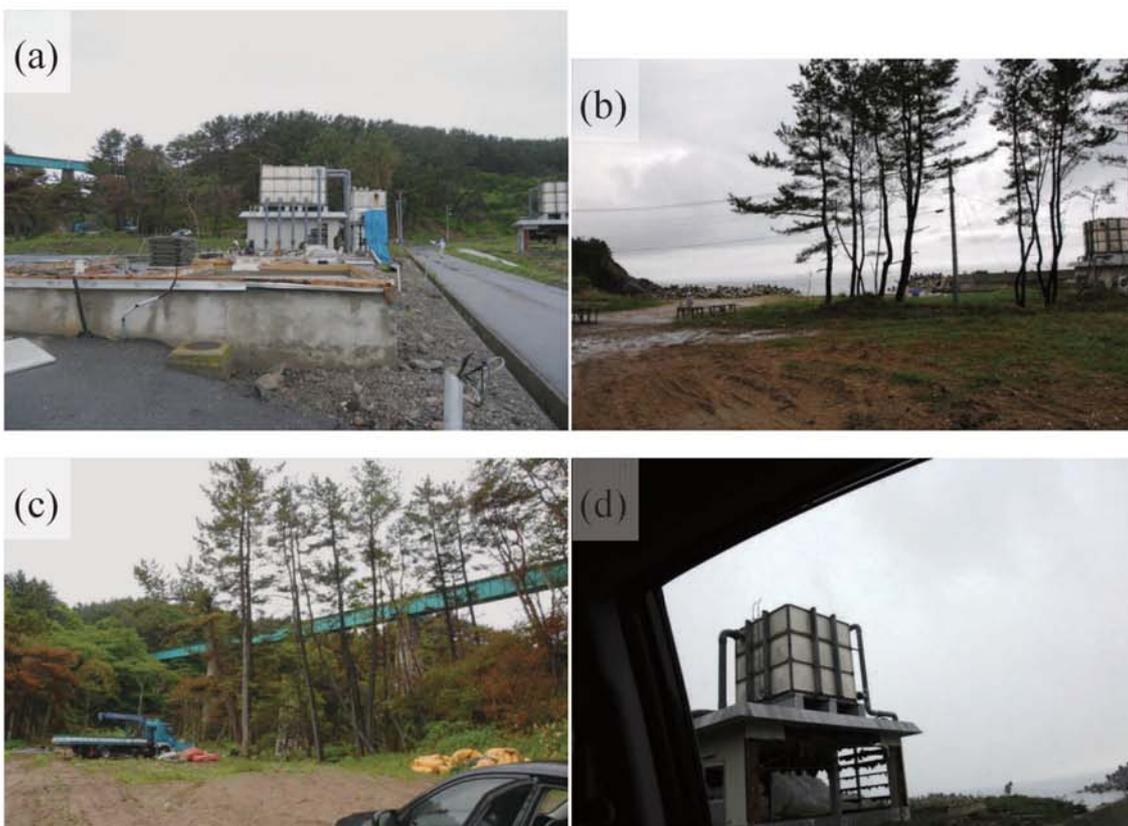
有家(うげ)(有家漁港)(津波高;図 A17, 被害状況ならびに津波痕跡調査地点;図 A18)は、JR八戸線有家駅付近の踏切を横断した後、線路に平行して走る道路を約1.5km南下したところにある。この踏切付近の線路は津波により曲げられており、不通になっていた。有家漁港において工事に携わる人の目撃証言から、工事用住宅区域内にある給水塔ビルの屋根上端まで浸水したことが明らかとなった。周辺の植物堆積や給水塔ビルの破損、ならびに証言に基づき測定された浸水高は、8.1mで

Fig. A18. (a)-(c) Damage at Uge (Uge Fishing Port). (d) Tsunami trace survey point at a damaged water tower (I4).

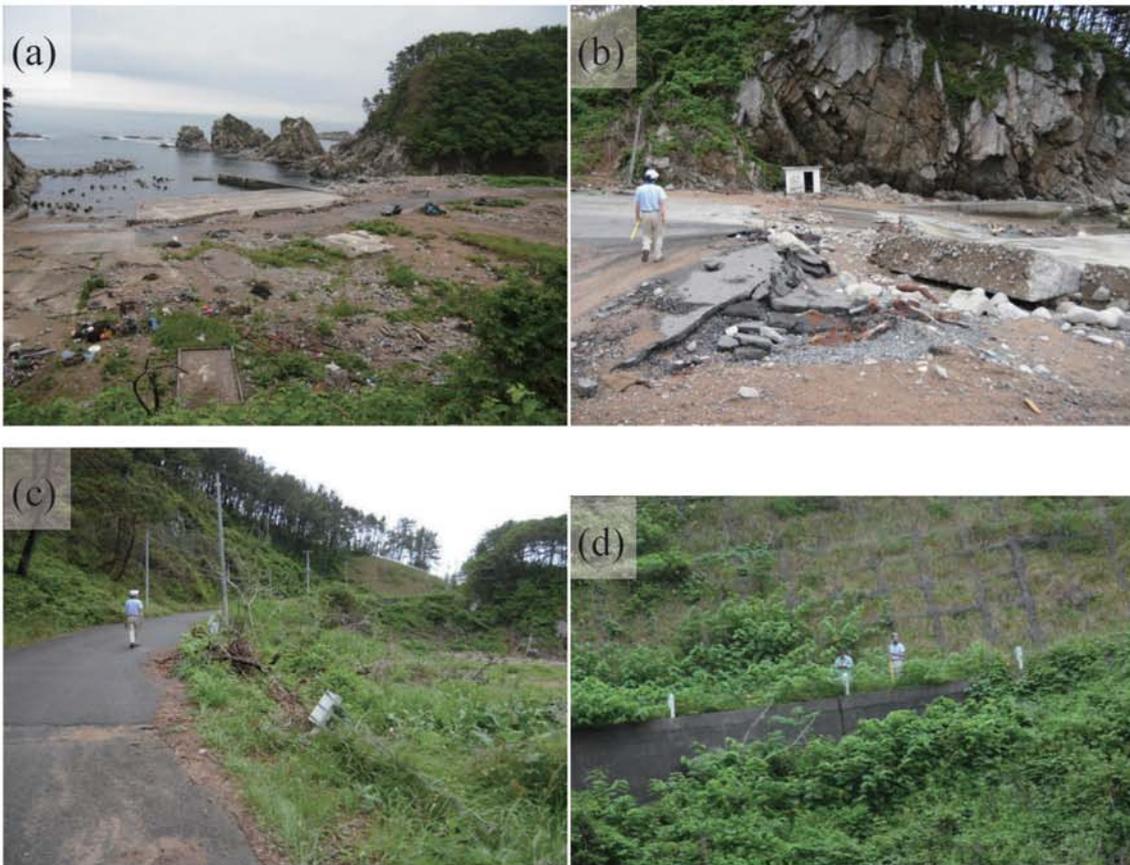
Fig. A20. (a)-(c) Damage at Nakano (Koge Fishing Port, Koge district). (d) Tsunami trace survey point at a slope (I5).

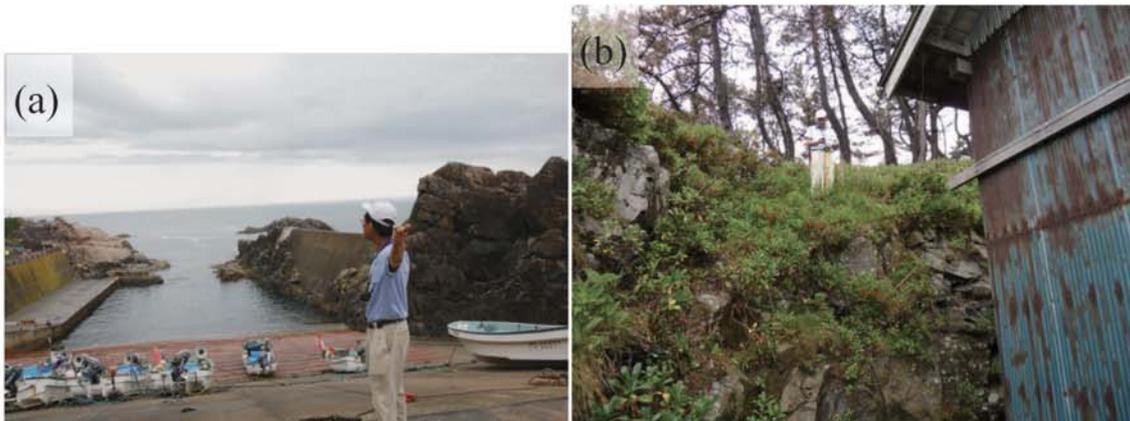
Fig. A22. (a) Damage at Takonoki Fishing Port. (b) Tsunami trace survey point (I6).

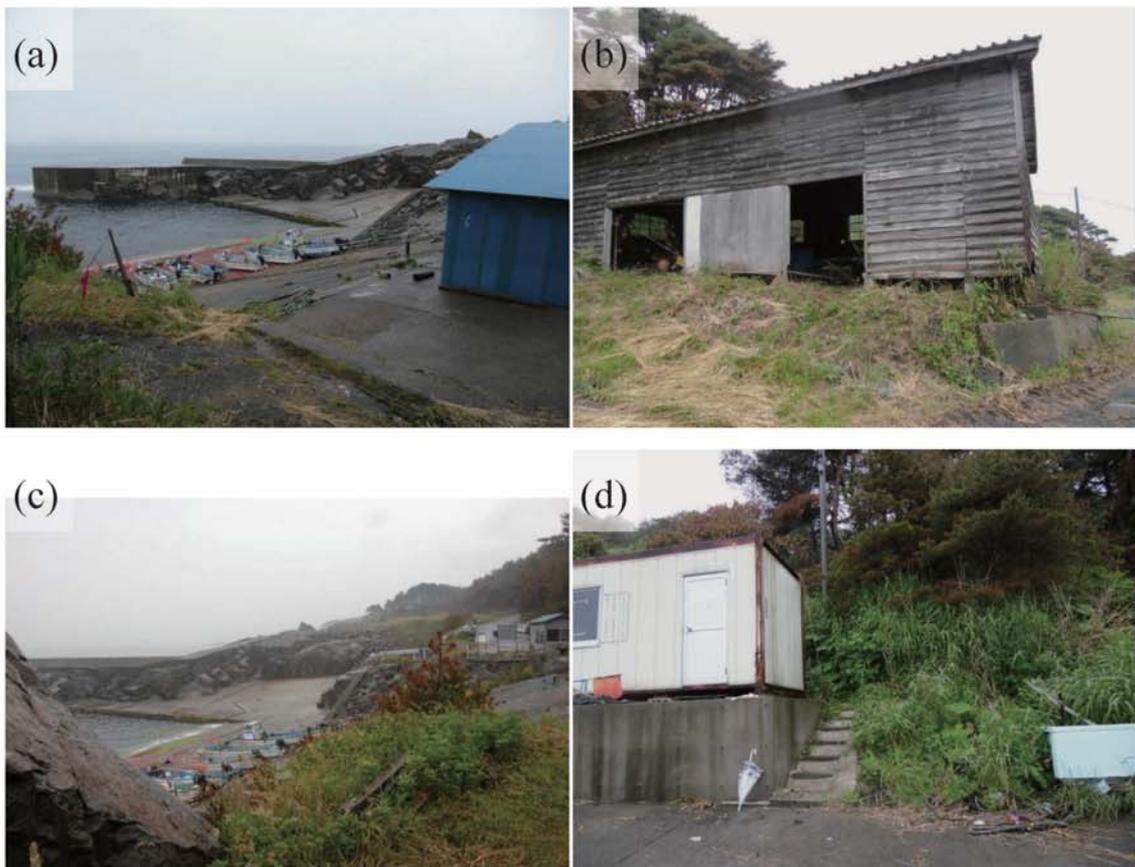
Fig. A24. (a)-(c) Damage at Samuraimachō-Mukaicho (Kawatsunai Fishing Port, Kawatsunai District). (d) Tsunami trace survey point (I7).

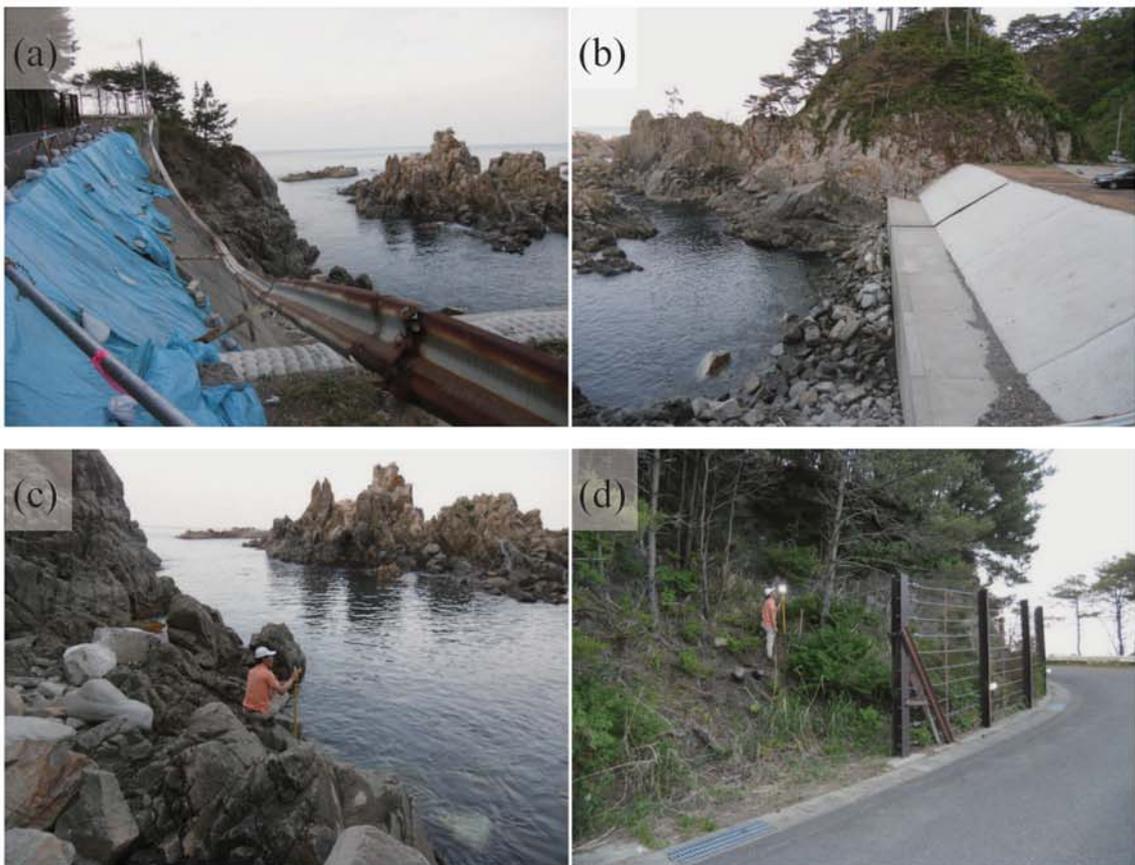
Fig. A26. (a)-(c) Damage at Samuraihamacho-Shiromae (Shiromae Fishing Port, Shiromae District). (d) Tsunami trace survey point at a slope (I8).

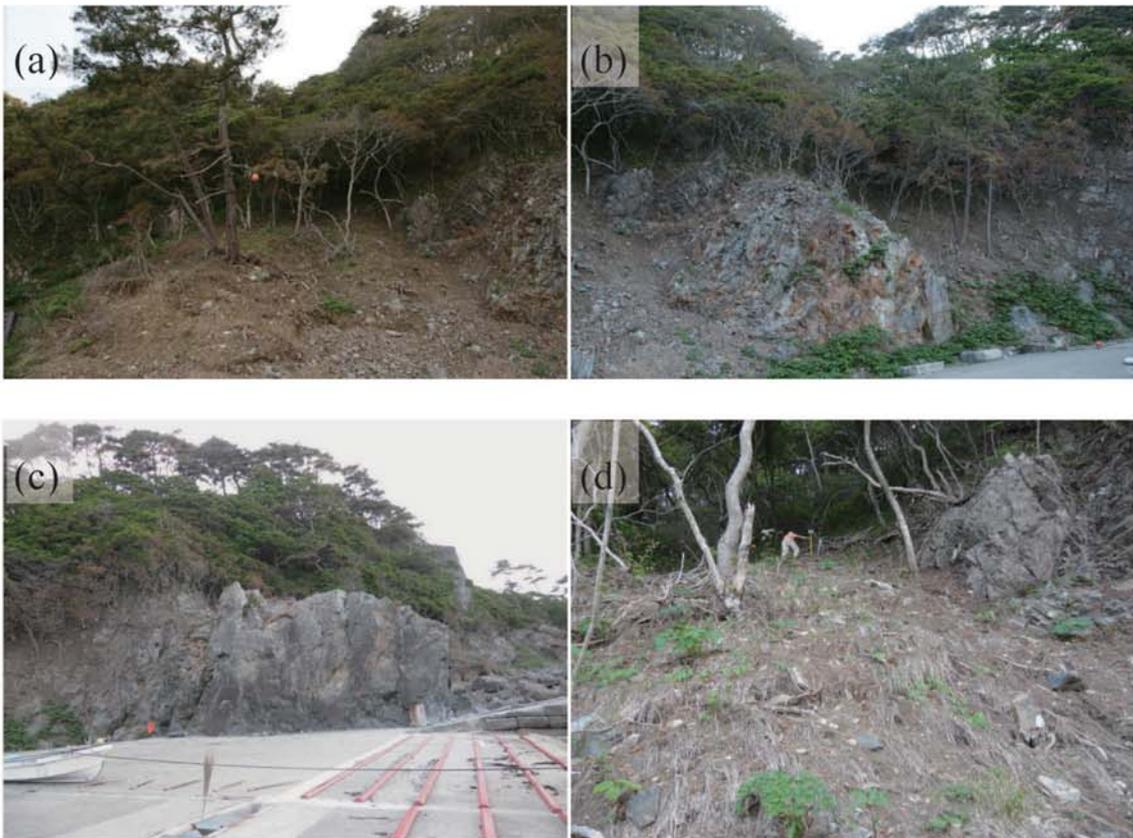
Fig. A28. (a)-(c) Damage at Samuraihamacho-Honnami (Shiromae Fishing Port, Honnami District). (d) Tsunami trace survey point at a slope in front of Shiromae Fishing Port (Honnami district) (I9).

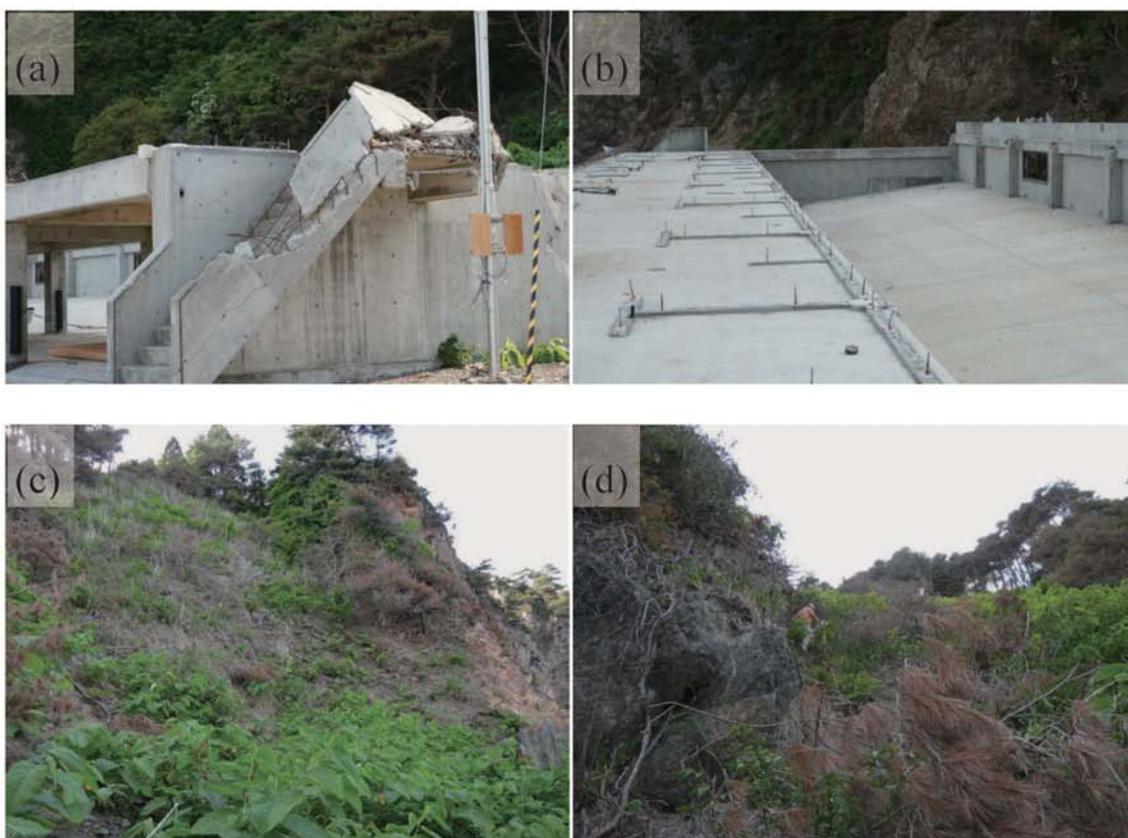
Fig. A30. (a)-(b) Damage at Samurairhamacho-Mugyo (Mugyo Fishing Port). (c)-(d) Tsunami trace survey point at the northern slope of Mugyo Fishing Port (I10).

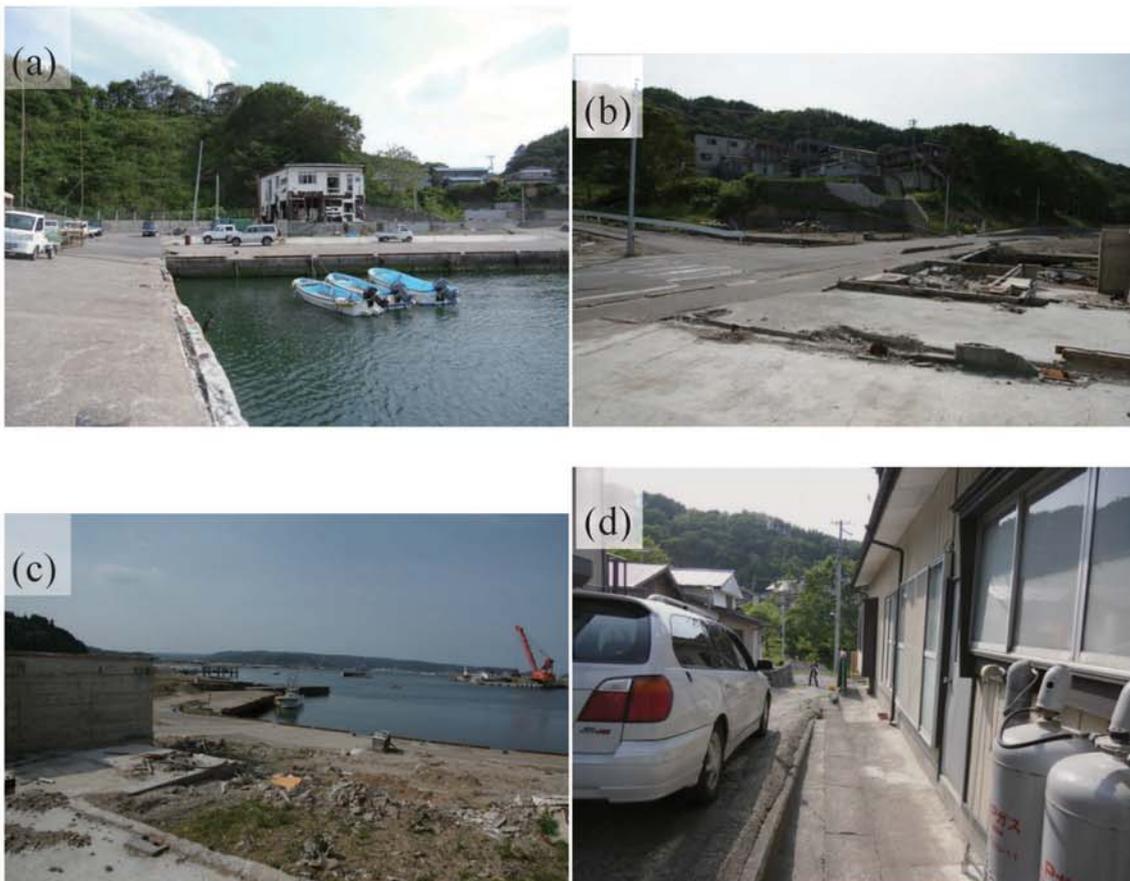
所から国道45号線を少し北に進むと山側に入る道路があり, その小道を登った場所に浜欠 (はまかけ) 氏宅がある. 居住者の証言から, 玄関前の床面まで津波が遡上したことが明らかになり, これに基づき測定された遡上高は, 10.7m であった (I11, 図 A32d).

Fig. A32. (a)-(c) Damage at Osanaicho (Tamanowaki; Tamanowaki Fishing Port). (d) Tsunami trace survey point in front of Mr. Hamakake's house (I11).

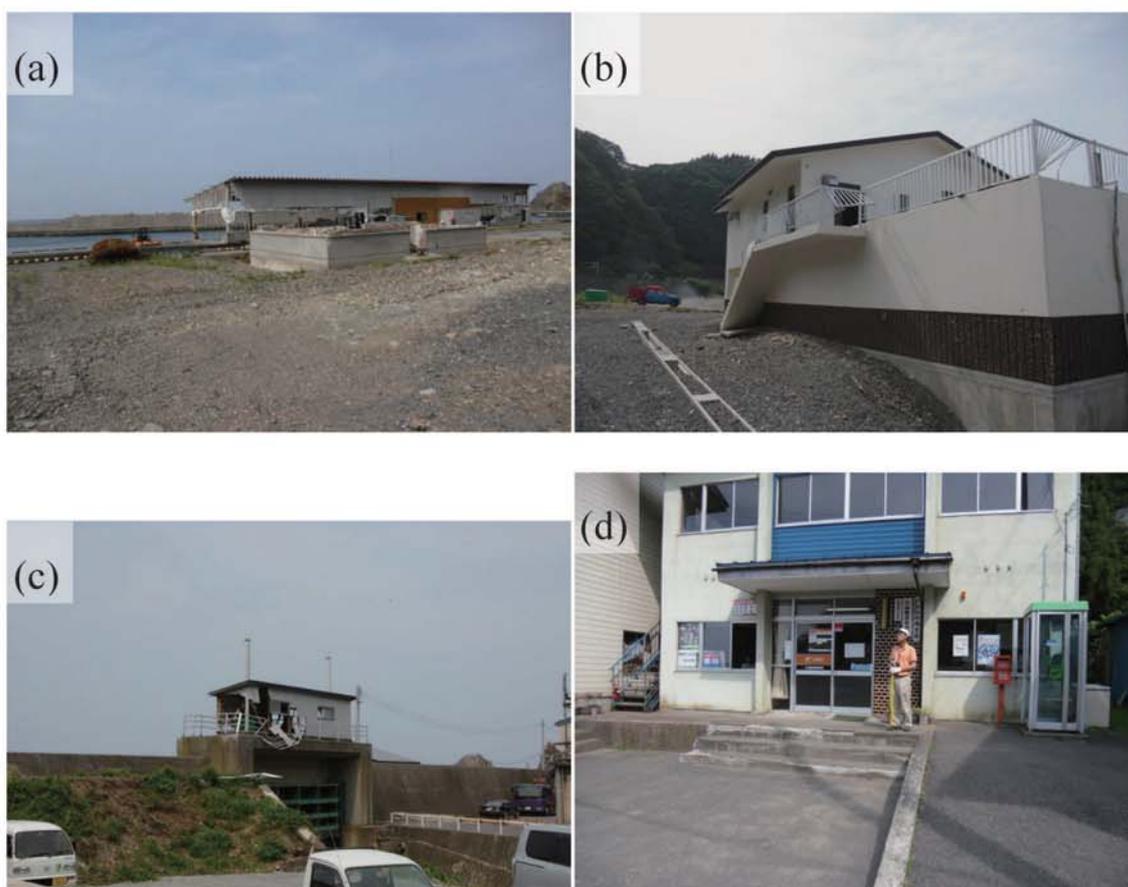
宇部町 (小袖; 小袖漁港小袖地区周辺) (津波高; 図 A33, 被害状況ならびに津波痕跡調査地点; 図 A34) では, 防潮堤の水門制御施設において, 天井付近まで壁板の破損が認められ, これに基づき測定された浸水高は12.0m であった (I12, 図 A34c). また, 小袖簡易郵便局前のコンクリート床面まで津波が遡上したことが郵便局員の証言から明らかとなり, これに基づき測定された遡上高は, 8.2m であった (I13, 図 A34d). 集落はすべて郵便局より標高が高く, 津波被害を免れていた. なお, 防潮堤より海側には漁業施設があったが, その2階上部まで浸水痕跡が認められた.

Fig. A34. (a)-(b) Damage at Ubecho (Kosode). (c) Tsunami trace survey point at the damaged regulation plant of a water gate. (I12). (d) Tsunami trace survey point in front of Kosode post office (I13).

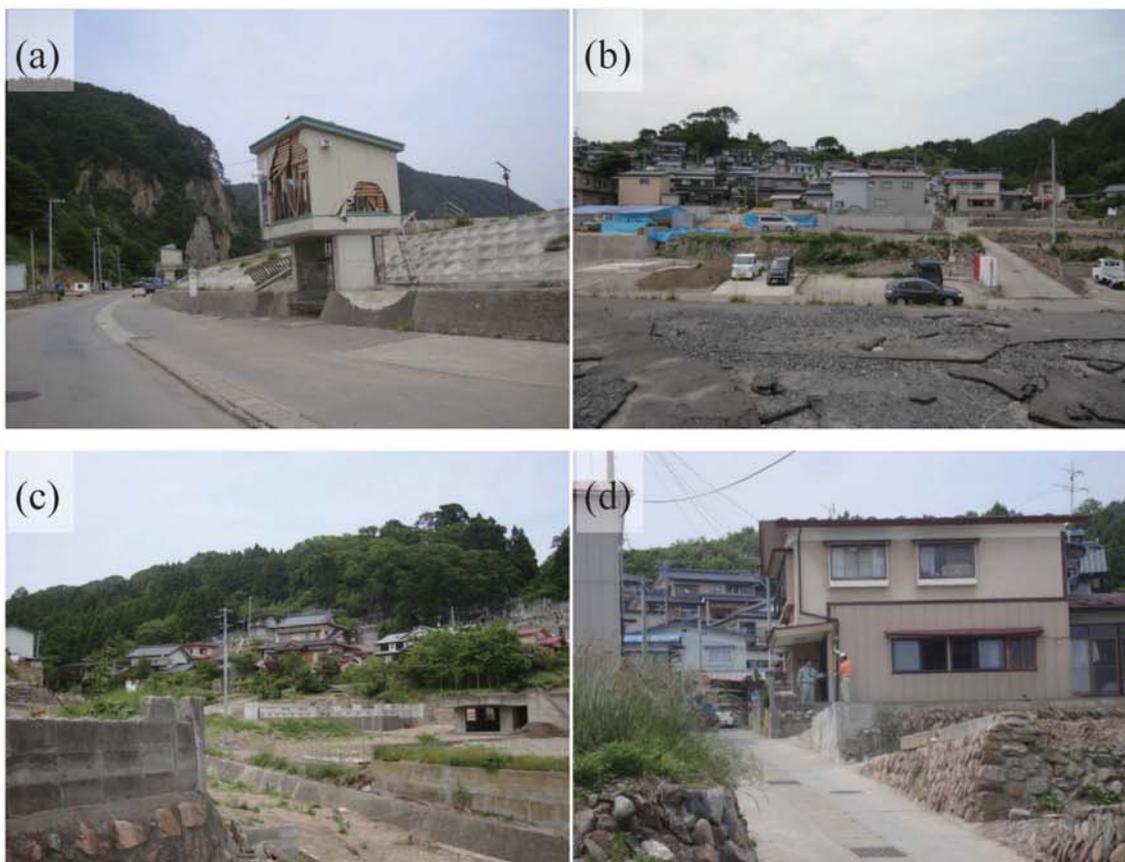
宇部町 (久喜; 久喜漁港) (津波高; 図 A37, 被害状況ならびに津波痕跡調査地点; 図 A38) は, 防潮堤の内側に住宅が雛壇状に建ち並ぶ地区であり, 海岸道路に沿った家屋が津波によって流失していた (図 A38b). 海岸から内陸部に至る細い道路の北側にある坂本氏宅では, 玄関の床面から高さ1mまで浸水したことが, 証言により得られた. この証言ならびに配電器具の損傷に基づき測定された浸水高は, 14.6m であった (I15, 図 A38d).

Fig. A38. (a)-(c) Damage at Ubecho (Kuki). (d) Tsunami trace survey point (I15) (1m above ground level at Mr. Sakamoto's house).

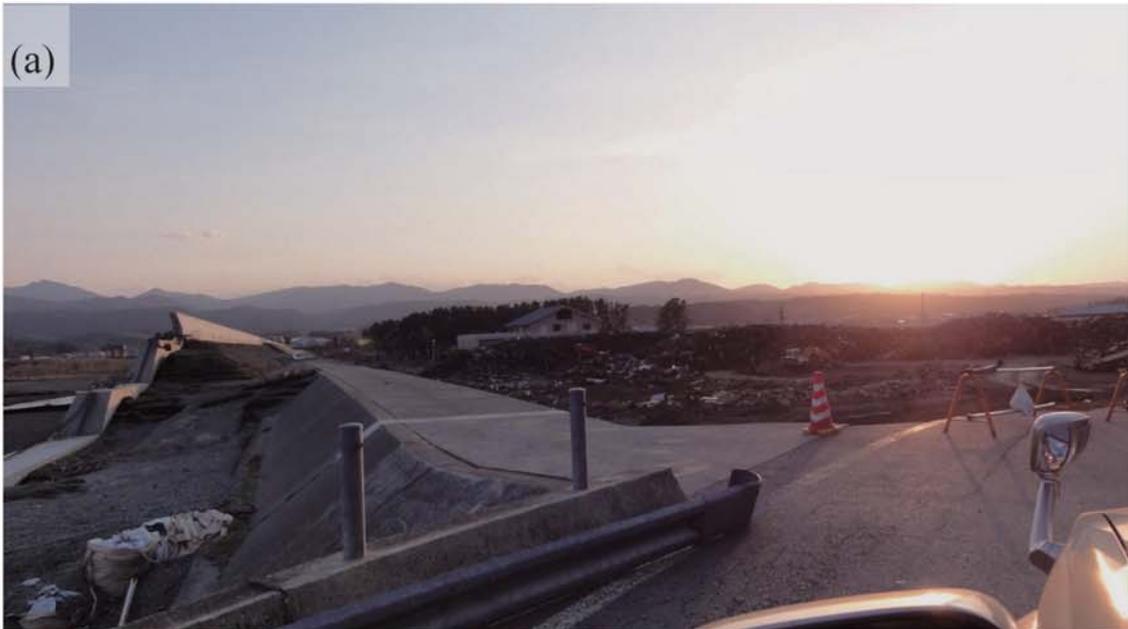
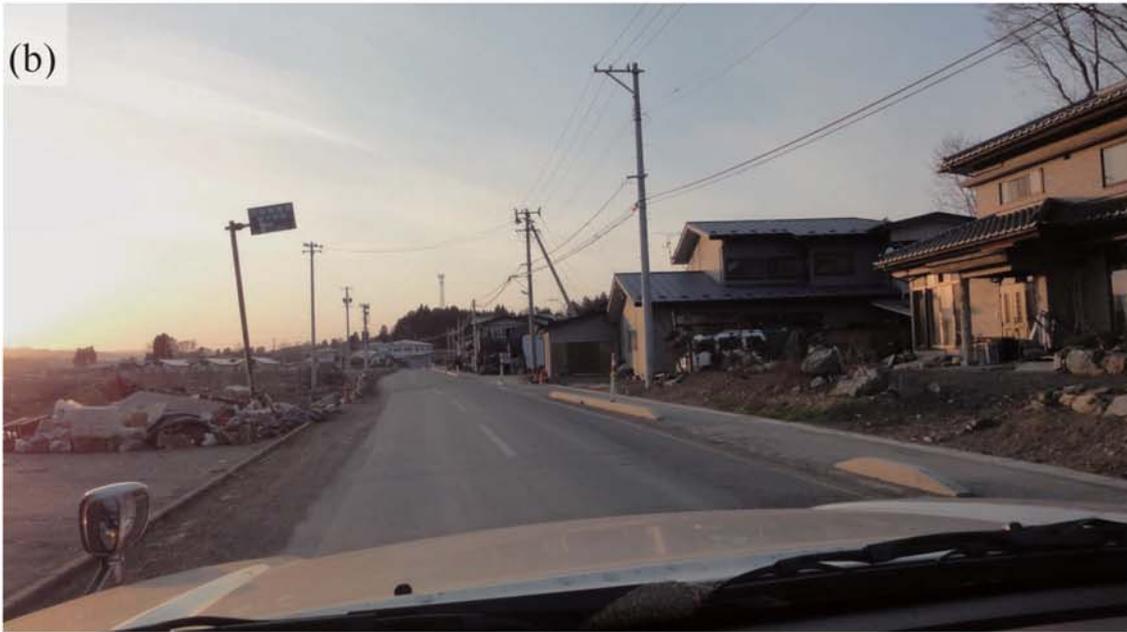
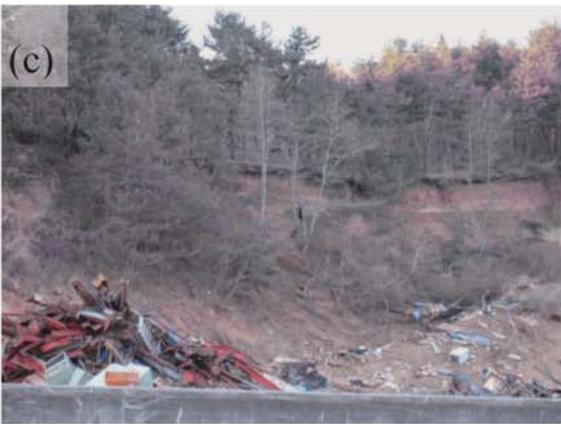
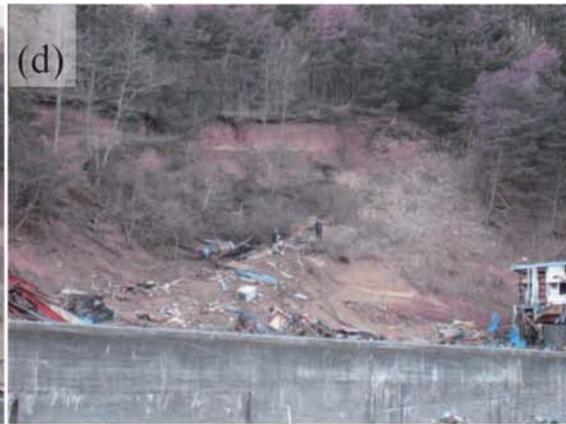
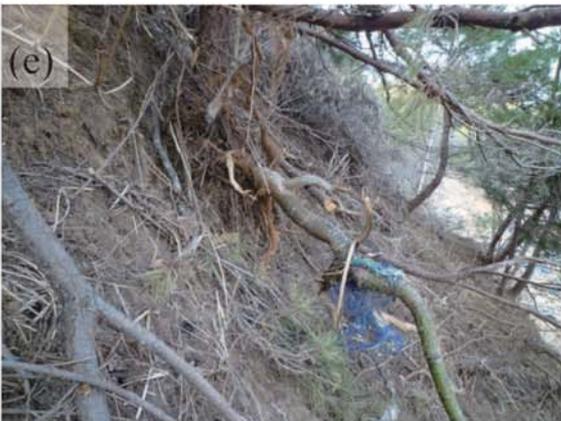
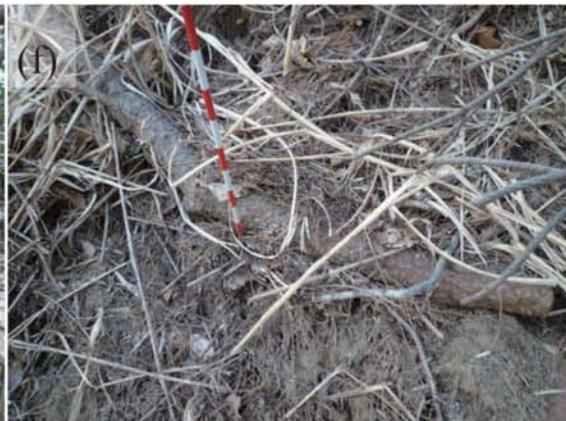
野田 (野田漁港) (津波高; 図 A39, 被害状況ならびに津波痕跡調査地点; 図 A40) では, 野田漁港の北西側に位置する海沿いの崖において堆積物, 雑草流跡や植生に基づき22.8mの遡上高が測定された (I16, 図 A40c). また, 瓦礫等の漂着物の上限に基づいて測定された遡上高は16.4mであった (I17, 図 A40d). 海沿いの崖の階段脇の斜面では, 漁業用具が木の枝に付着しており, これより下部で手すりの折れや街灯の破損が認められた. これに基づく遡上高は18.5mであった (I18, 図 A40e, f).

Fig. A40. (a)-(b) Damage at Noda. (c) Tsunami trace survey point at a slope (I16). (d) Tsunami trace survey point at the top of debris (I17). (e)-(f) Tsunami trace survey point at a slope next to steps (I18).
