2011年東北地方太平洋沖地震の津波高調査

Field Surveys of Tsunami Heights from the 2011 off the Pacific Coast of Tohoku, Japan Earthquake

We report the results of field surveys conducted by the Earthquake Research Institute, to measure tsunami heights from the 2011 off the Pacific coast of Tohoku, Japan Earthquake (M 9.0), on March 11. Measurements were taken at 296 points on the Sanriku coasts of Aomori, Iwate, and Miyagi Prefectures, and the Pacific coasts of Ibaraki and Chiba Prefectures. The data are included in the results of the 2011 Tohoku Earthquake Tsunami Joint Survey Group. We did not cover the Sendai plain in the southern Miyagi Prefecture because other parties extensively measure there, nor Fukushima Prefecture because of the accident of the Fukushima Dai-ichi nuclear power plant. The twelve surveys first sought traces indicating tsunami runup or inundation heights. Reliability was classified into A (most reliable based on clear physical evidence and eyewitness accounts), B (mostly based on natural traces), and C (least reliable based on equivocal evidence). Most physical evidence obtained after June was not significant; therefore, reliance was mostly placed on eyewitness accounts. Loc

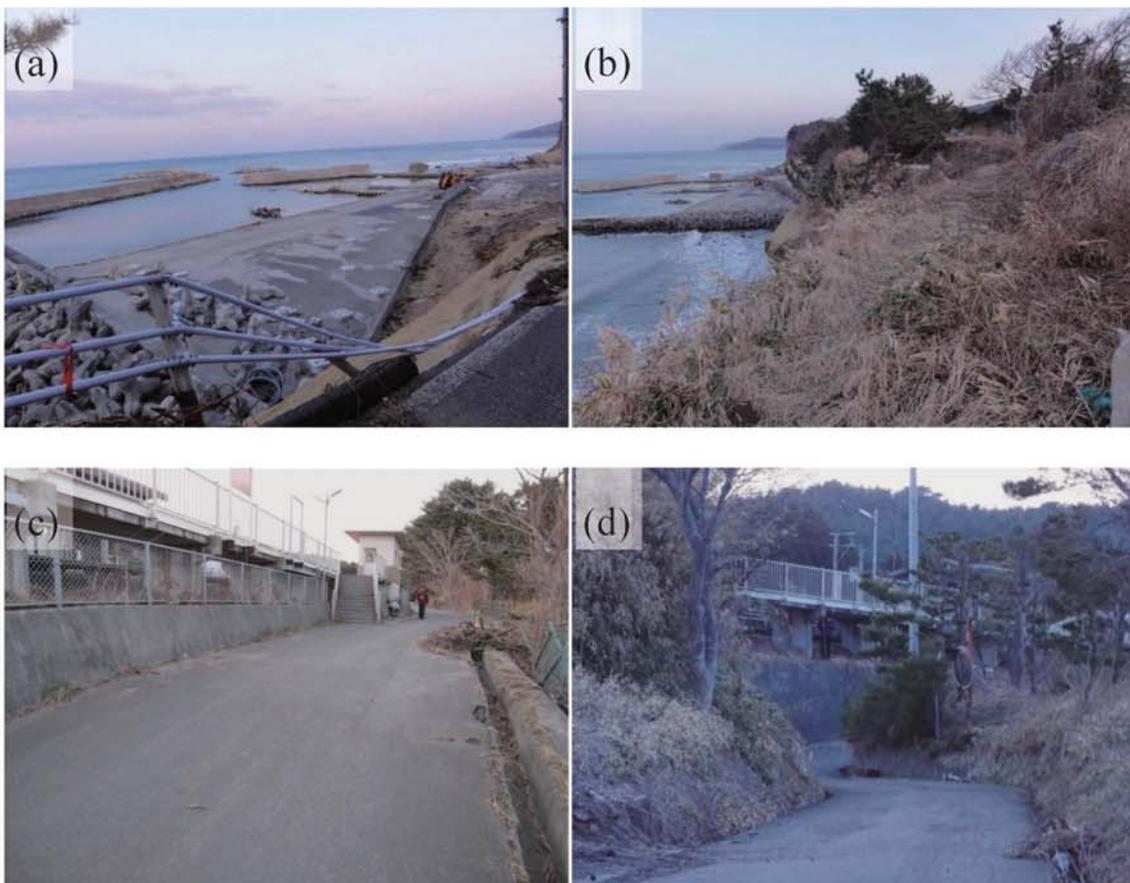
Fig. A44. (a)-(b) Damage at Tamagawa Fishing Port. (c) Damage at Nodatamagawa station of Sanriku railway. (d) Tsunami trace survey point below the platform of Nodatamagawa station (I20).

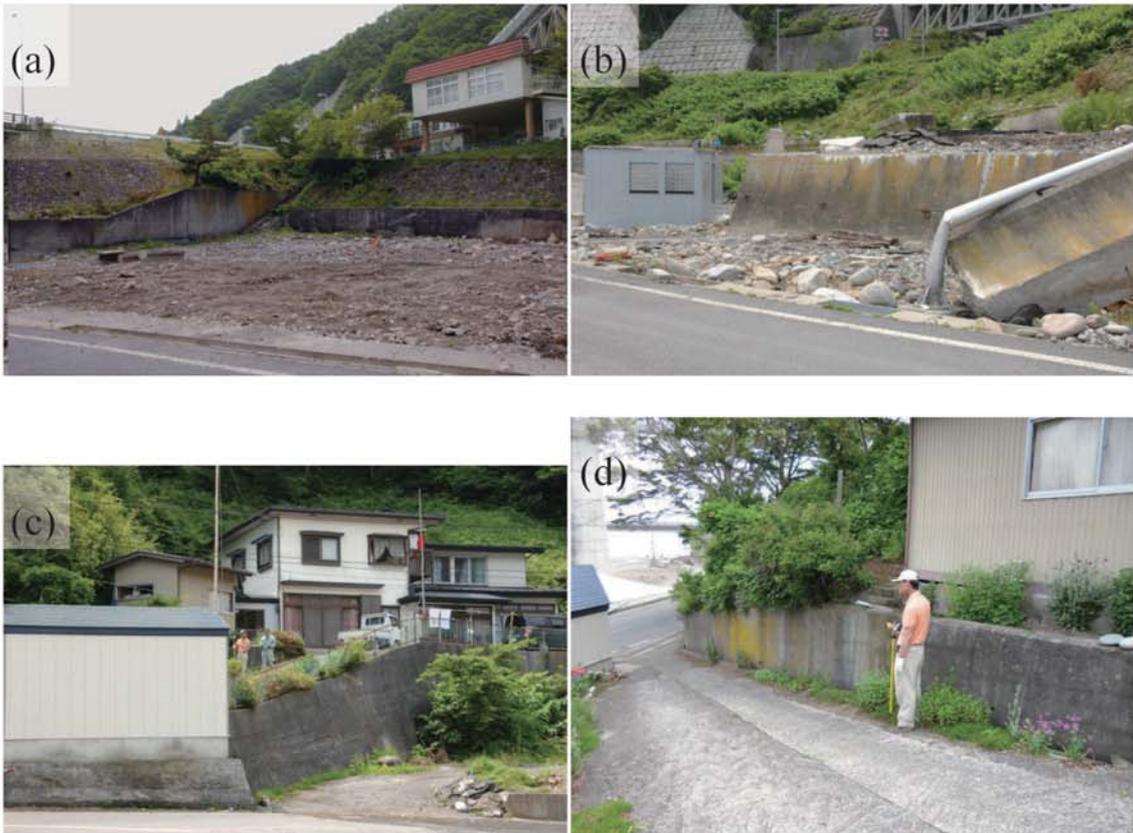
Fig. A46. (a)-(b) Damage at Tamagawa (Shimoakka). (c)-(d) Tsunami trace survey point at the slope leading to Mr. Ono's house. (I21).

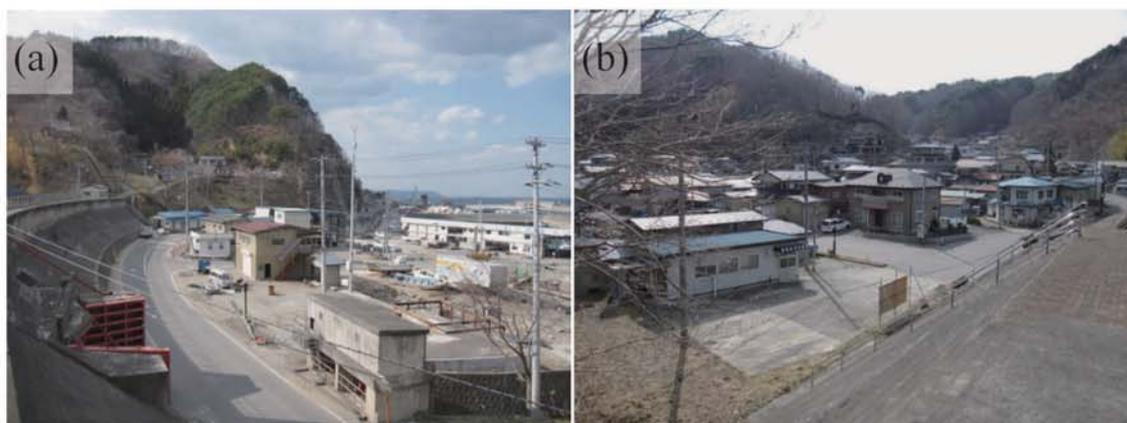
太田名部 (太田名部漁港) (津波高; 図 A47, 被害状況ならびに津波痕跡調査地点; 図 A48) では、高さ 15 m の防潮堤が居住区への津波を防ぎ、防潮堤より海側における魚市場等で被害があったものの (図 A48a), 防潮堤より内陸では顕著な被害は認められなかった (図 A48b)。防潮堤より海側にある魚市場では、看板が剥離または折れ曲がっており、プリズムを用いずにレーザー測距計によってこれを測定したところ、8.4 m の浸水高であった (I22, 図 A48c)。また、おおた美容院壁面には明瞭な浸

Fig. A48. (a) Destructive damage outside the coastal levee (Otanabe Fishing Port). (b) Very minor damage inside the coastal levee (residential district). (c) Tsunami trace survey point at the name board of the fish market (I22) (d)-(e) Watermark on the wall of a hair salon (2.2 m above ground level; I23). (f) Tsunami trace survey point at the middle of the coastal levee (I24) (g) Tsunami trace survey point at the middle of the coastal levee (I25).

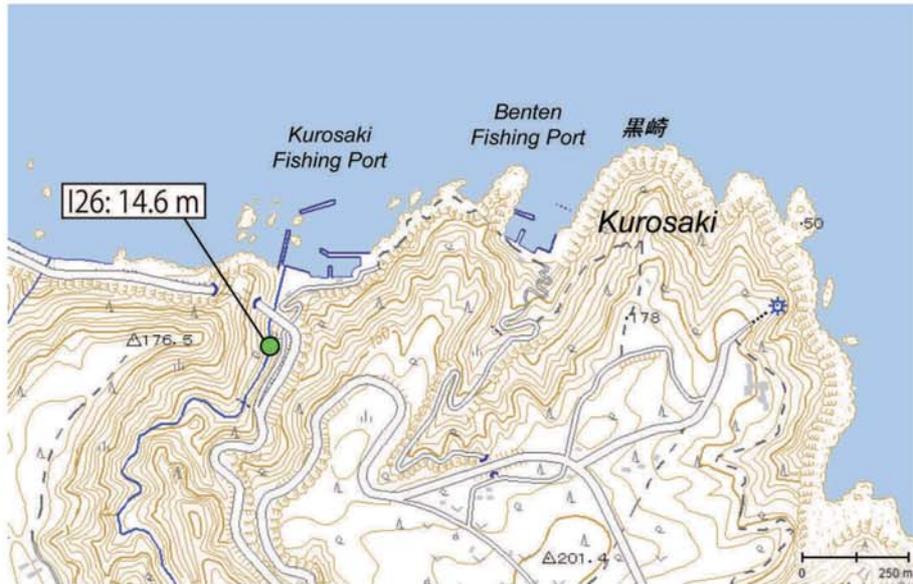
Fig. A49. Tsunami height at Kurosaki (Kurosaki Fishing Port), Fudai Village, Iwate Prefecture (added with digital topographic map 1/25,000 from the Geospatial Information Authority of Japan). The symbol and its meaning are the same as in Fig. 3.

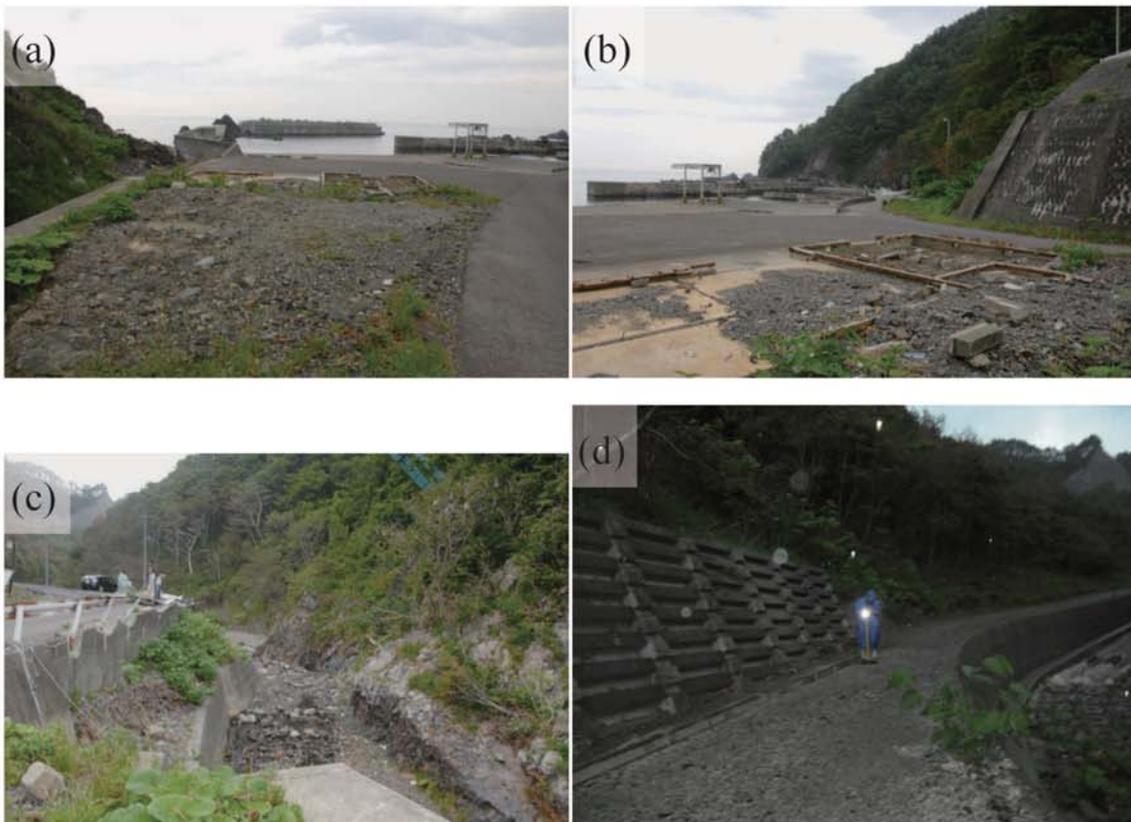
Fig. A50. (a)-(c) Damage at Kurosaki (Kurosaki Fishing Port). (d) Tsunami trace survey point (I26).

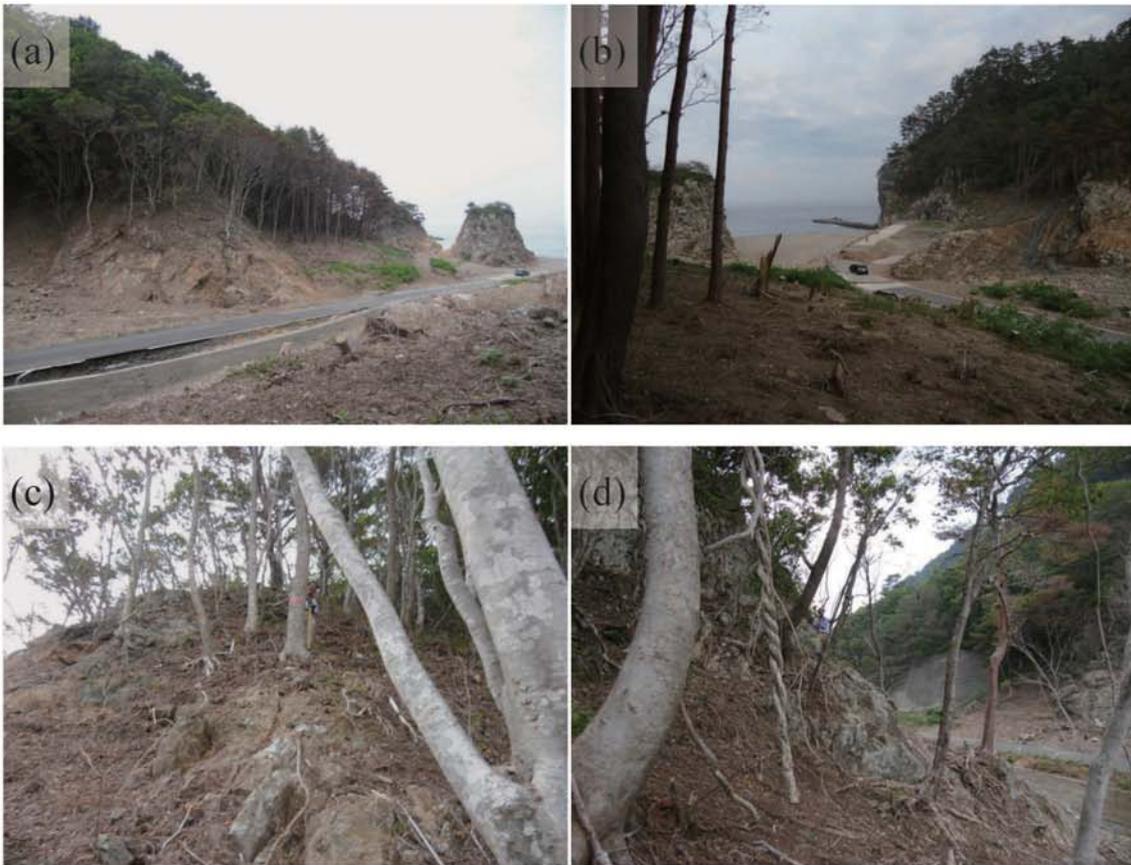
Fig. A52. (a) Damage at Kitayama and Tsukue (Omioishi). (b) Tsunami trace survey point at the northern slope (I27). (c) Tsunami trace survey point at the southern slope (I28). (d) Tsunami trace survey point at the southern slope (I29).

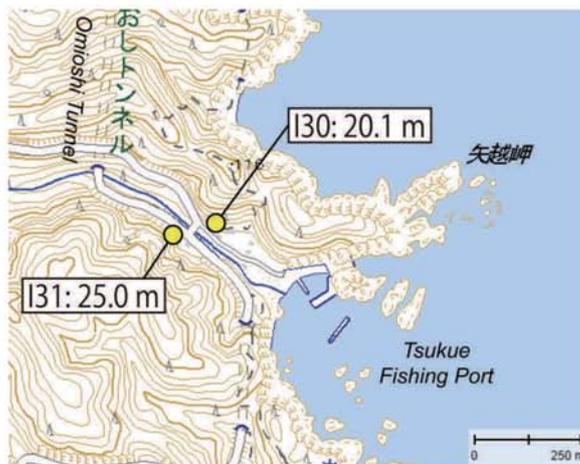
Fig. A53. Tsunami heights at Tsukue, Tanohata Village, Iwate Prefecture (added with digital topographic map 1/25,000 from the Geospatial Information Authority of Japan). The symbols and their meanings are the same as in Fig. 3.

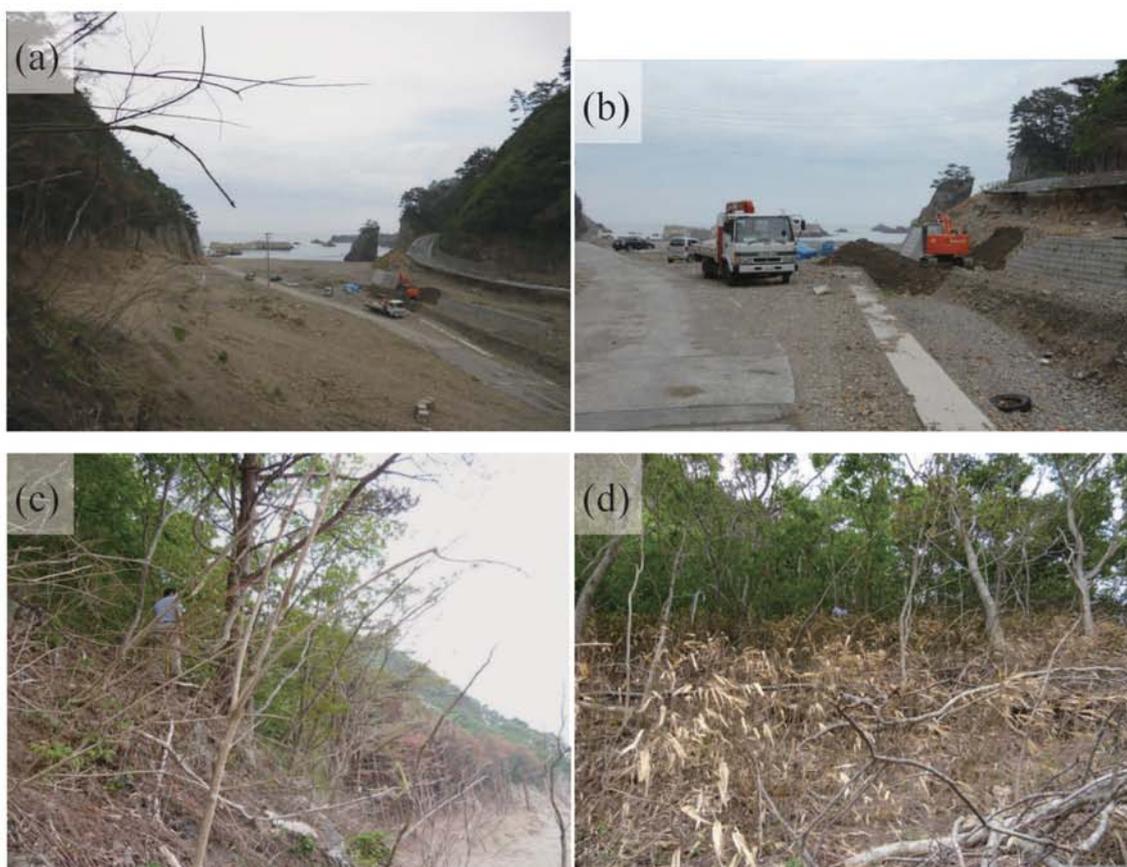
Fig. A54. (a)-(b) Damage at Tsukue Fishing Port. (c) Tsunami trace survey point at the northern slope (I30). (d) Tsunami trace survey point at the southern slope (I31).

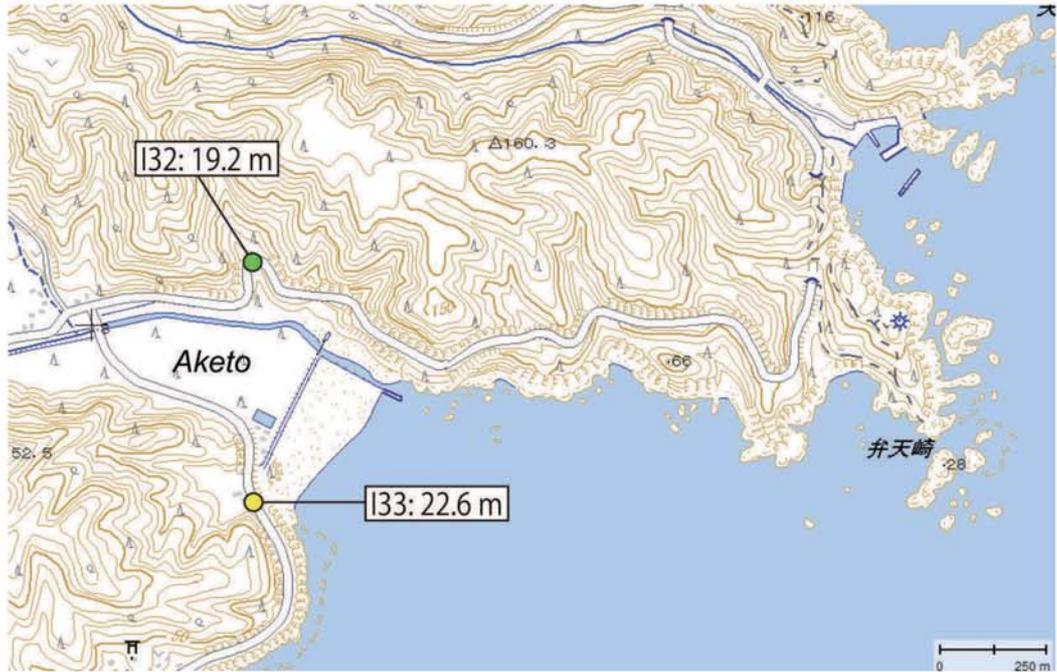
Fig. A55. Tsunami heights at Aketo, Tanohata Village, Iwate Prefecture (added with digital topographic map 1/25,000 from the Geospatial Information Authority of Japan). The symbols and their meanings are the same as in Fig. 3.

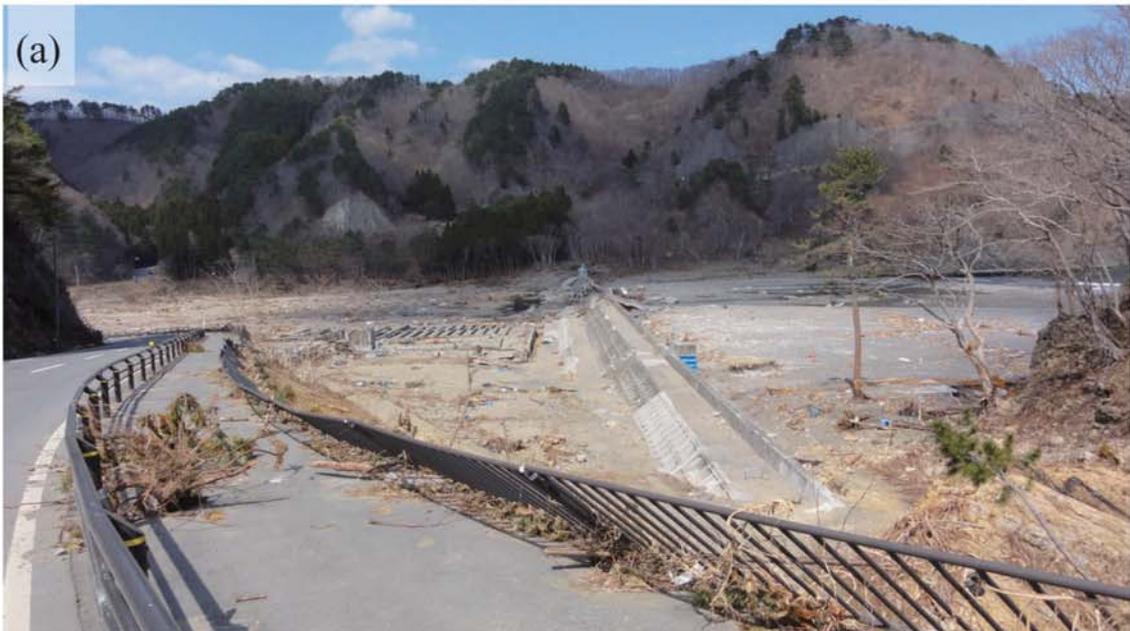
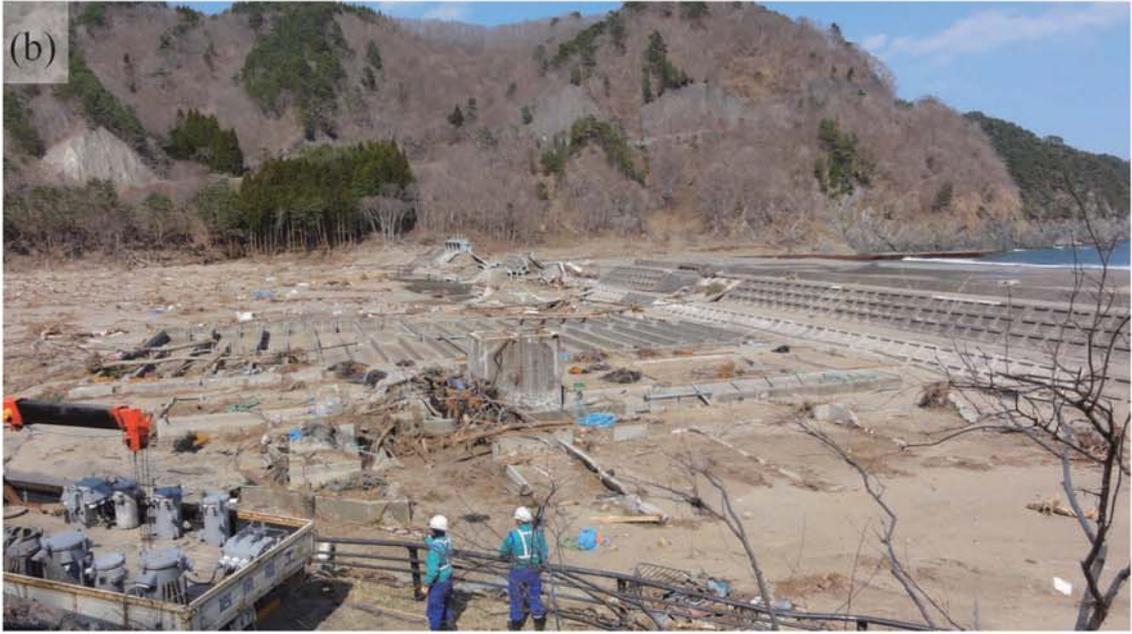
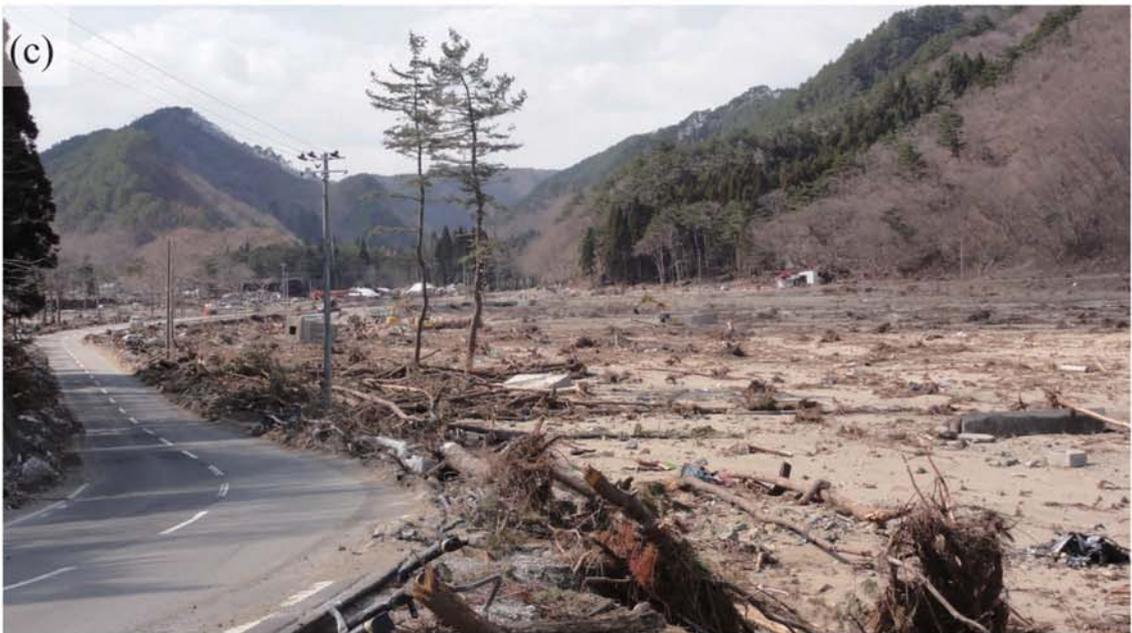
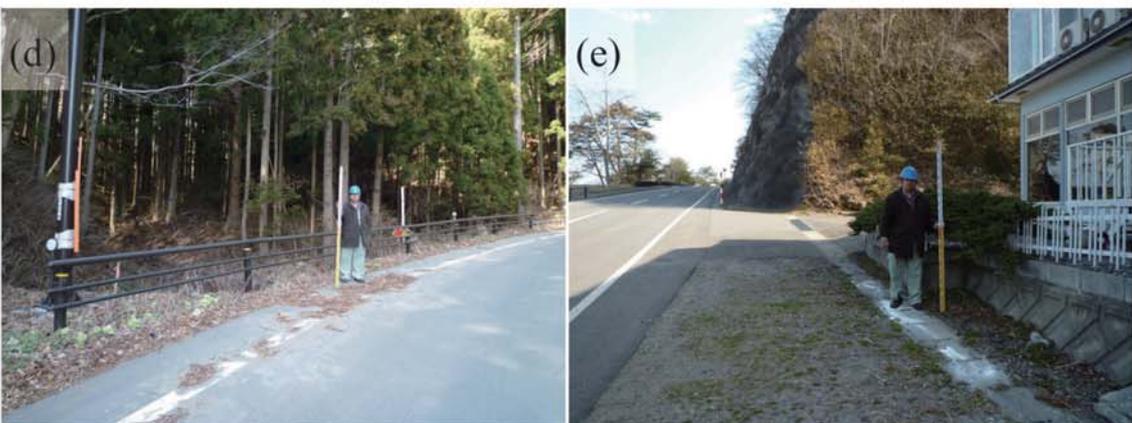
Fig. A56. (a)-(c) Damage at Aketo. (d) Tsunami trace survey point at the northern slope (I32). (e) Tsunami trace survey point at the southern slope (in front of the restaurant Hiraiga-Umisho I33).

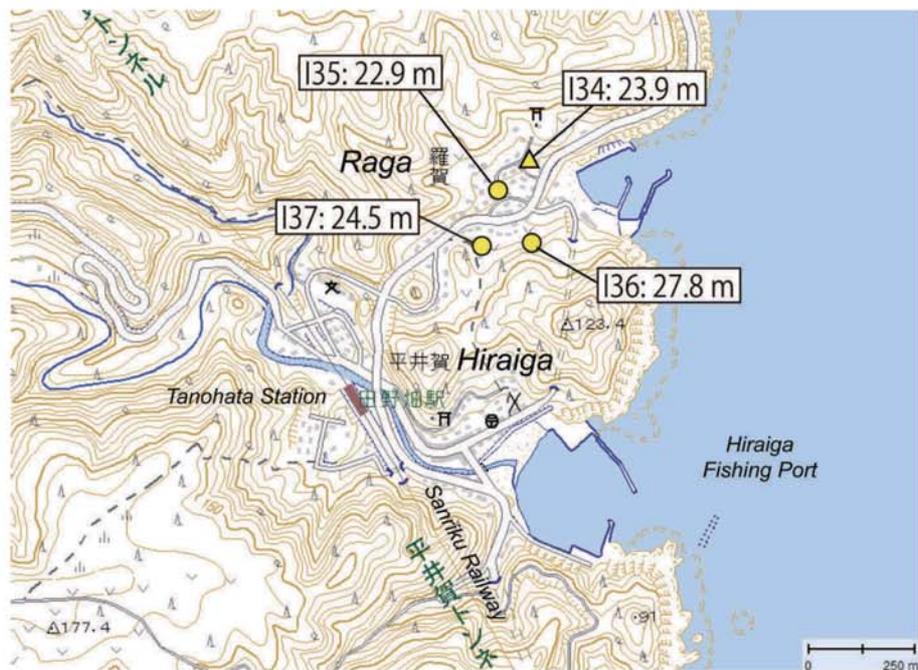
Fig. A57. Tsunami heights at Raga, Tanohata Village, Iwate Prefecture (added with digital topographic map 1/25,000 from the Geospatial Information Authority of Japan). The symbols and their meanings are the same as in Fig. 3.

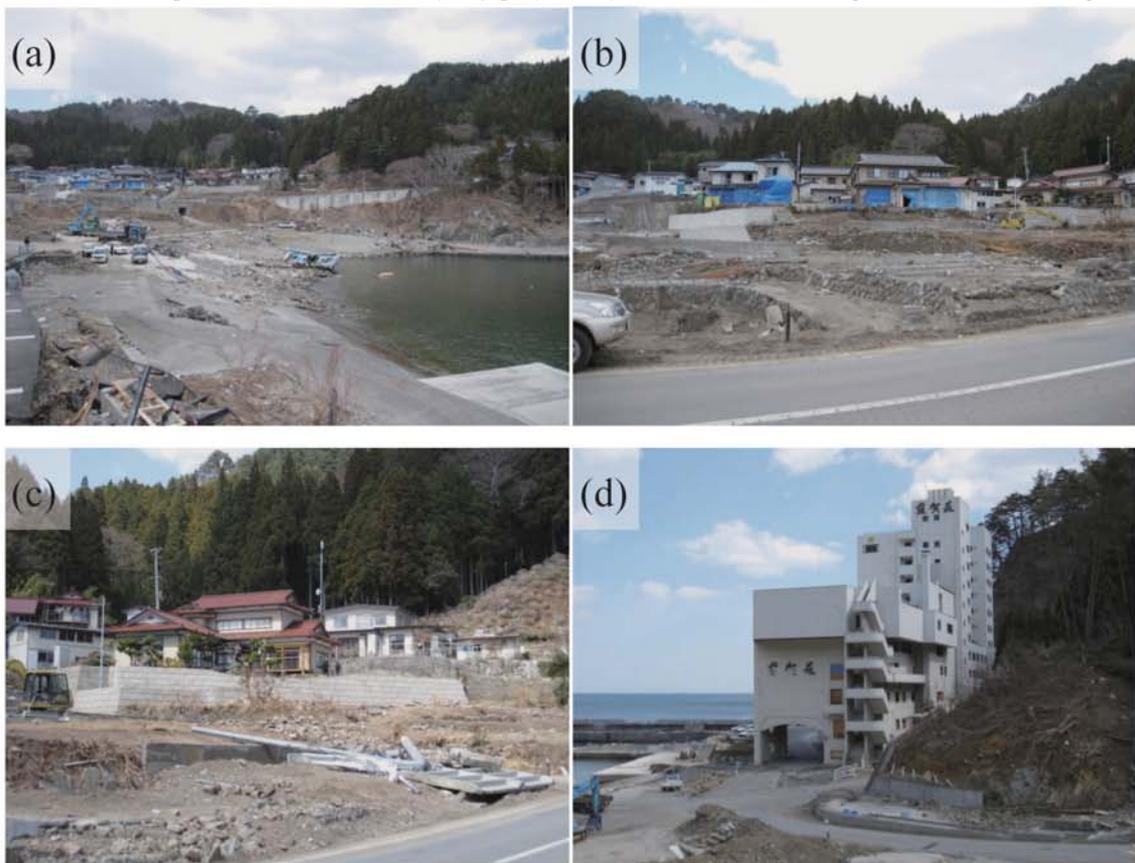
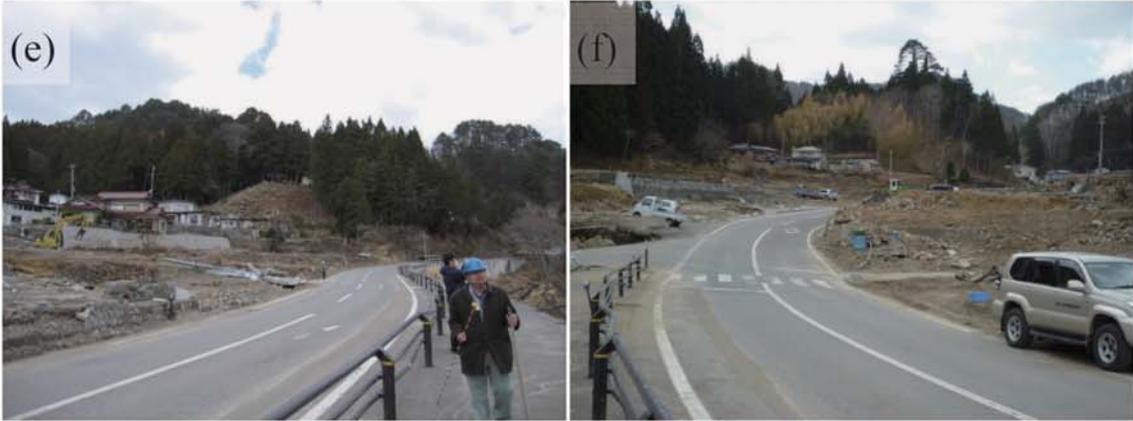
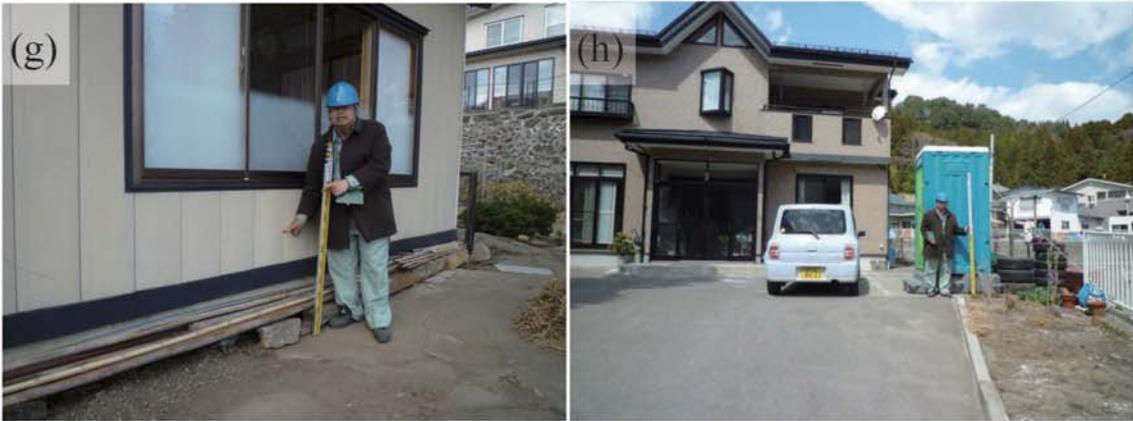
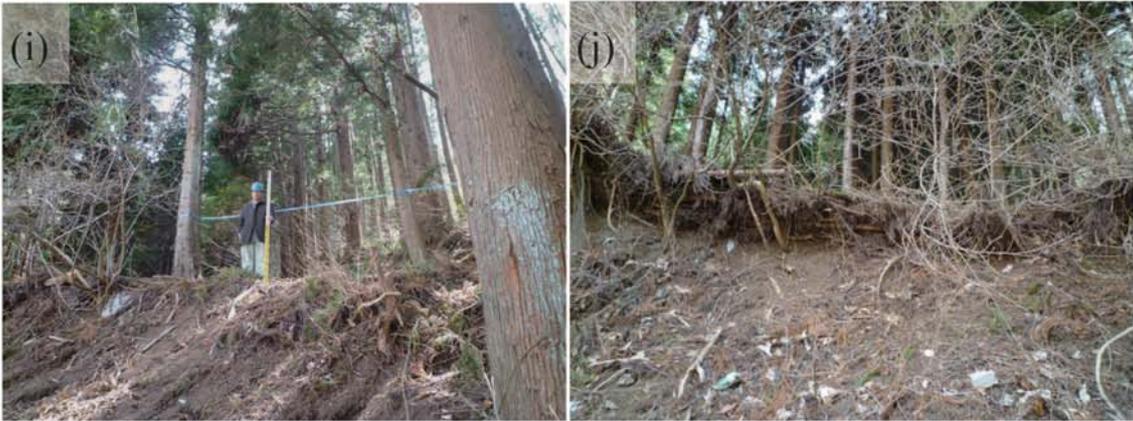
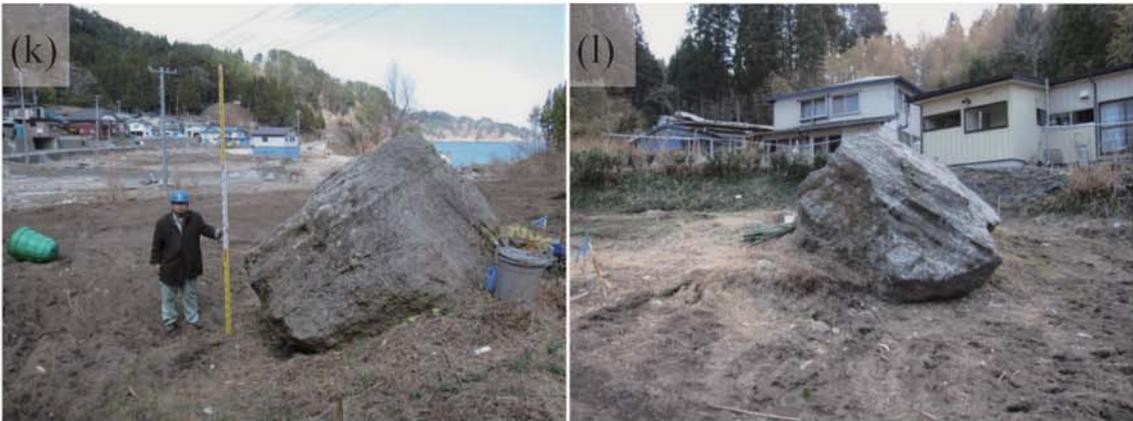
Fig. A58. (a)-(f) Damage at Raga. (g) Tsunami trace survey point at Ms. Miiko Nakajima's house (0.66 m above ground level; I34). (h) Tsunami trace survey point in front of Mr. Shimosaka's house (I35). (i)-(j) Tsunami trace survey point at the southern slope (I36). (k)-(l) Tsunami trace survey point at the southern slope (in front of tsunami stone carried by the 1896 Meiji Sanriku tsunami; I37).

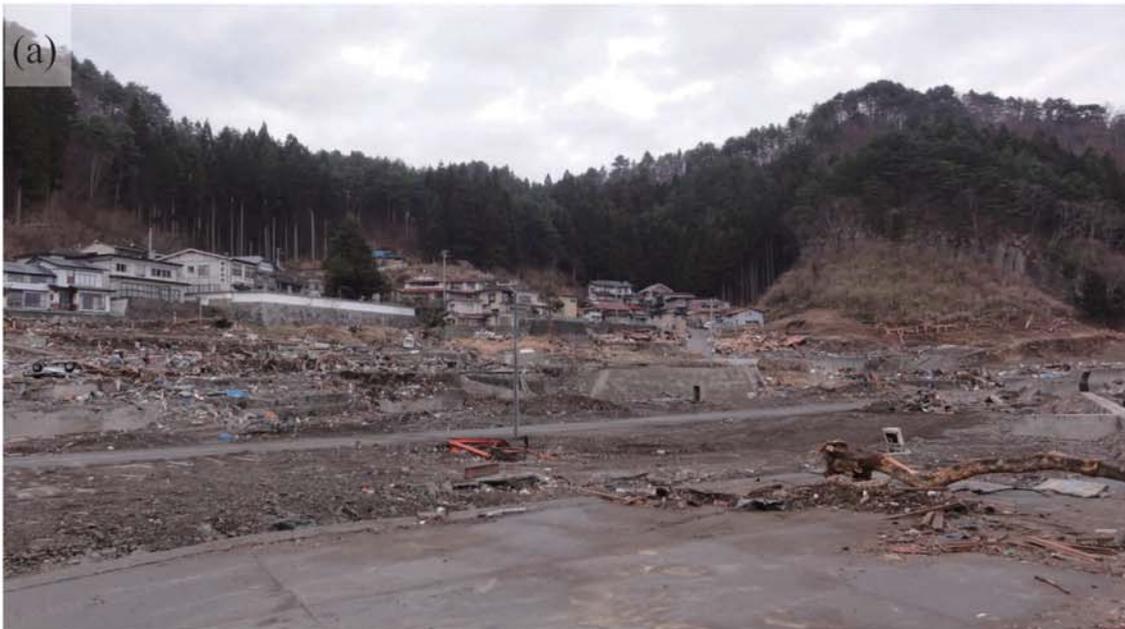
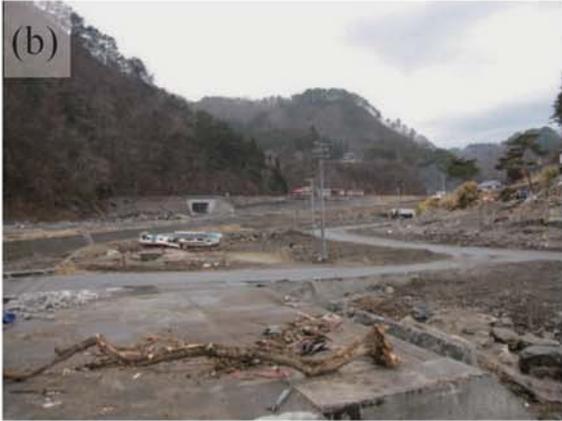
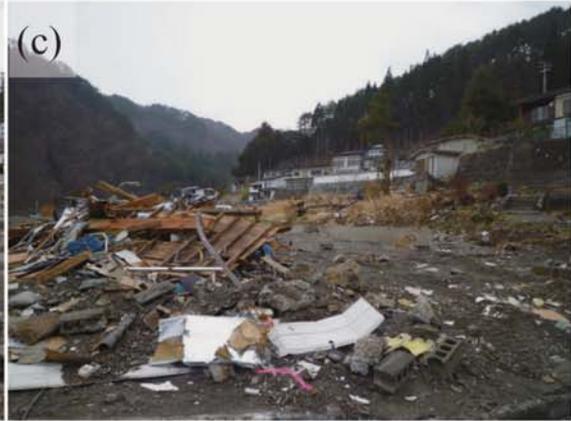
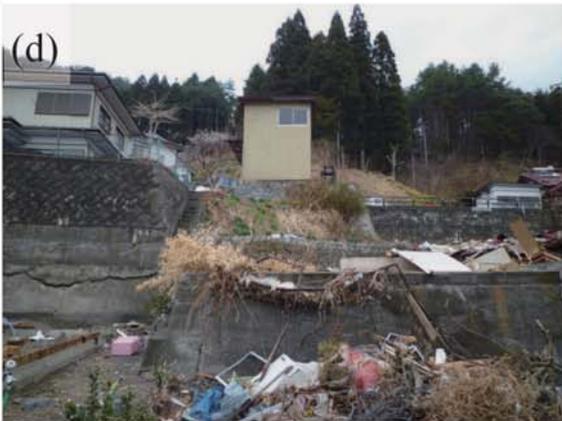
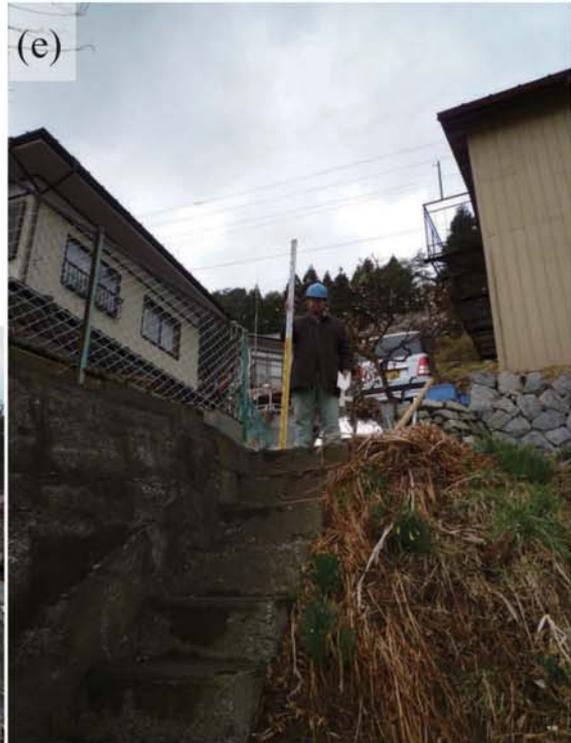
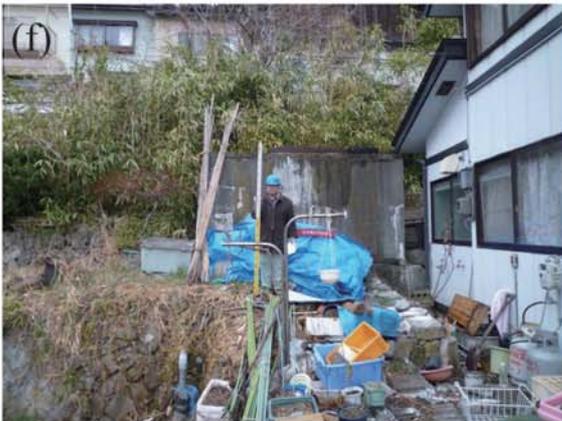
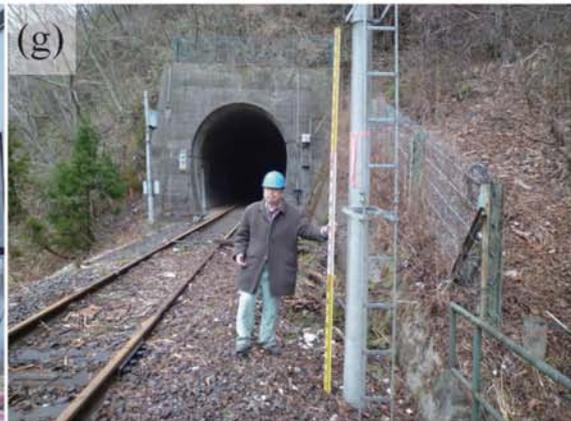
Fig. A60. (a)-(c) Damage at Raga (Hiraiga) and Wano. (d)-(e) Tsunami trace survey point in front of Mr. Osawa's house (I38). (f) Tsunami trace survey point at a house below the Kumano shrine (I39). (g) Tsunami trace survey point at a power utility pole near the Sanriku railway (I40).

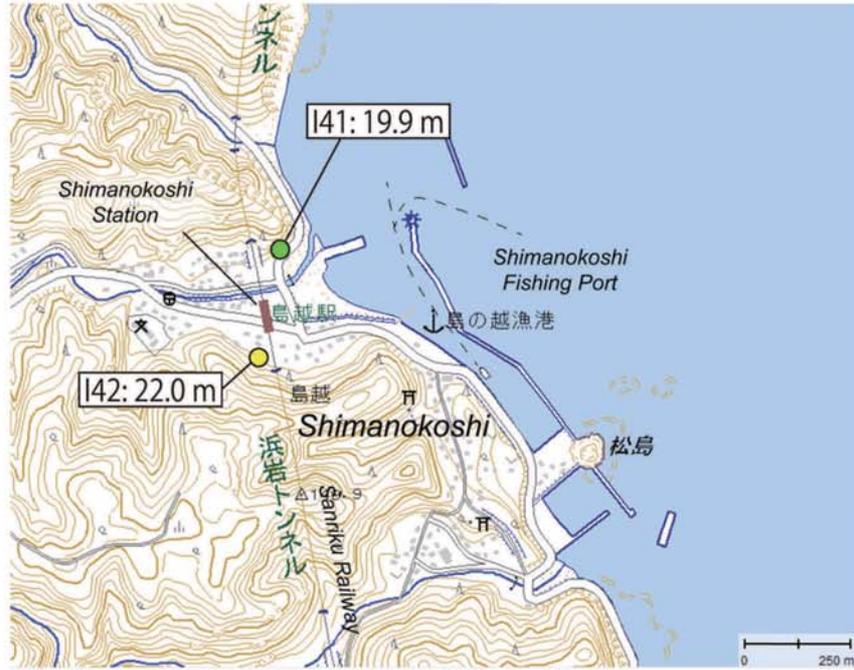
Fig. A61. Tsunami heights at Shimanokoshi, Tanohata Village, Iwate Prefecture (added with digital topographic map 1/25,000 from the Geospatial Information Authority of Japan). The symbols and their meanings are the same as in Fig. 3.

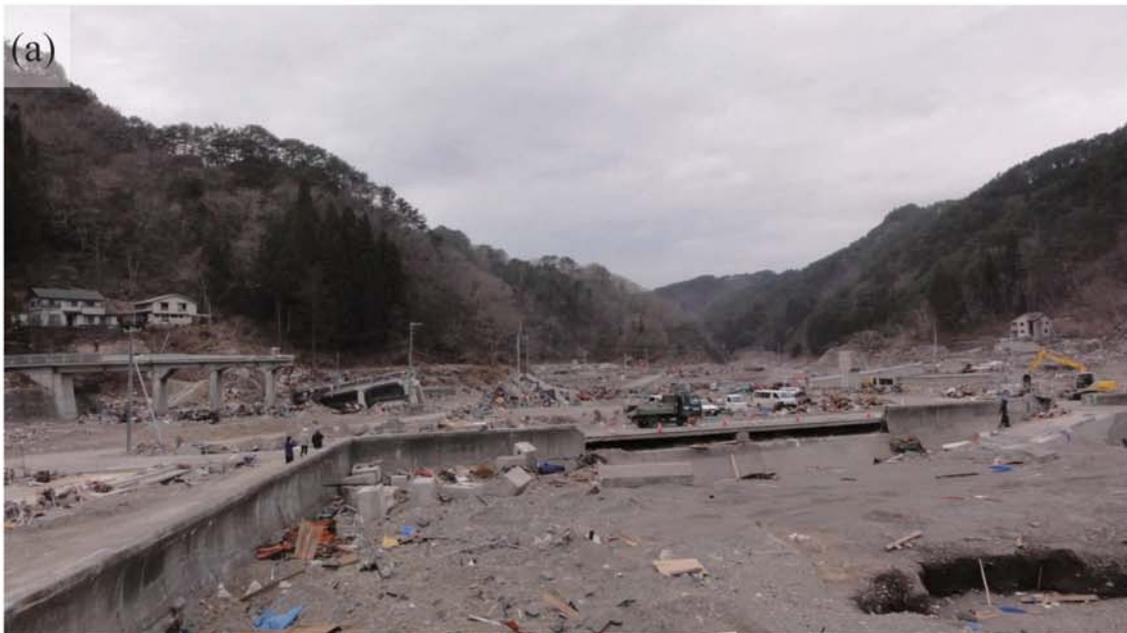
Fig. A62. (a)-(c) Damage at Shimanokoshi (d) Tsunami trace survey point at the northern slope near the dai-ni Shimanokoshi tunnel of the Sanriku railway (I41). (e)-(g) Tsunami trace survey point in the garden of Mr. Hayano's house (I42). (h) Buoys on a tree located in front of Mr. Hayano's house. (i) View from the garden of Mr. Hayano's house.

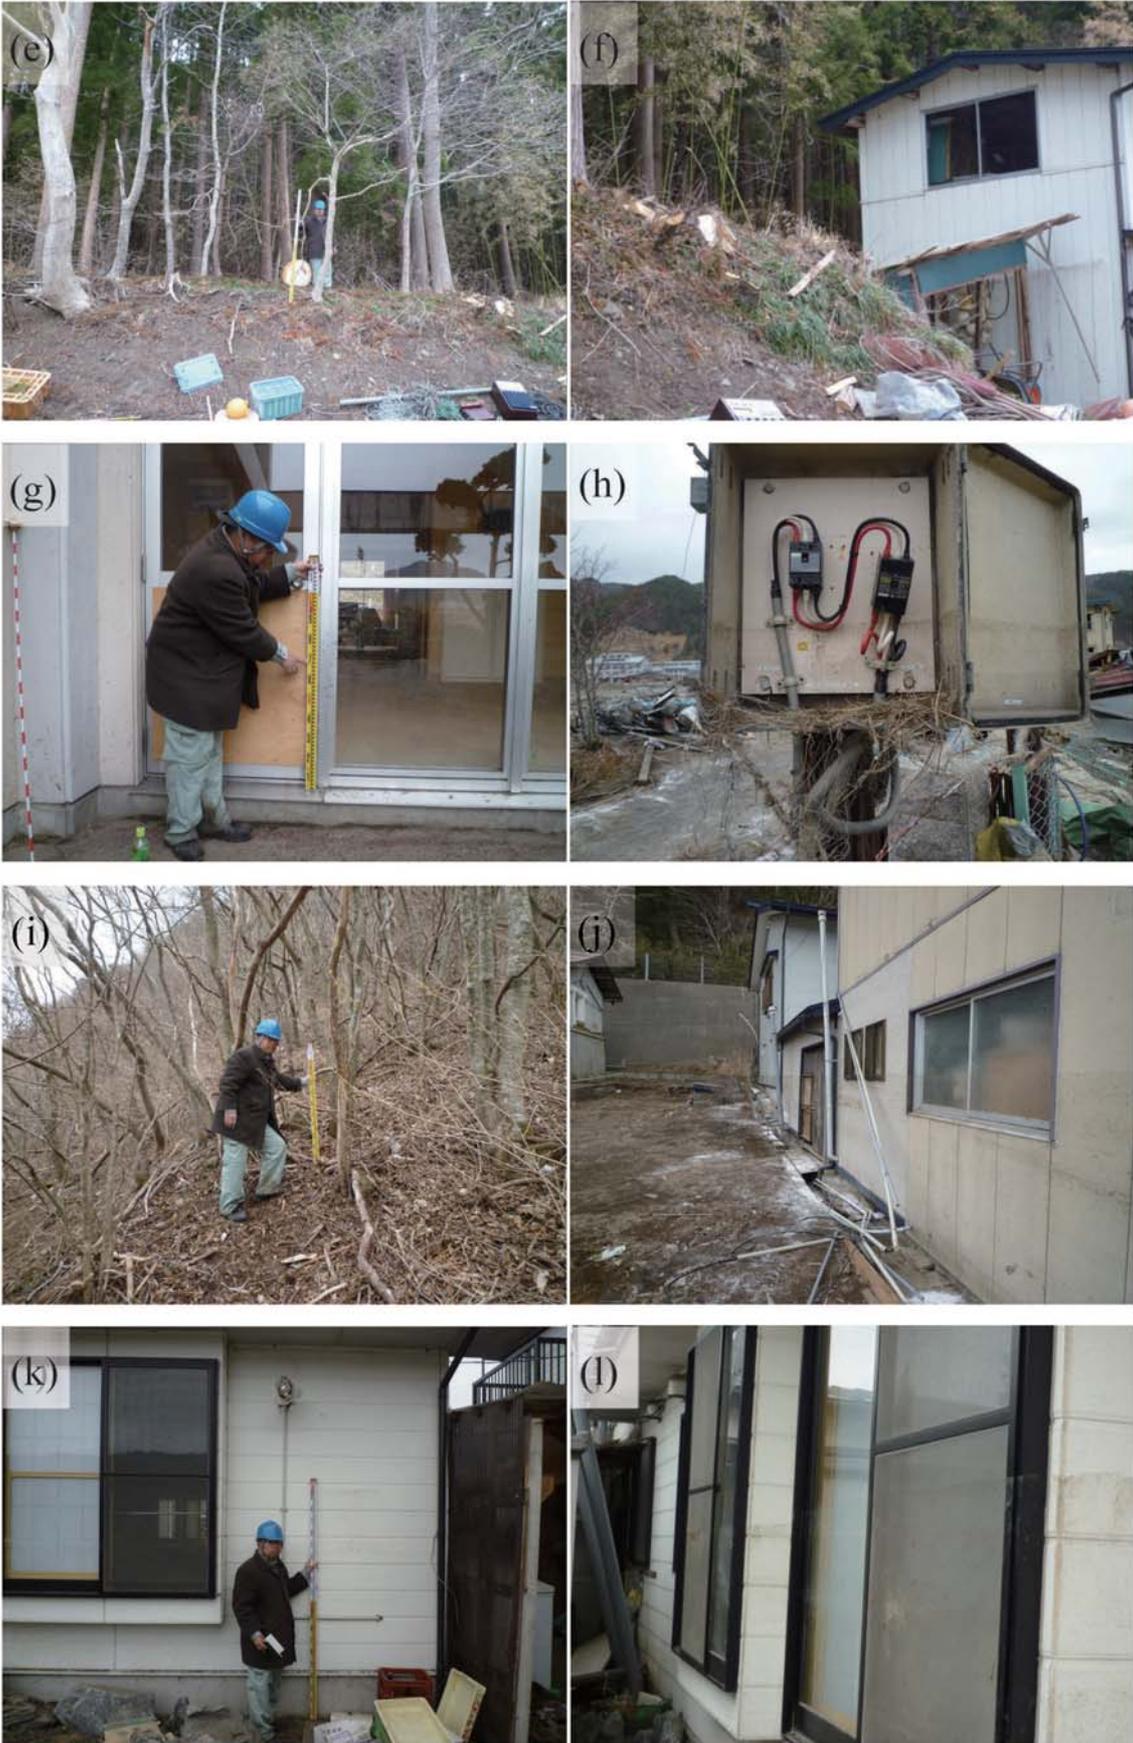
Fig. A64. (a)-(d) Damage at Omoto. (e)-(f) Tsunami survey point at the slope behind Omoto Fishing Port (I43). (g) Watermark on a window of Omoto junior high school (I44). (h) Watermark on a distribution board at the northern side of the Omoto River (I45). (i)-(j) Watermark on a wall surface of Omoto-onsen (I46). (k) Tsunami survey point at a slope located south of the embankment (I47). (l) Watermark on a wall surface at a residential district (southern side of the Omoto River; I48).

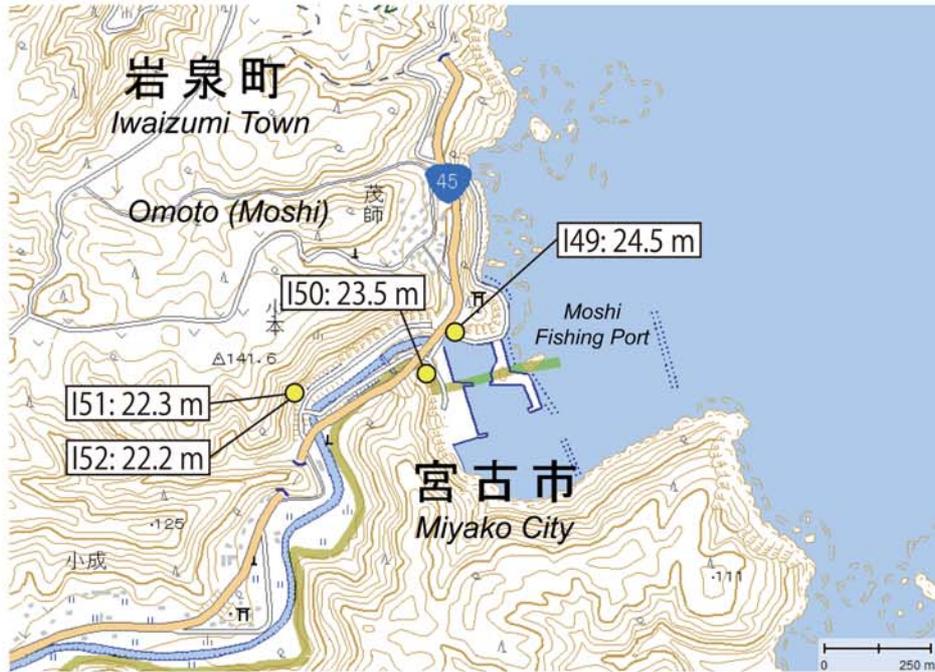
Fig. A65. Tsunami heights at Moshi, Omoto, Iwaizumi Town, Iwate Prefecture (added with digital topographic map 1/25,000 from the Geospatial Information Authority of Japan). The symbols and their meanings are the same as in Fig. 3.
