2011年東北地方太平洋沖地震の津波高調査

Field Surveys of Tsunami Heights from the 2011 off the Pacific Coast of Tohoku, Japan Earthquake

We report the results of field surveys conducted by the Earthquake Research Institute, to measure tsunami heights from the 2011 off the Pacific coast of Tohoku, Japan Earthquake (M 9.0), on March 11. Measurements were taken at 296 points on the Sanriku coasts of Aomori, Iwate, and Miyagi Prefectures, and the Pacific coasts of Ibaraki and Chiba Prefectures. The data are included in the results of the 2011 Tohoku Earthquake Tsunami Joint Survey Group. We did not cover the Sendai plain in the southern Miyagi Prefecture because other parties extensively measure there, nor Fukushima Prefecture because of the accident of the Fukushima Dai-ichi nuclear power plant. The twelve surveys first sought traces indicating tsunami runup or inundation heights. Reliability was classified into A (most reliable based on clear physical evidence and eyewitness accounts), B (mostly based on natural traces), and C (least reliable based on equivocal evidence). Most physical evidence obtained after June was not significant; therefore, reliance was mostly placed on eyewitness accounts. Loc

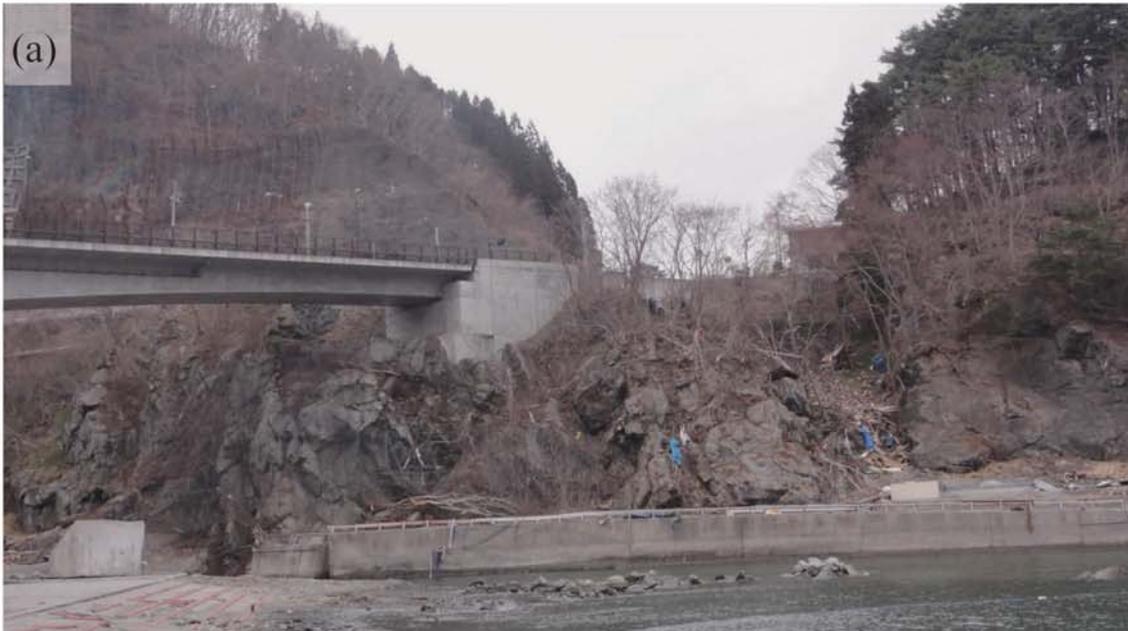
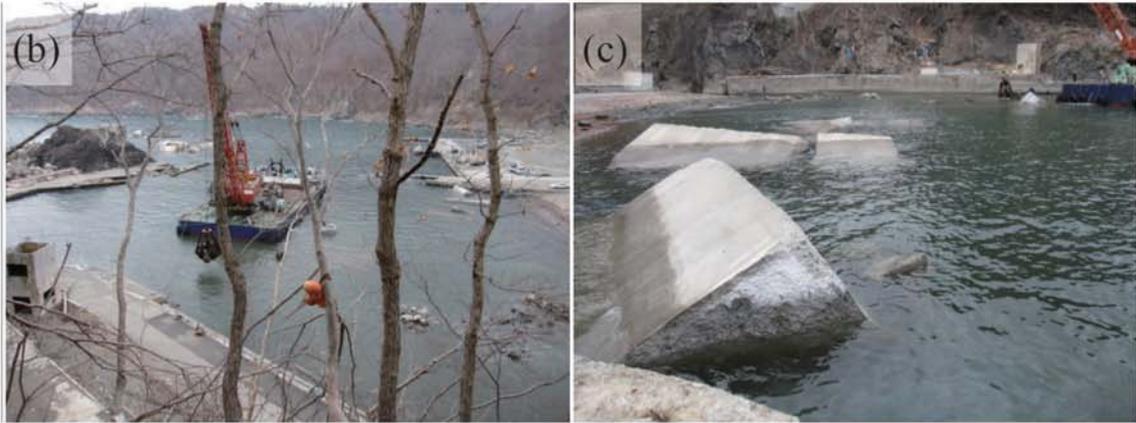
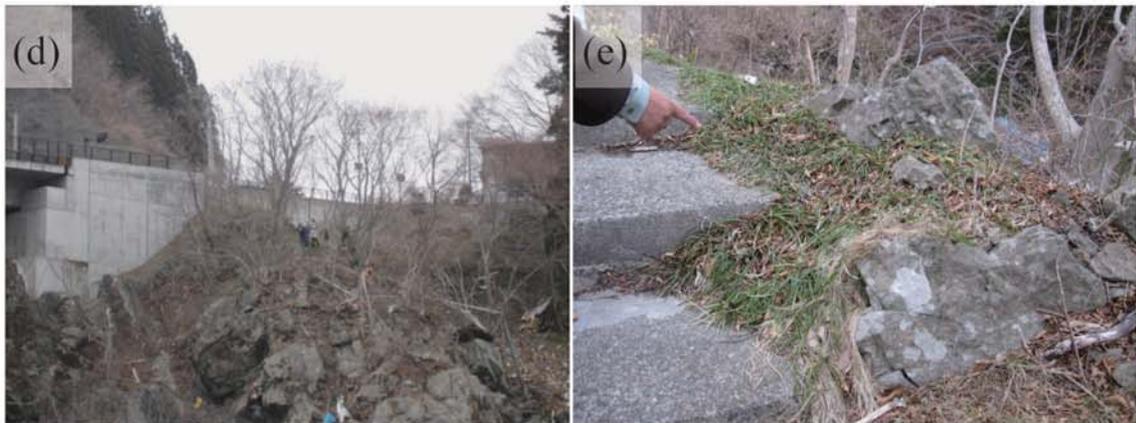
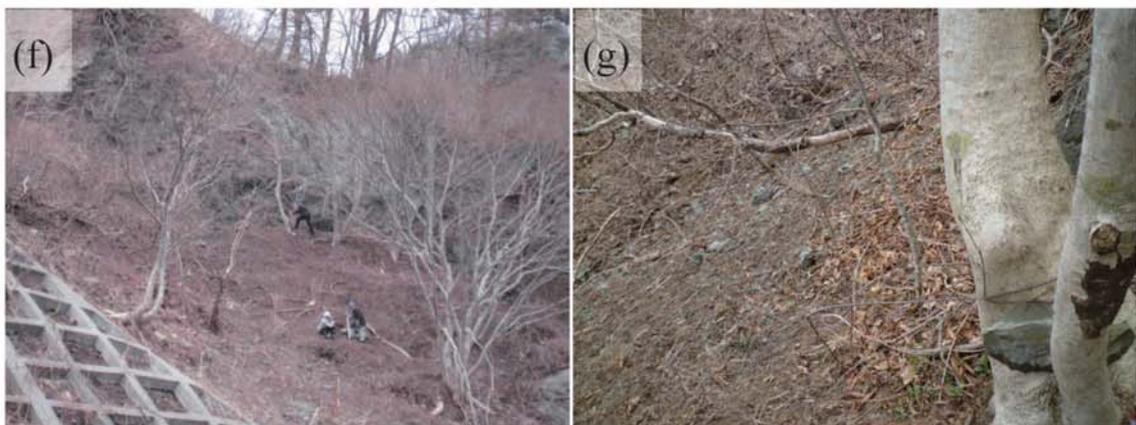
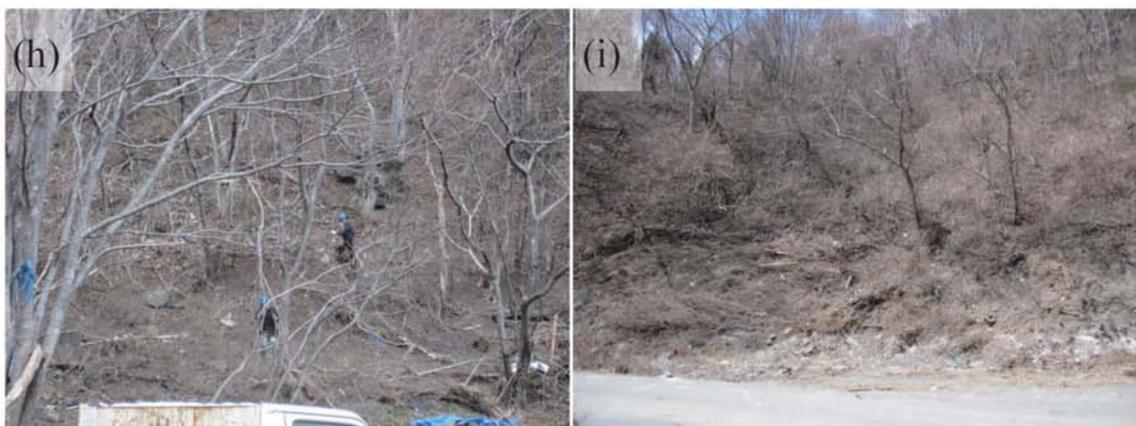
Fig. A66. (a)-(c) Damage at Moshi Fishing Port. (d)-(e) Tsunami trace survey point at a slope behind the northern coast of Omoto Fishing Port (I49). (f)-(g) Tsunami trace survey point at a slope behind the western coast of Omoto Fishing Port (I50). (h) Tsunami trace survey point at a slope near the benchmark (I51). (i) Tsunami trace survey point at a slope near the benchmark (I52).

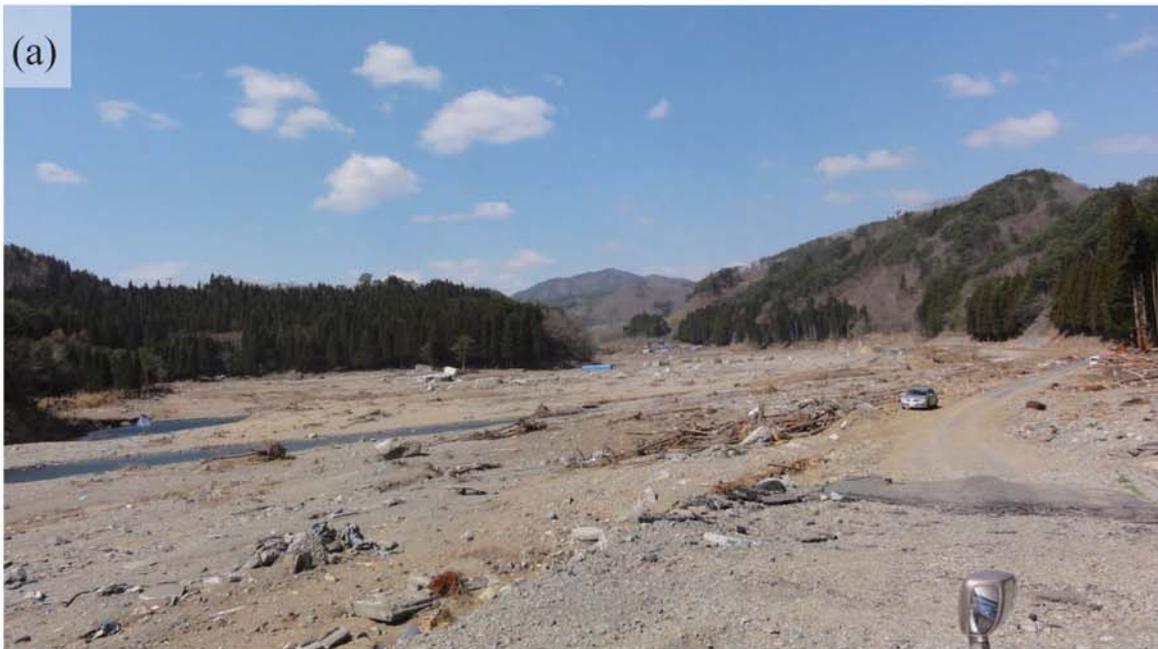
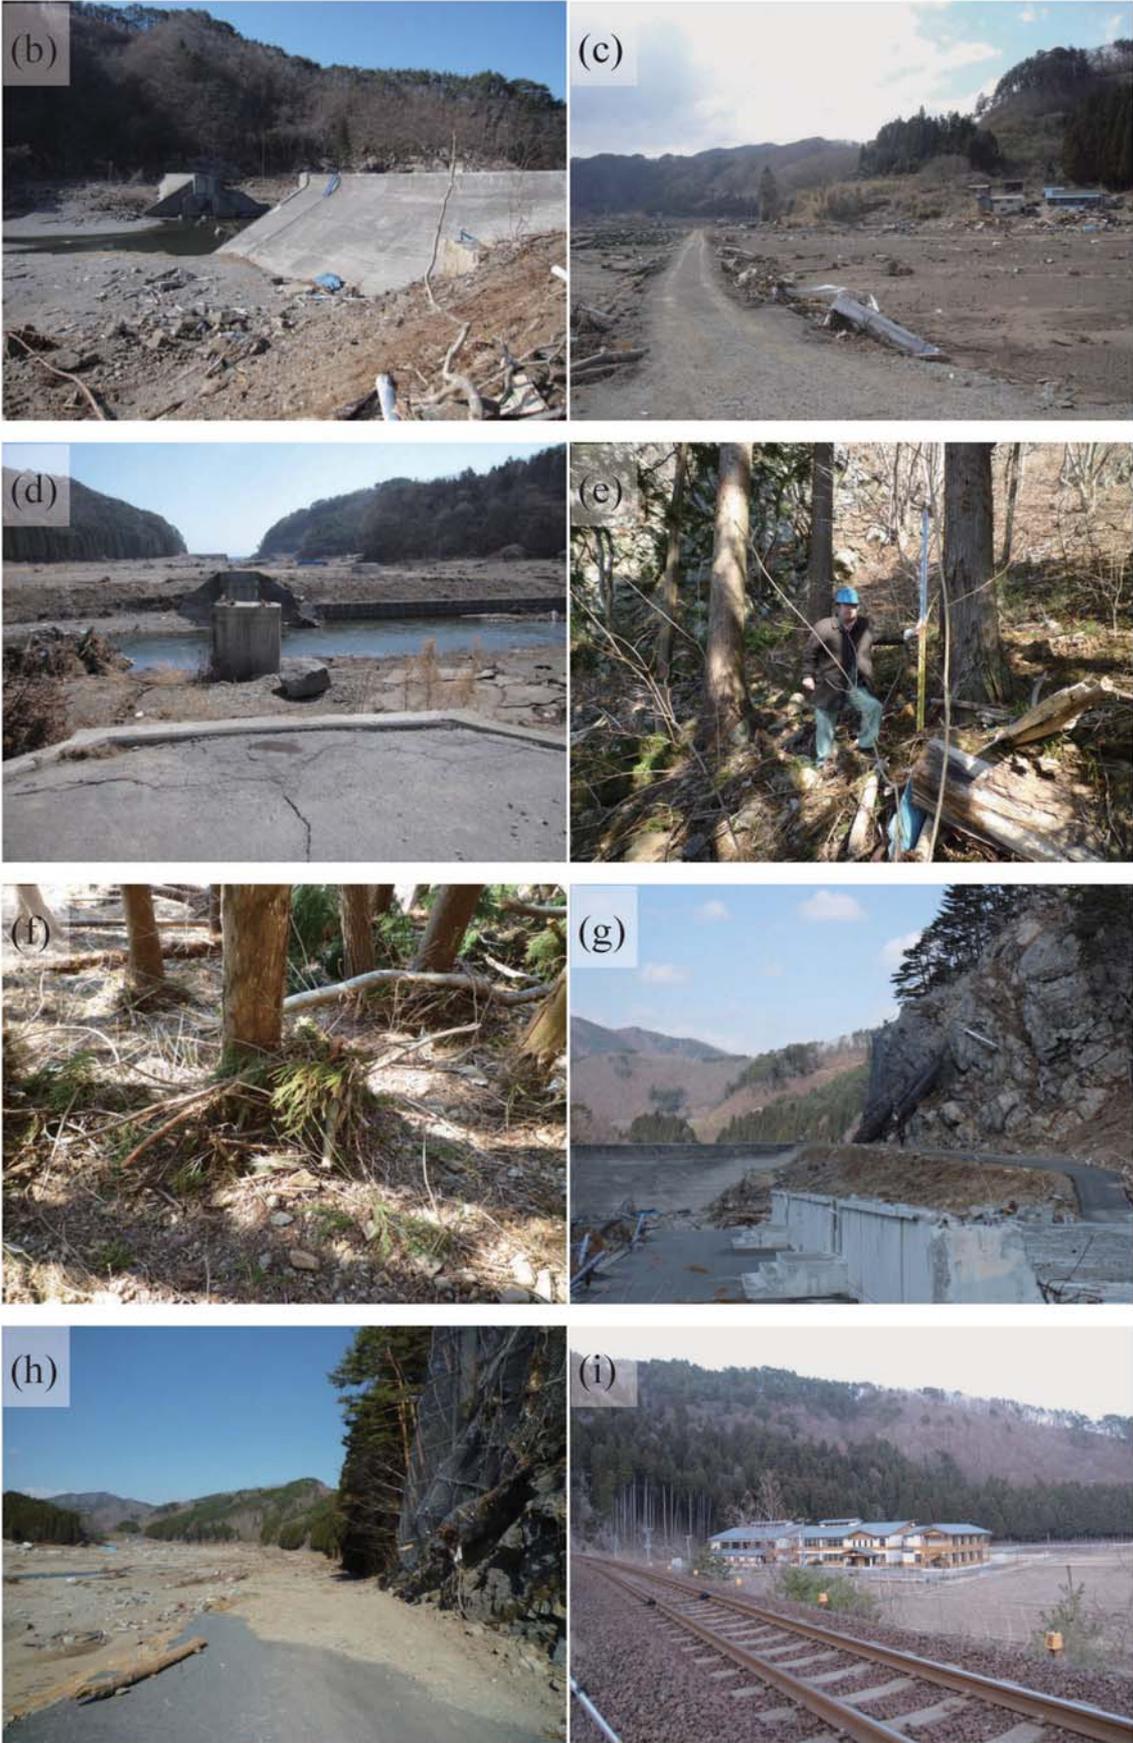
Fig. A68. (a)-(d) Damage at Taro-Shimosettai. (e)-(f) Tsunami trace survey point at the northern slope (I53). (g)-(h) Garbage attached to iron fence due to the passage of tsunami (I55). (i) The third taro junior high school, which the tsunami inundated at ground level (I56).

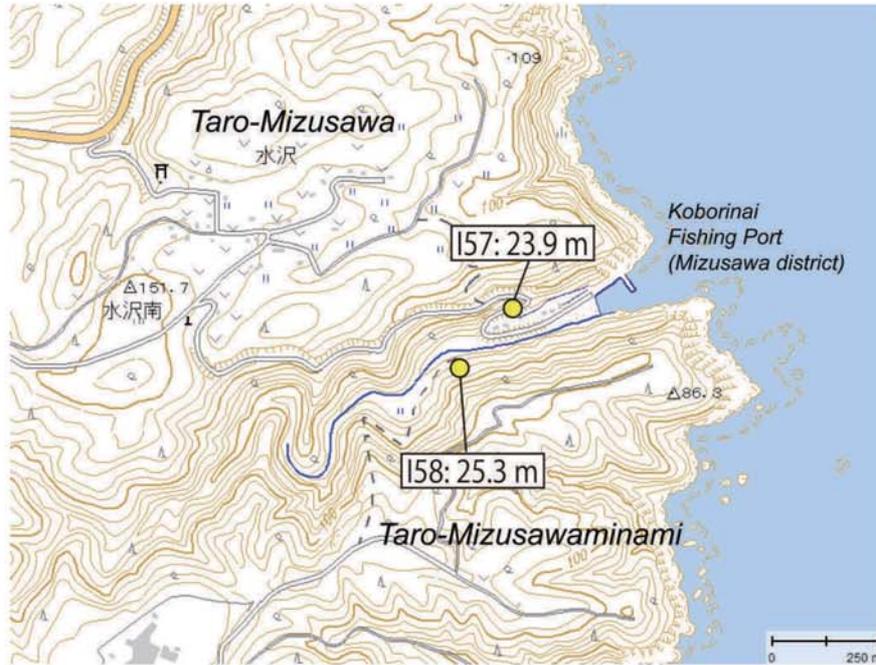
Fig. A69. Tsunami heights at Taro-Mizusawa (I57) and Taro-Mizusawaminami (I58), Miyako City, Iwate Prefecture (added with digital topographic map 1/25,000 from the Geospatial Information Authority of Japan). The symbols and their meanings are the same as in Fig. 3.

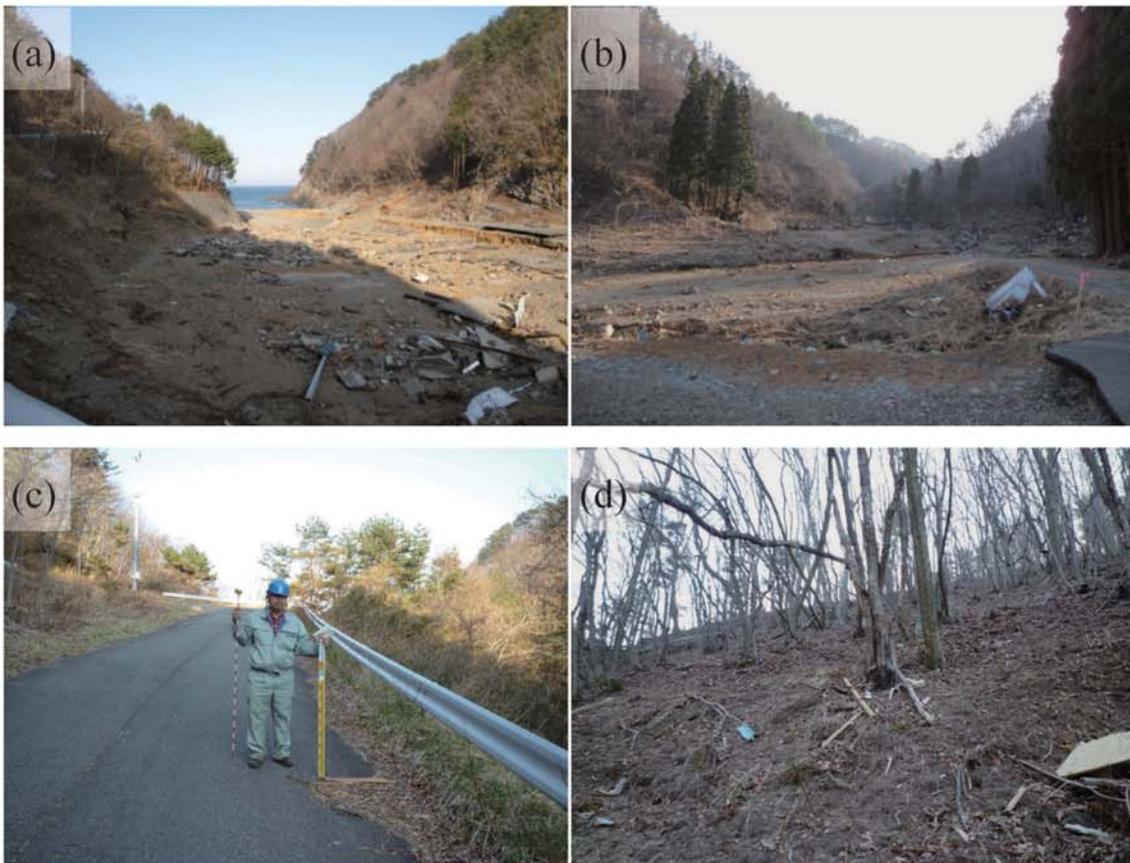
Fig. A70. (a)-(b) Damage at Taro-Mizusawa and Taro-Mizusawaminami. (c) Tsunami trace survey point on the road leading to Mizusawa district of Koborinai Fishing Port (I57). (d) Tsunami trace survey point at the southern slope near a dam (I58).

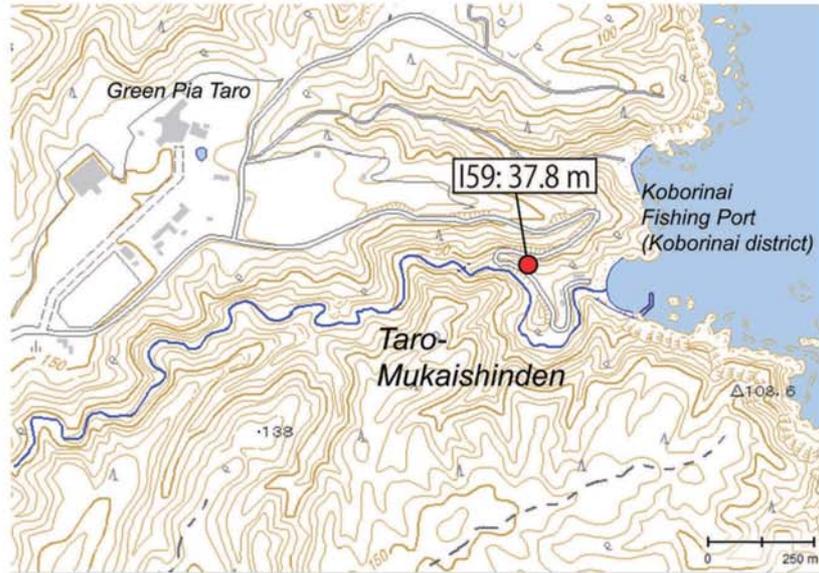
Fig. A71. Tsunami height at Taro-Mukaishinden (Koborinai Fishing Port, Koborinai District), Miyako City, Iwate Prefecture (added with digital topographic map 1/25,000 from the Geospatial Information Authority of Japan). The symbol and its meaning are the same as in Fig. 3.

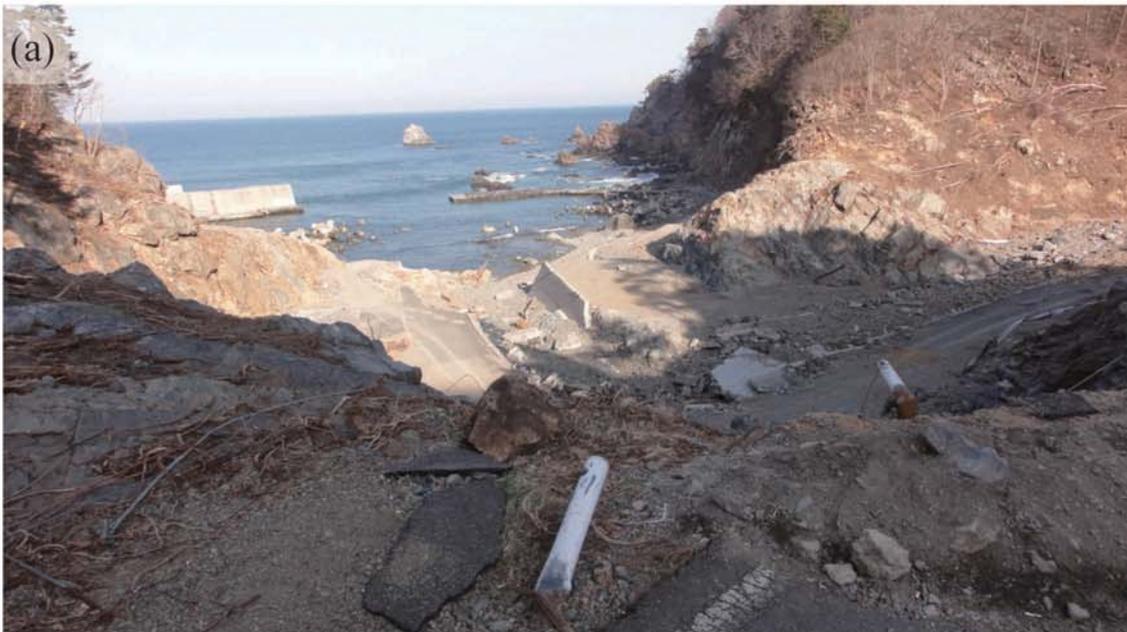
Fig. A72. (a)-(d) Damage at Taro-Mukaishinden (Koborinai Fishing Port, Koborinai District). (e)-(f) Tsunami trace survey using transit. (g)-(i) Tsunami trace survey point in Mukaishinden (I59).

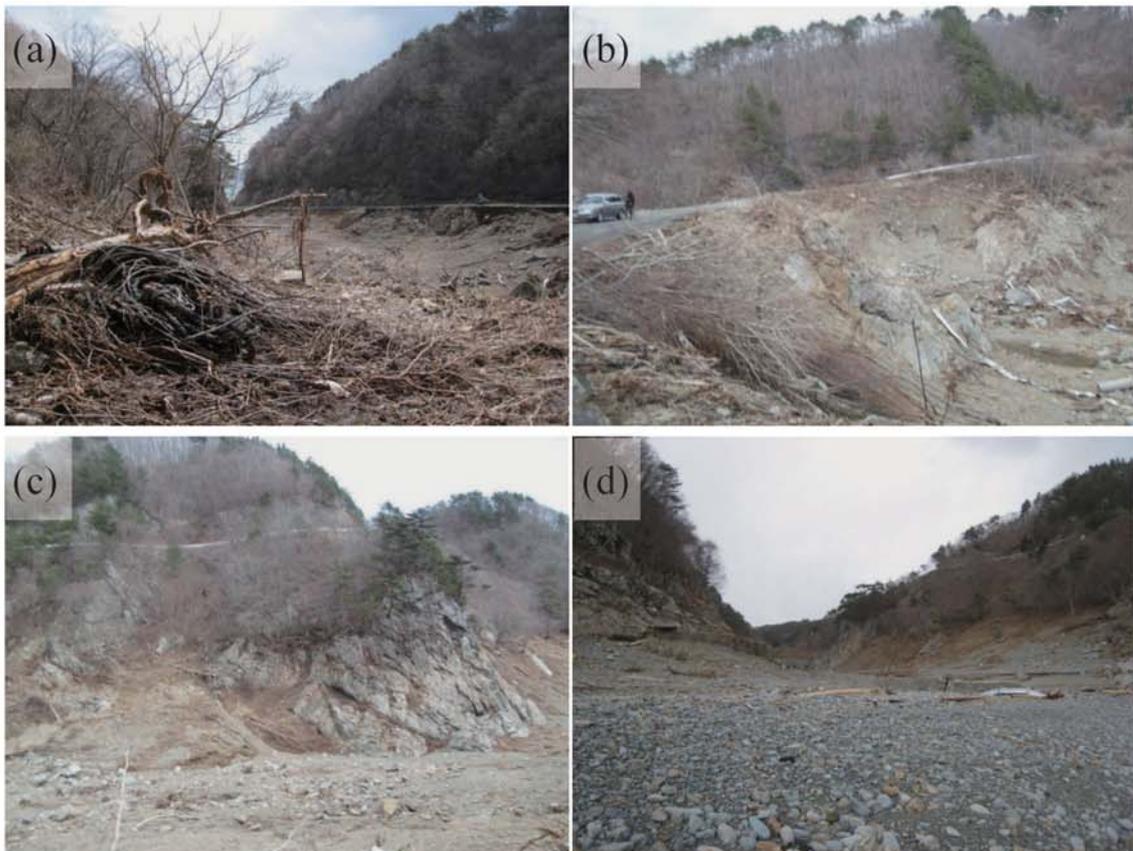
Fig. A74. (a)-(d) Damage at Taro-Aonotakiminami (Aonotaki Fishing Port).

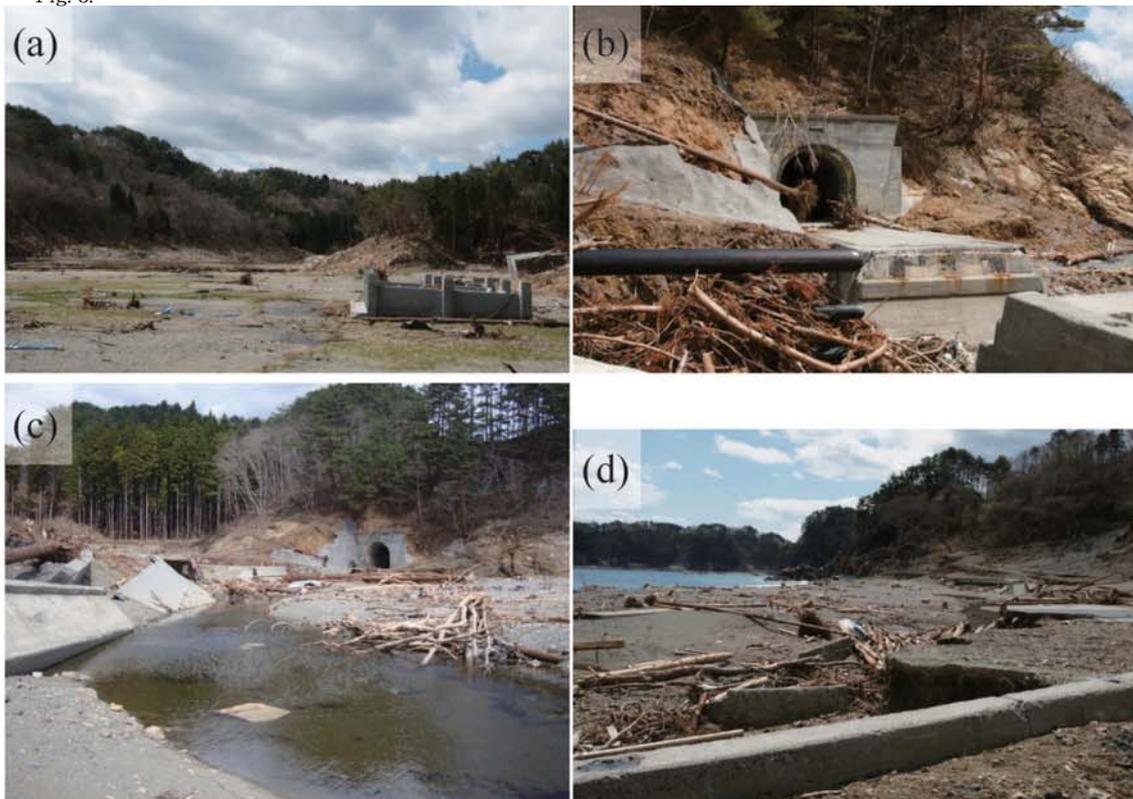
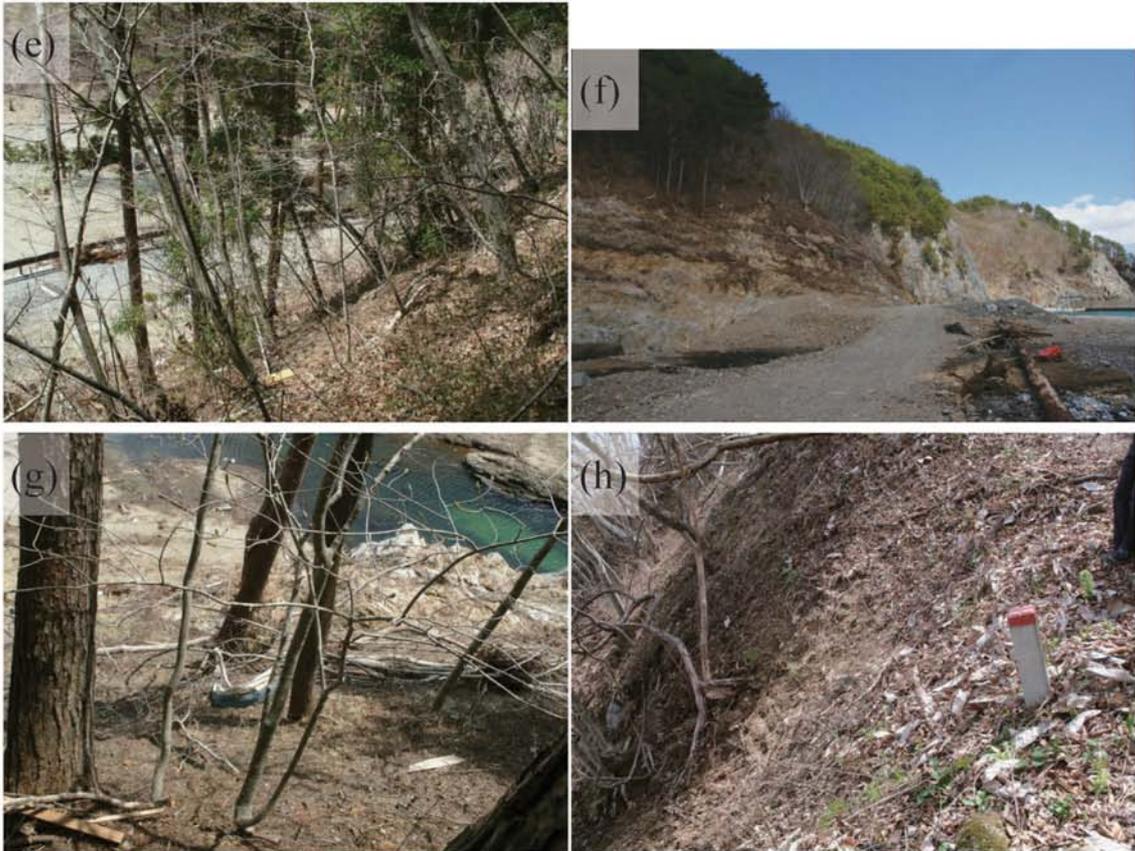
Fig. A76. (a)-(d) Damage at Taro-Otobeno. (e) Tsunami trace survey point at the northern slope (I61). (f) Tsunami trace survey point at the northern slope (I62). (g) Tsunami trace survey point at the northern slope near the river (I63). (h) Tsunami trace survey point at the southern slope (I65).

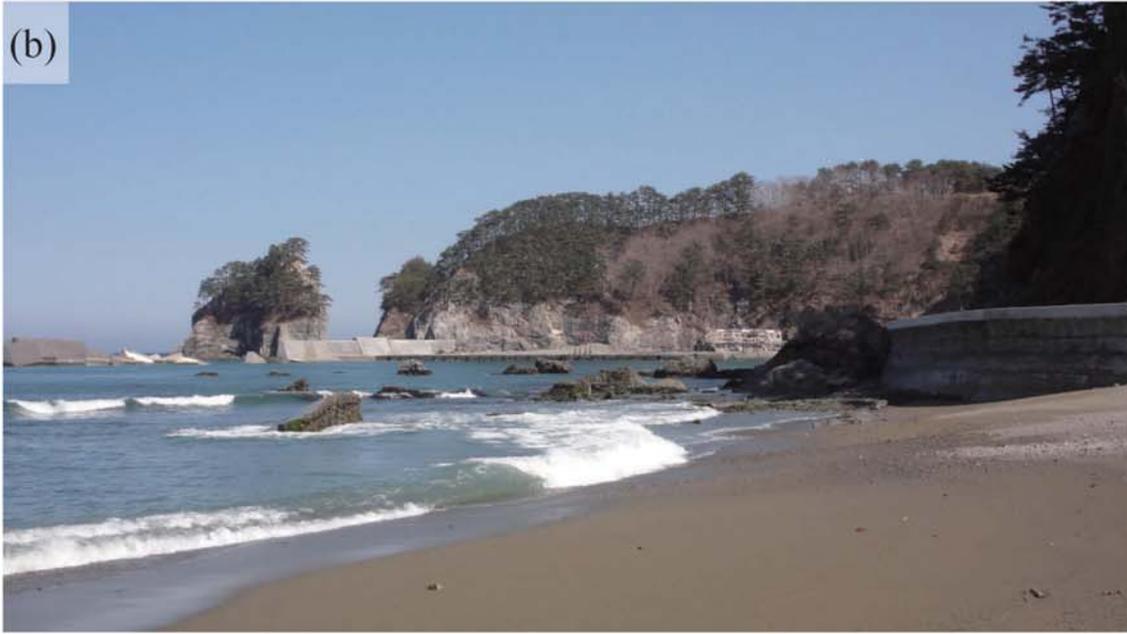
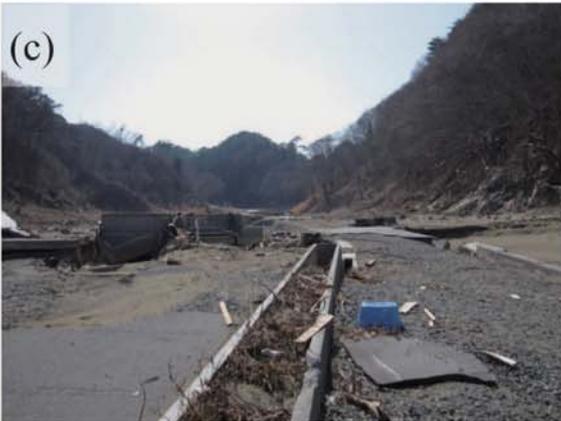
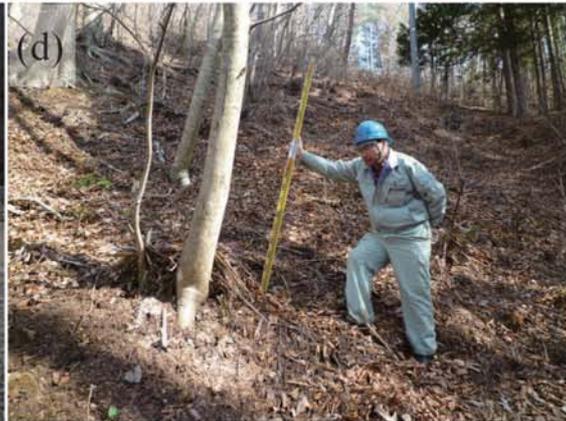
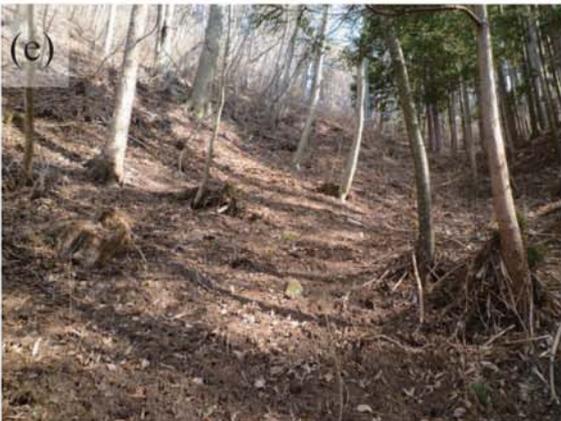
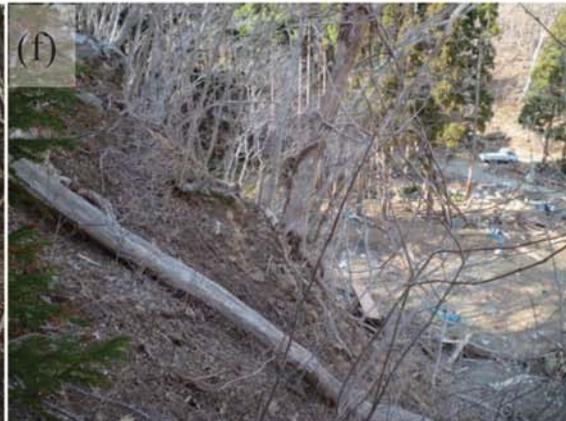
Fig. A78. (a)-(c) Damage at Taro-Wano. (d)-(e) Tsunami trace survey point at the southern slope (I66). (f) Tsunami trace survey point at the slope behind branching road (I67).

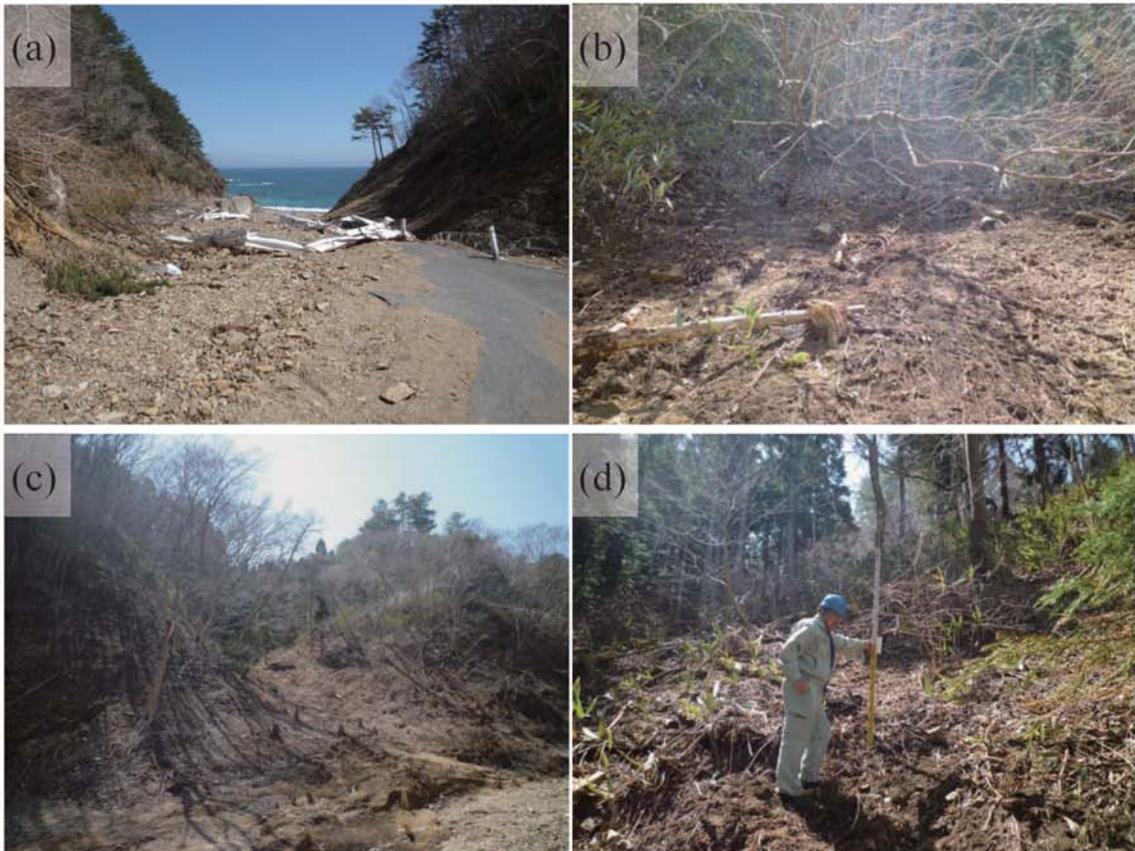
Fig. A80. (a)-(c) Damage at Taro-Koshida. (d) Tsunami trace survey point at the slope (I68).

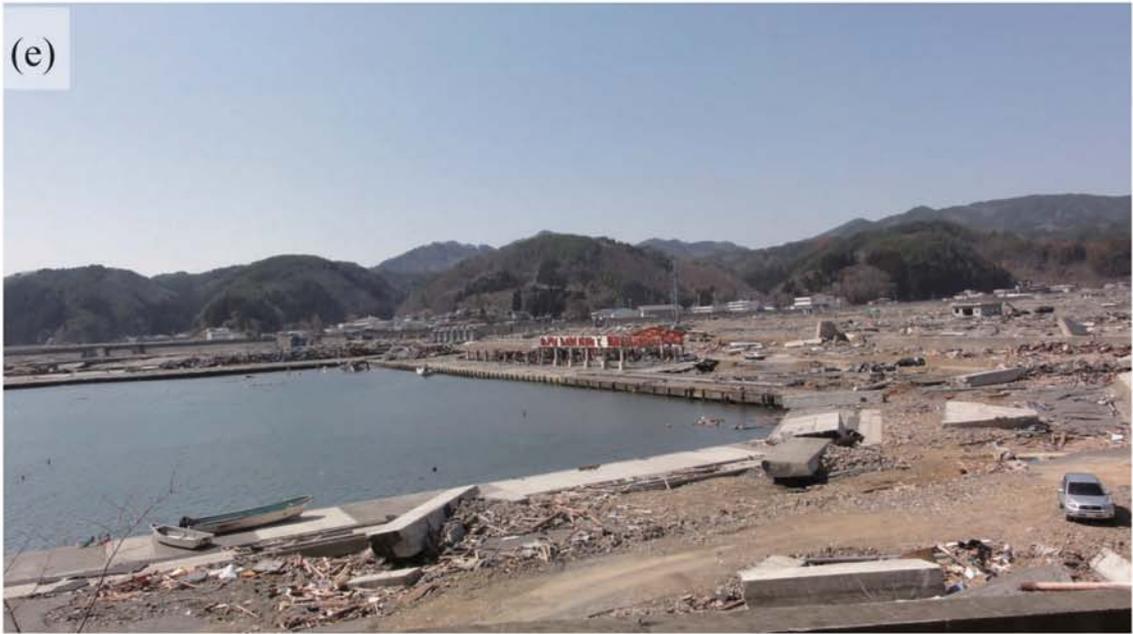
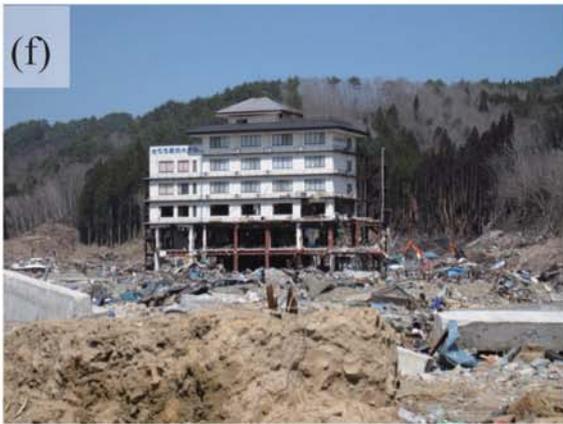
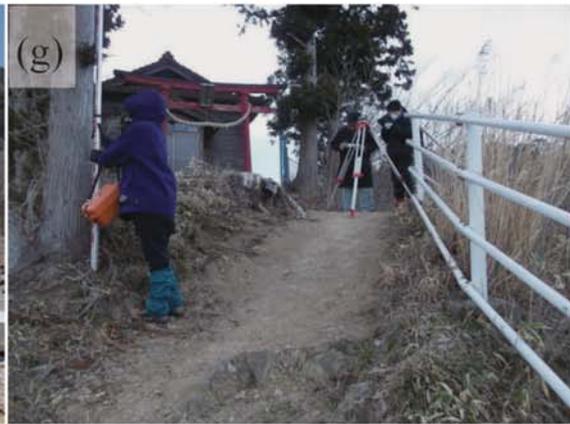
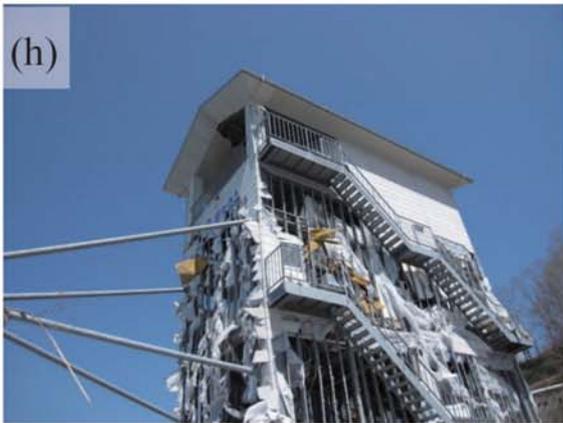
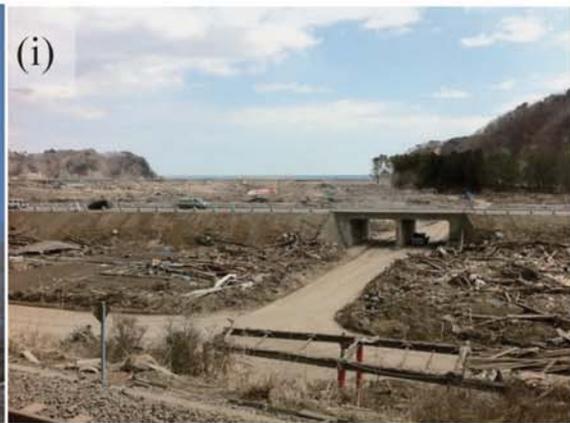
Fig. A82. (a)-(e) Damage at Taro-Nohara. (f) Taro kanko hotel (I70). (g) Tsunami trace survey point at the slop leading to the Dewa shrine (I71). (h) Tsunami trace survey point at the icehouse of Japan Fisheries Cooperatives (I72). (i) Tsunami trace survey point on a railroad of the Sanriku Railway (I73).

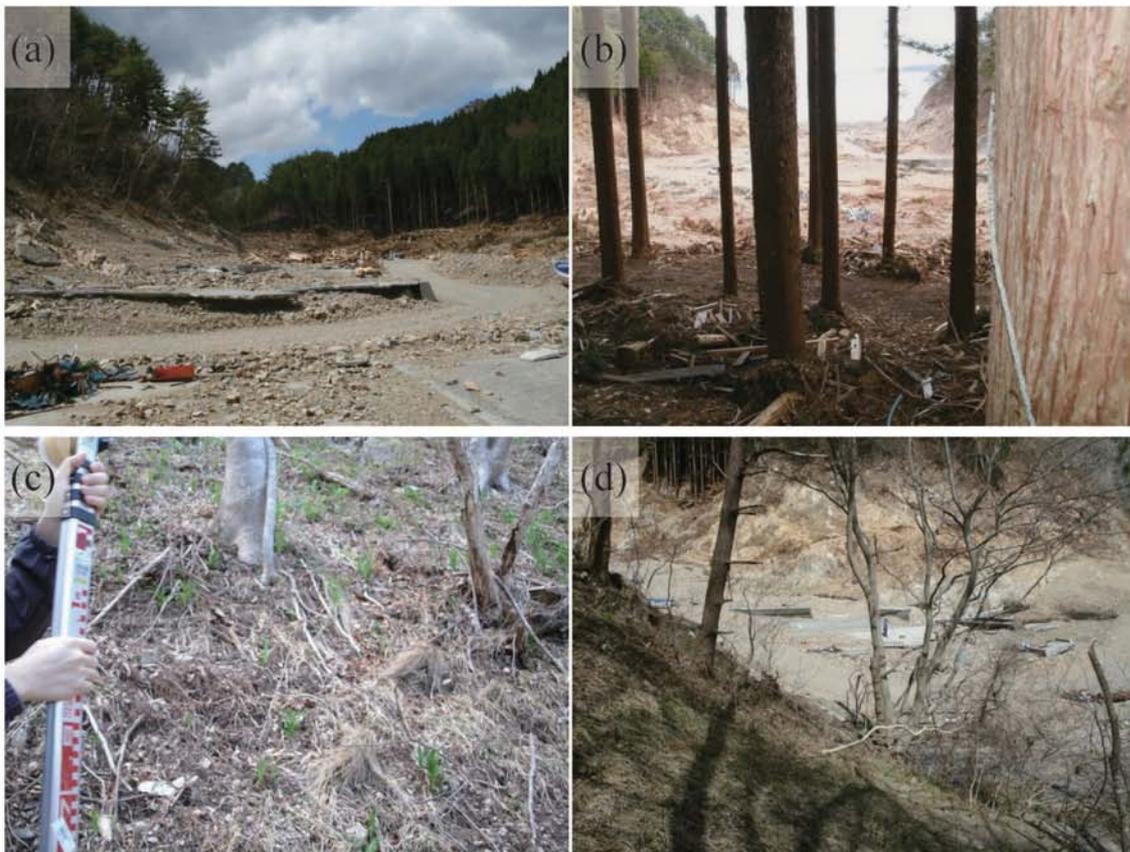
Fig. A84. (a) Damage at Taro-Nishimukaiyama and Taro-Kashinai (Kashinai Fishing Port). (b) Tsunami trace survey point (I74). (c) Tsunami trace survey point at the northern slope of Kashinai Fishing Port (I75). (d) Tsunami trace survey point at the southern slope of Kashinai Fishing Port (I76).

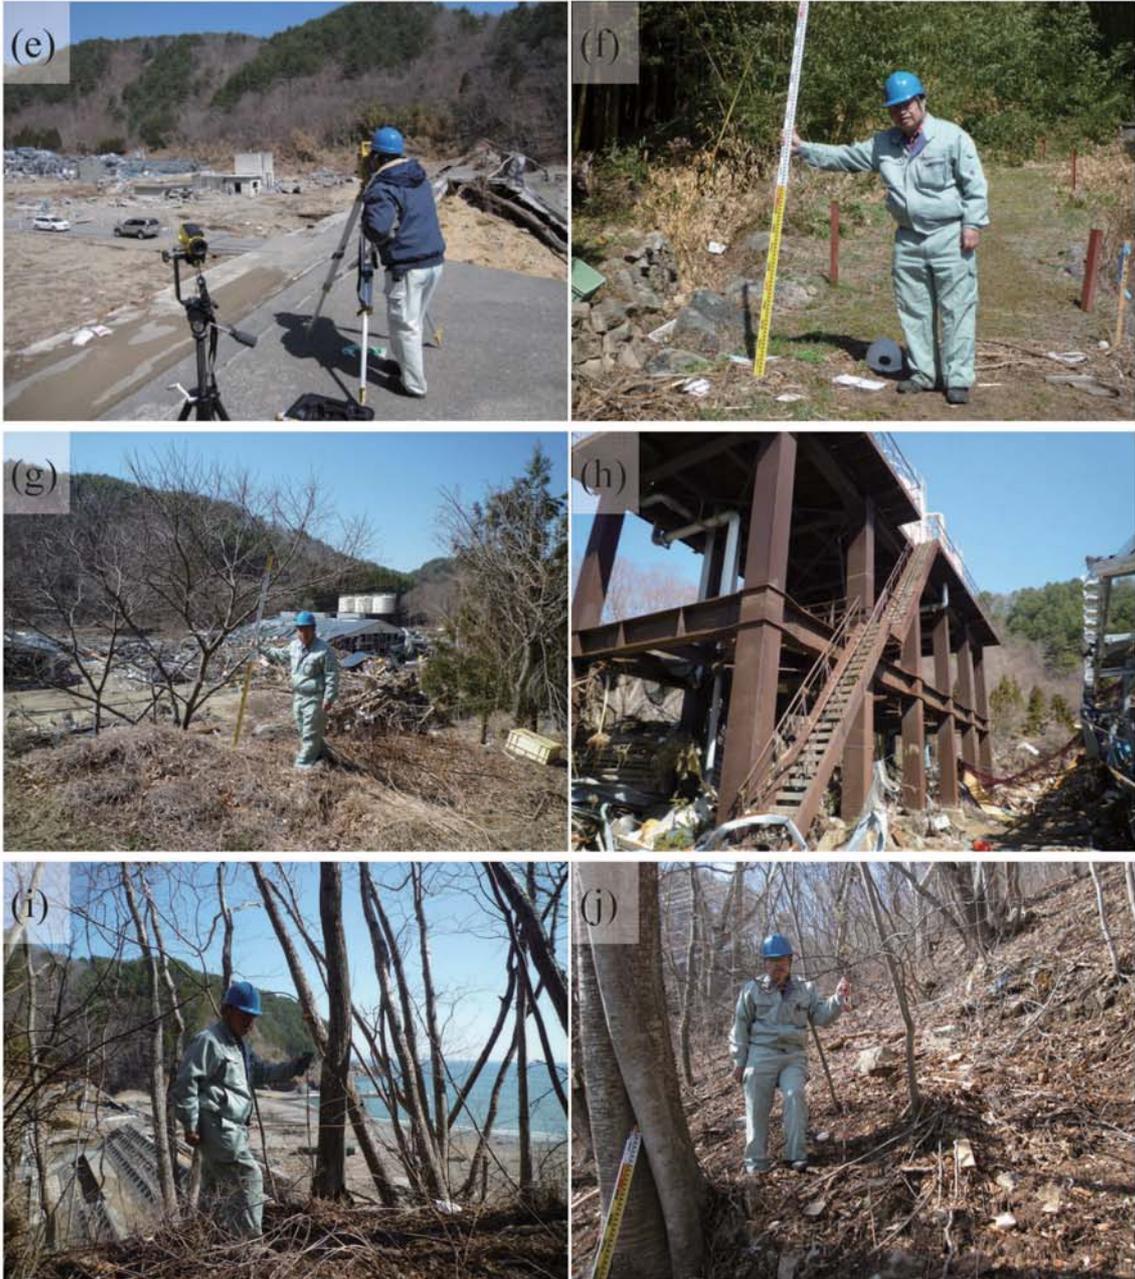
Fig. A88. (a)-(e) Damage at Sakiyama (Onappe). (f) Debris in front of the Kifune shrine (I80). (g) Tsunami trace survey point at the northern slope (I81). (h) Debris on iron steps at the culture and fishery industry center (I82). (i) Tsunami survey point at the southern slope (I83). (j) Tsunami survey point at the southern slope (I84).

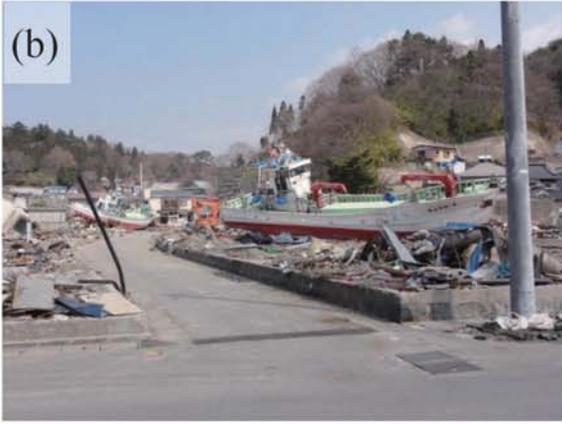
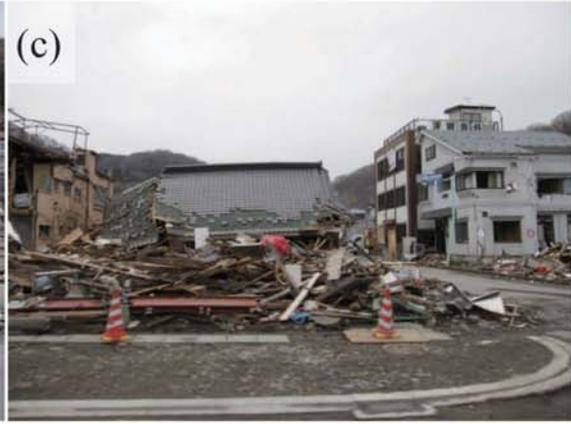
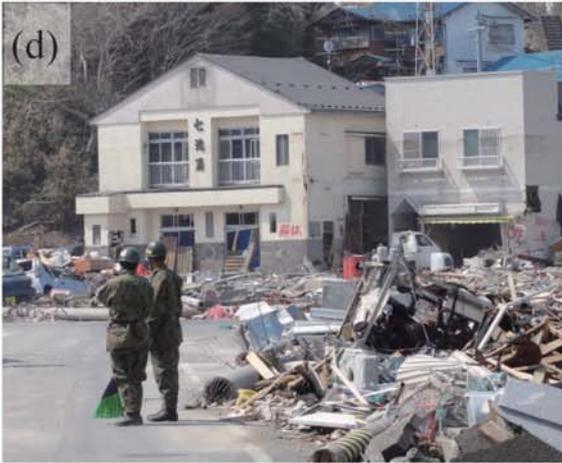
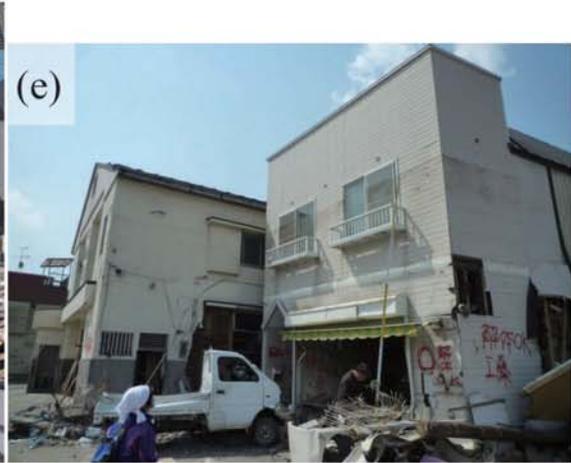
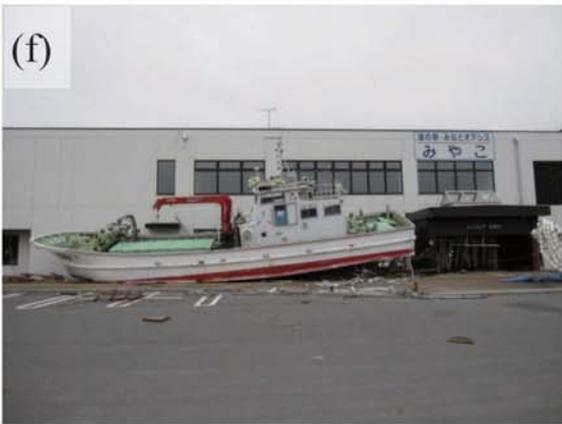
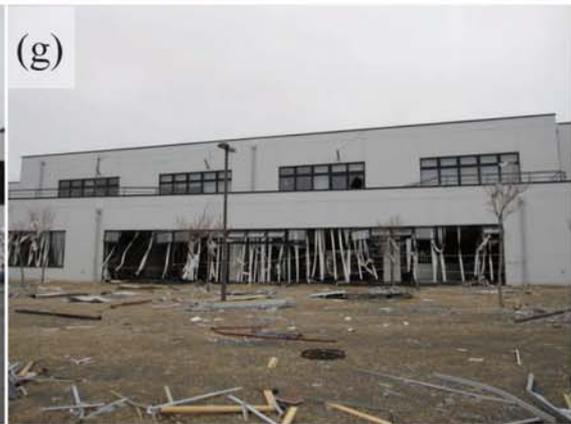
Fig. A90. (a)-(c) Damage at Kuwagasaki (Nakamachi) and Rinkodori. (d)-(e) Watermark on a house neighboring the Nanataki bathhouse in Kuwagasaki (Nakamachi) (I86). (f)-(g) Roadside area called Minato-Oasis in Rinkodori (I87).

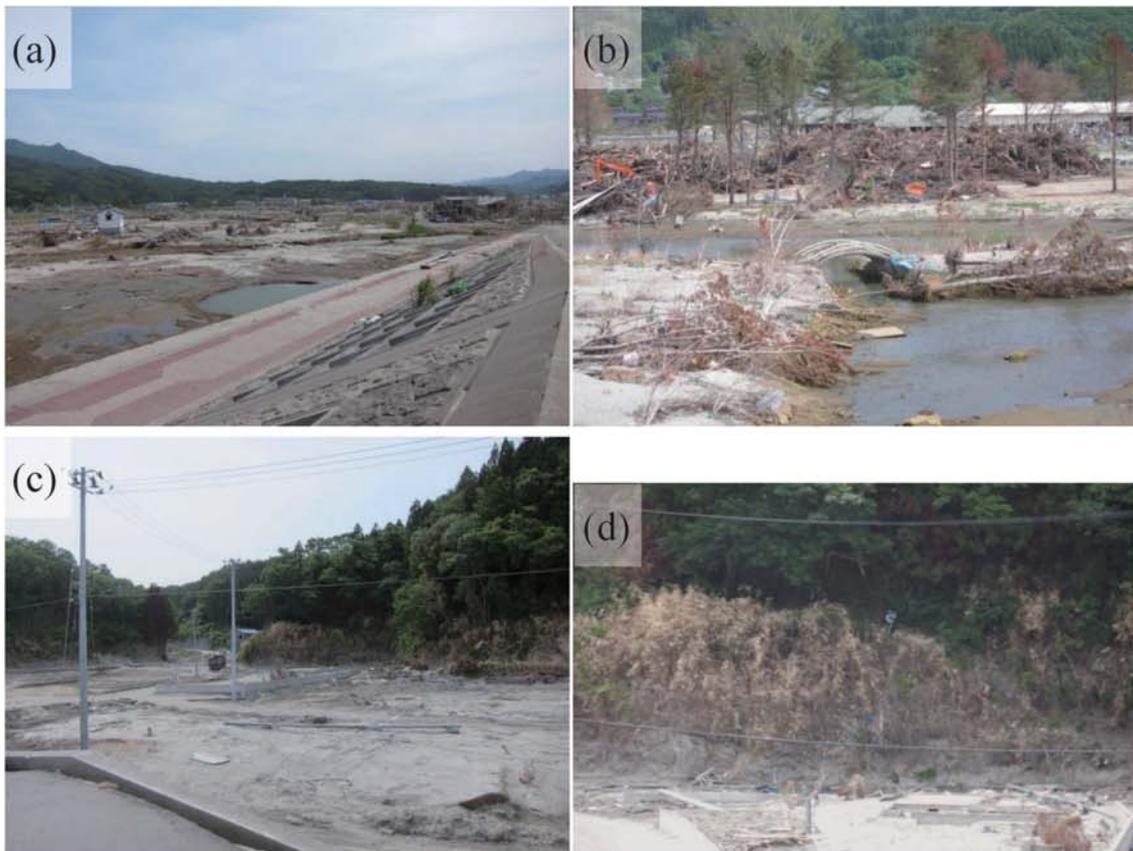
Fig. A92. (a)-(c) Damage at Tsugaruishi (Norinowaki). (d) Tsunami trace survey point at the western slope (I88).

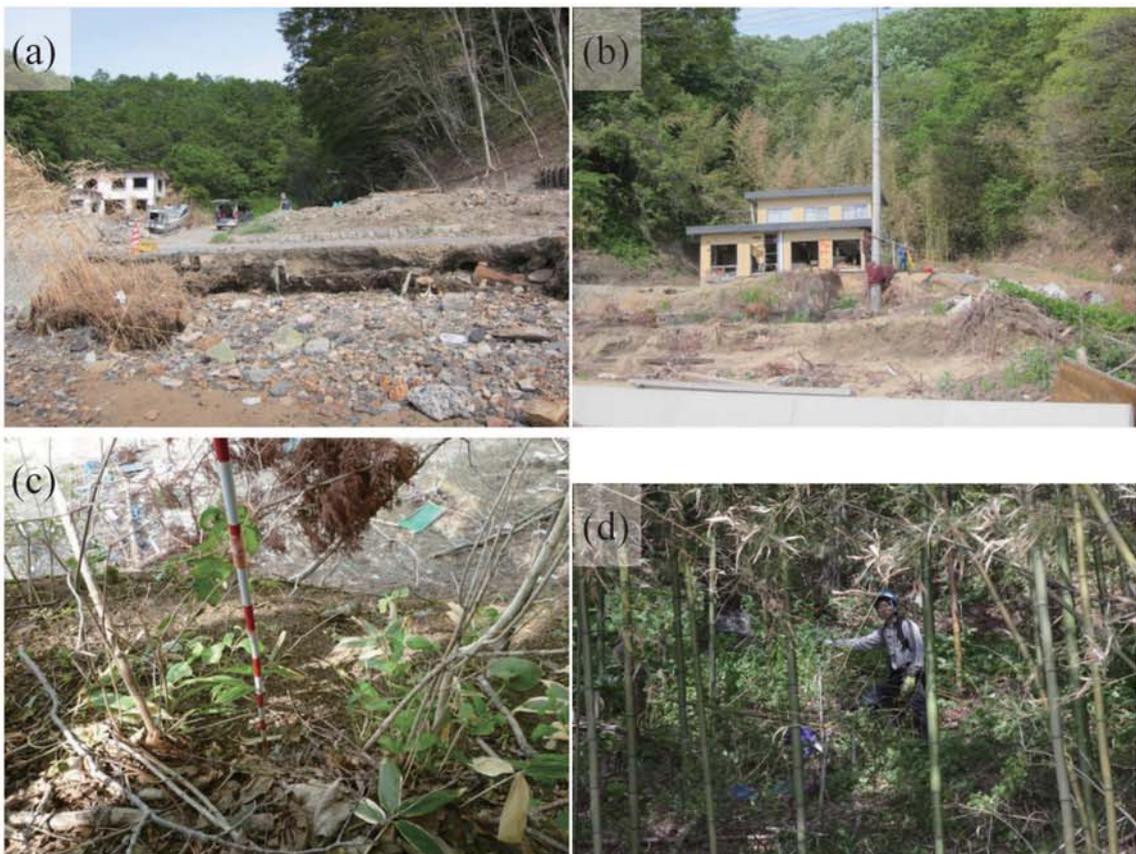
Fig. A94. (a)-(b) Damage at Akamae. (c) Tsunami trace survey point at the slope (I89). (d) Tsunami trace survey point at a bamboo forest (I90).
