2011年東北地方太平洋沖地震の津波高調査

Field Surveys of Tsunami Heights from the 2011 off the Pacific Coast of Tohoku, Japan Earthquake

We report the results of field surveys conducted by the Earthquake Research Institute, to measure tsunami heights from the 2011 off the Pacific coast of Tohoku, Japan Earthquake (M 9.0), on March 11. Measurements were taken at 296 points on the Sanriku coasts of Aomori, Iwate, and Miyagi Prefectures, and the Pacific coasts of Ibaraki and Chiba Prefectures. The data are included in the results of the 2011 Tohoku Earthquake Tsunami Joint Survey Group. We did not cover the Sendai plain in the southern Miyagi Prefecture because other parties extensively measure there, nor Fukushima Prefecture because of the accident of the Fukushima Dai-ichi nuclear power plant. The twelve surveys first sought traces indicating tsunami runup or inundation heights. Reliability was classified into A (most reliable based on clear physical evidence and eyewitness accounts), B (mostly based on natural traces), and C (least reliable based on equivocal evidence). Most physical evidence obtained after June was not significant; therefore, reliance was mostly placed on eyewitness accounts. Loc

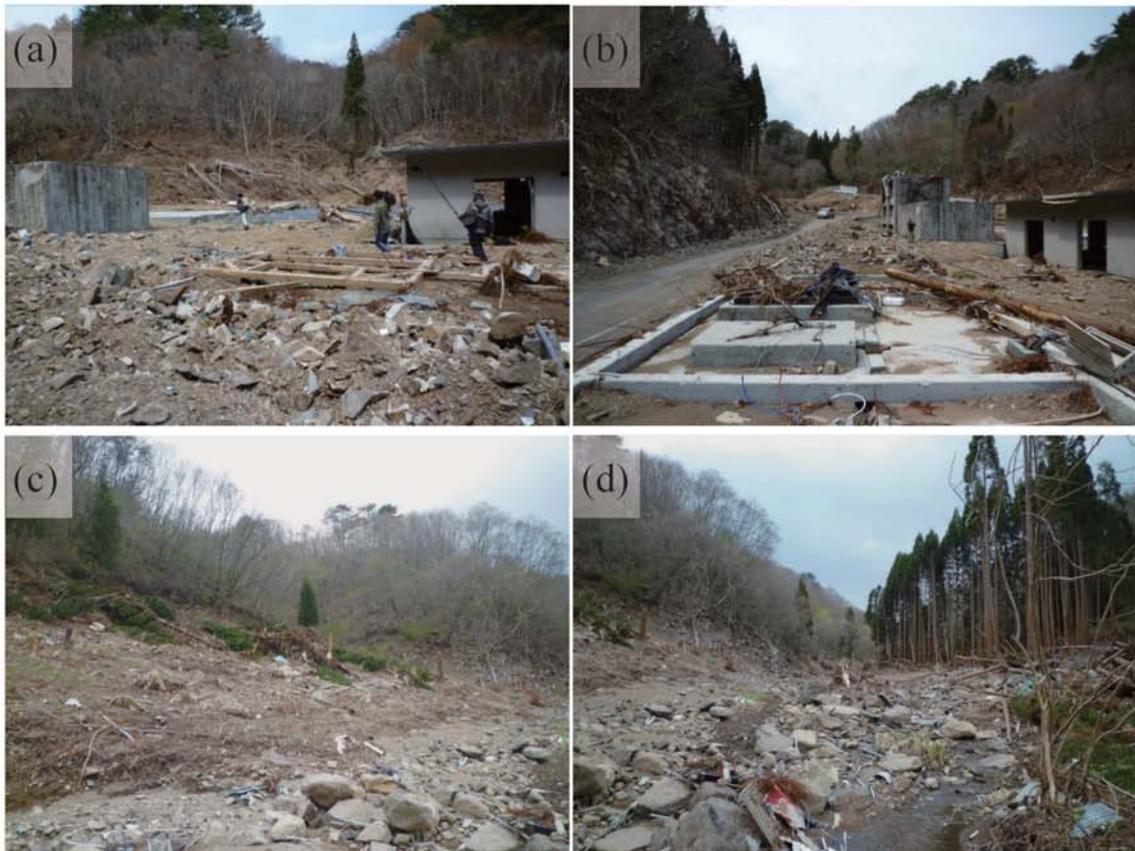
Fig. A96. (a)-(d) Damage at Omoe (Tatehama). (e) Tsunami trace survey point at the northern slope (I91). (f)-(h) Tsunami trace survey point at the southern slope (I92). (i)-(j) Tsunami trace survey point at the upstream northern slope (I93).

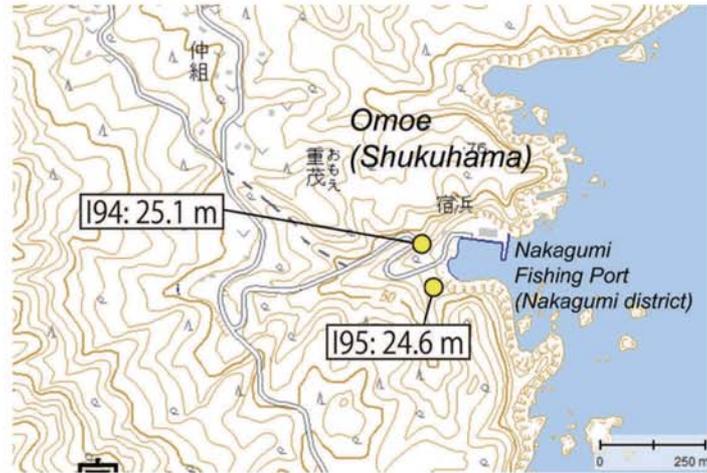
Fig. A97. Tsunami heights at Omoe (Shukuhama), Miyako City, Iwate Prefecture (added with digital topographic map 1/25,000 from the Geospatial Information Authority of Japan). The symbols and their meanings are the same as in Fig. 3.

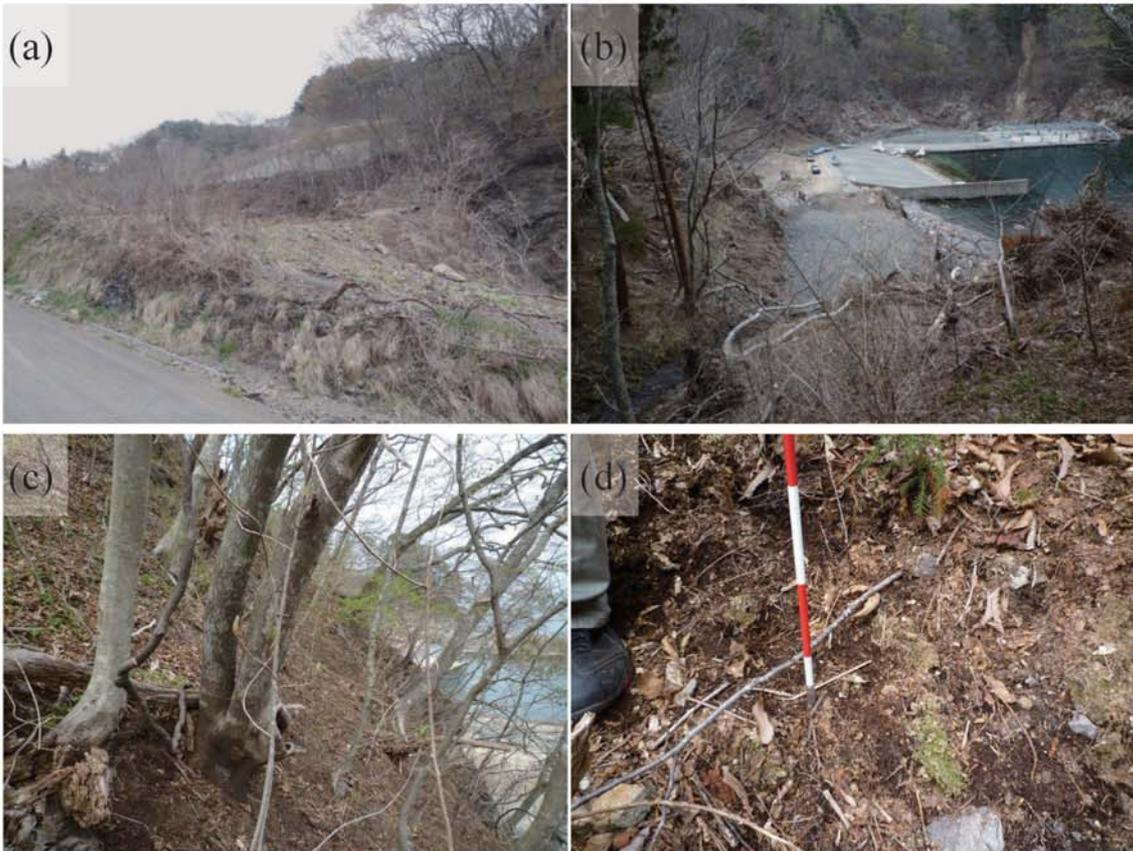
Fig. A98. (a)-(b) Damage at Omoe (Shukuhama). (c) Tsunami trace survey point at the northern slope (I94). (d) Tsunami trace survey point at the southern slope (I95).

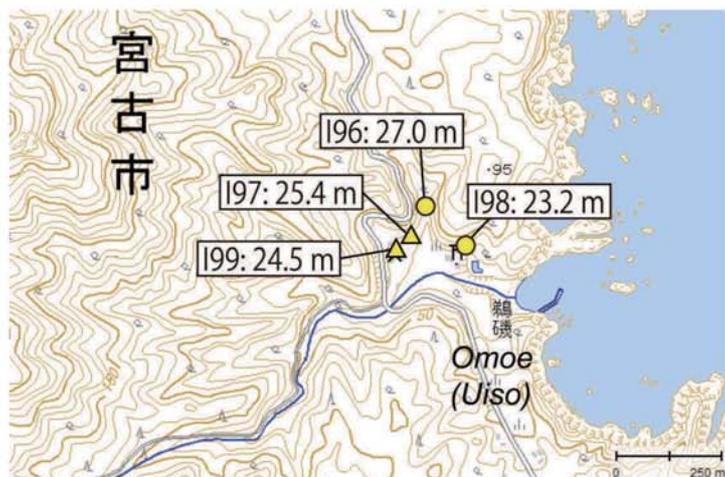
Fig. A99. Tsunami heights at Omoe (Uiso), Miyako City, Iwate Prefecture (added with digital topographic map 1/25,000 from the Geospatial Information Authority of Japan). The symbols and their meanings are the same as in Fig. 3.

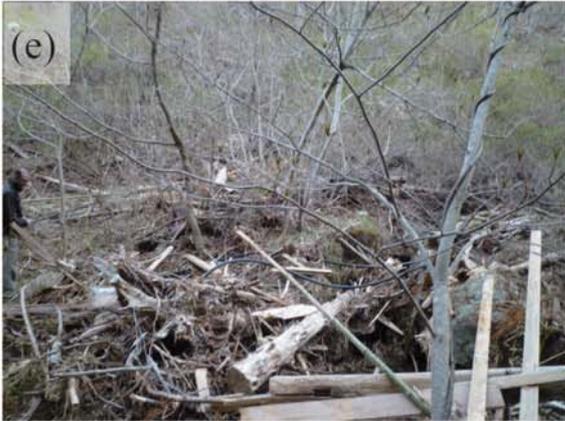
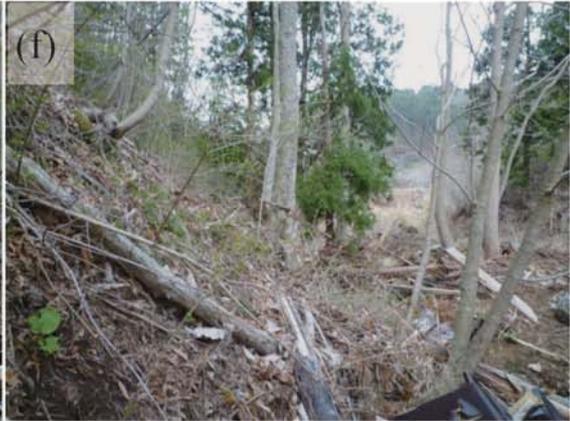
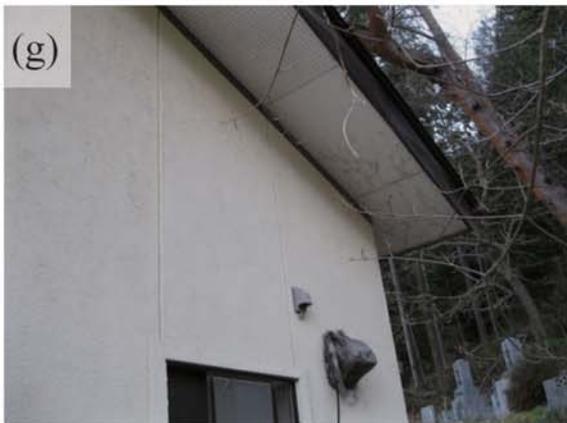
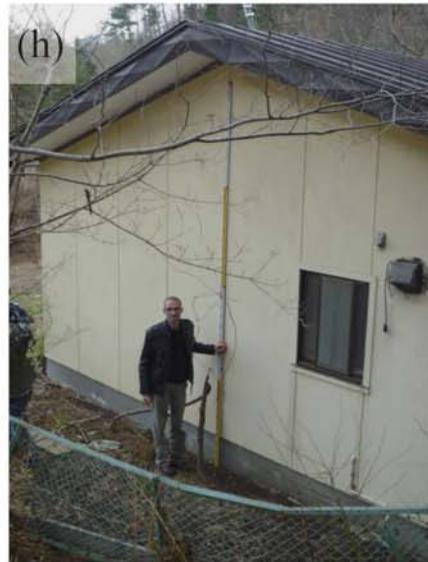
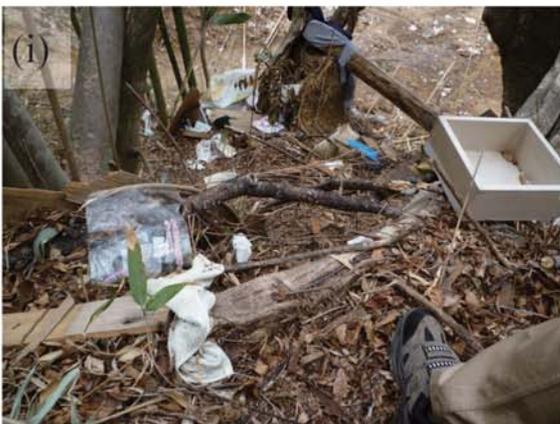
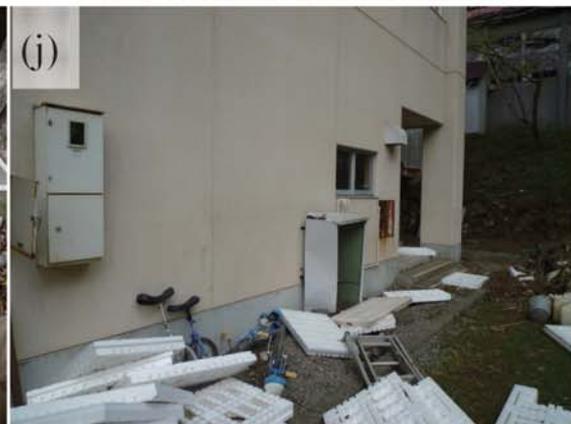
Fig. A100. (a)-(d) Damage at Omoe (Uiso). (e)-(f) Tsunami trace survey point at a slope north of Uiso elementary school (I96). (g)-(h) Watermark on a building neighboring Uiso elementary school (3.70 m above ground level; I97). (i) Tsunami trace survey point at a slope east of Uiso elementary school (I98). (j) Watermark on a surface wall of Uiso elementary school (1.20 m above ground level; I99).

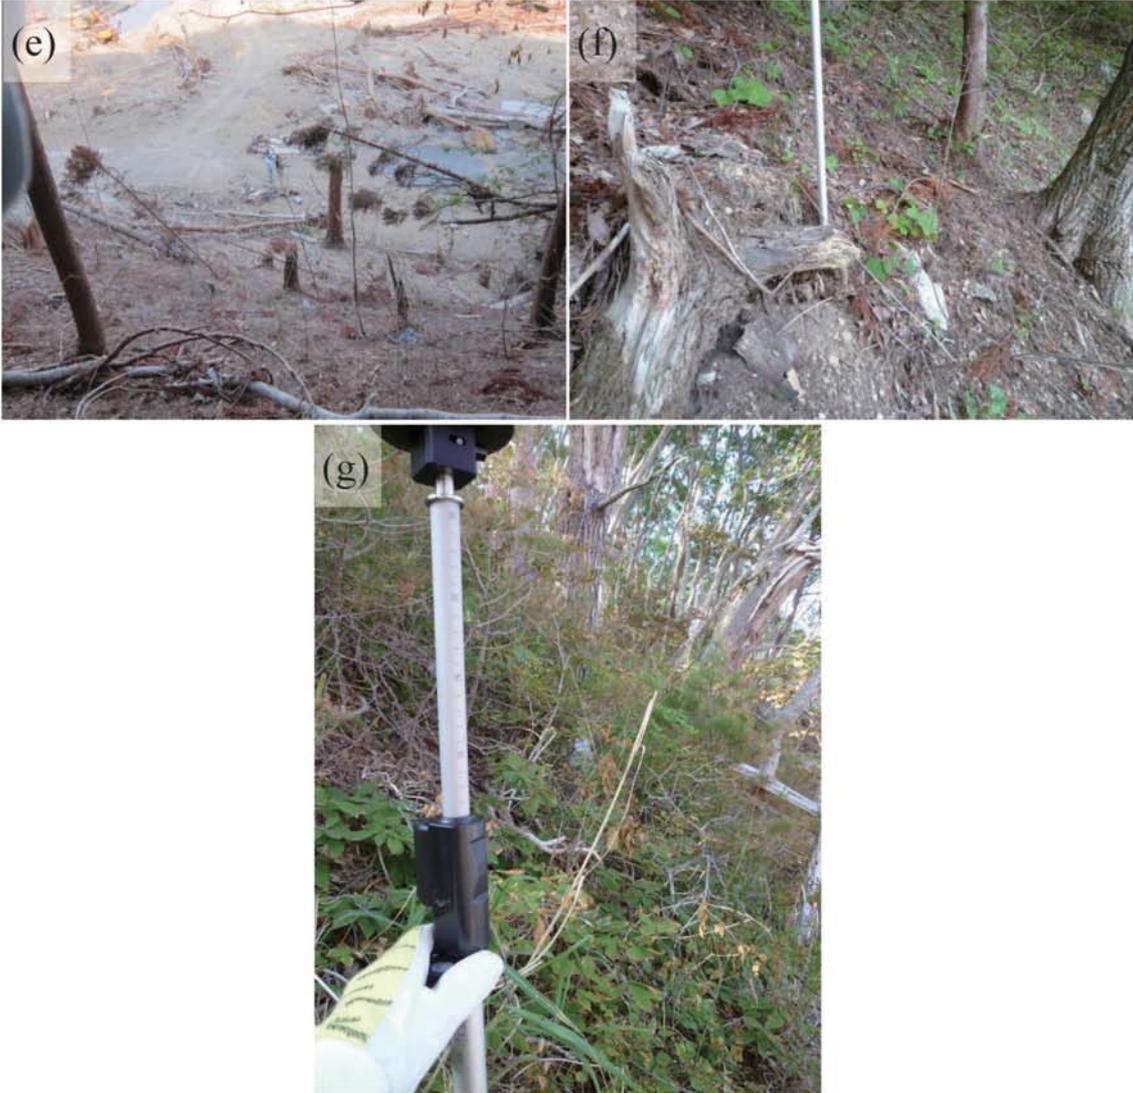
Fig. A102. (a)-(d) Damage at Omoe (Aramaki). (e) Tsunami trace survey point at the northern slope (I100). (f) Tsunami trace survey point at the western slope (I101). (g) Tsunami trace survey point at the southwestern slope (I102).

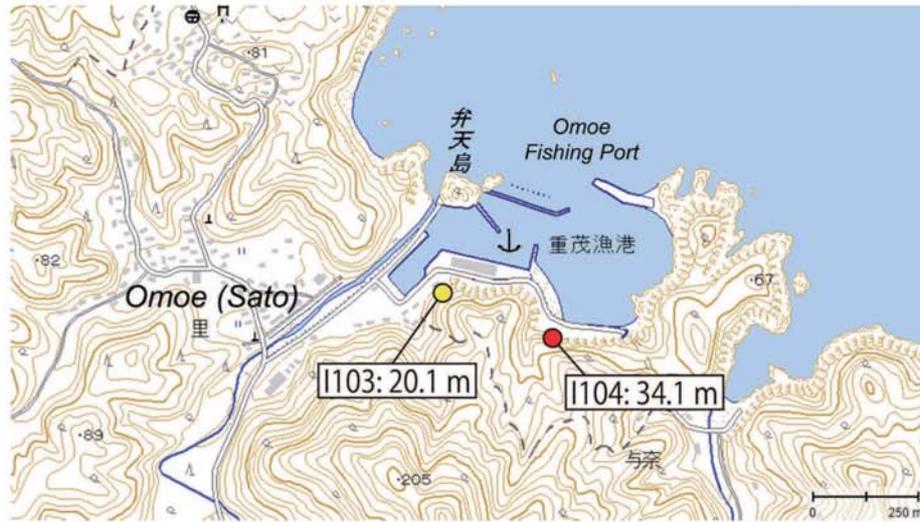
Fig. A103. Tsunami heights at Omoe (Sato; Omoe Fishing Port), Miyako City, Iwate Prefecture (added with digital topographic map 1/25,000 from the Geospatial Information Authority of Japan). The symbols and their meanings are the same as in Fig. 3.

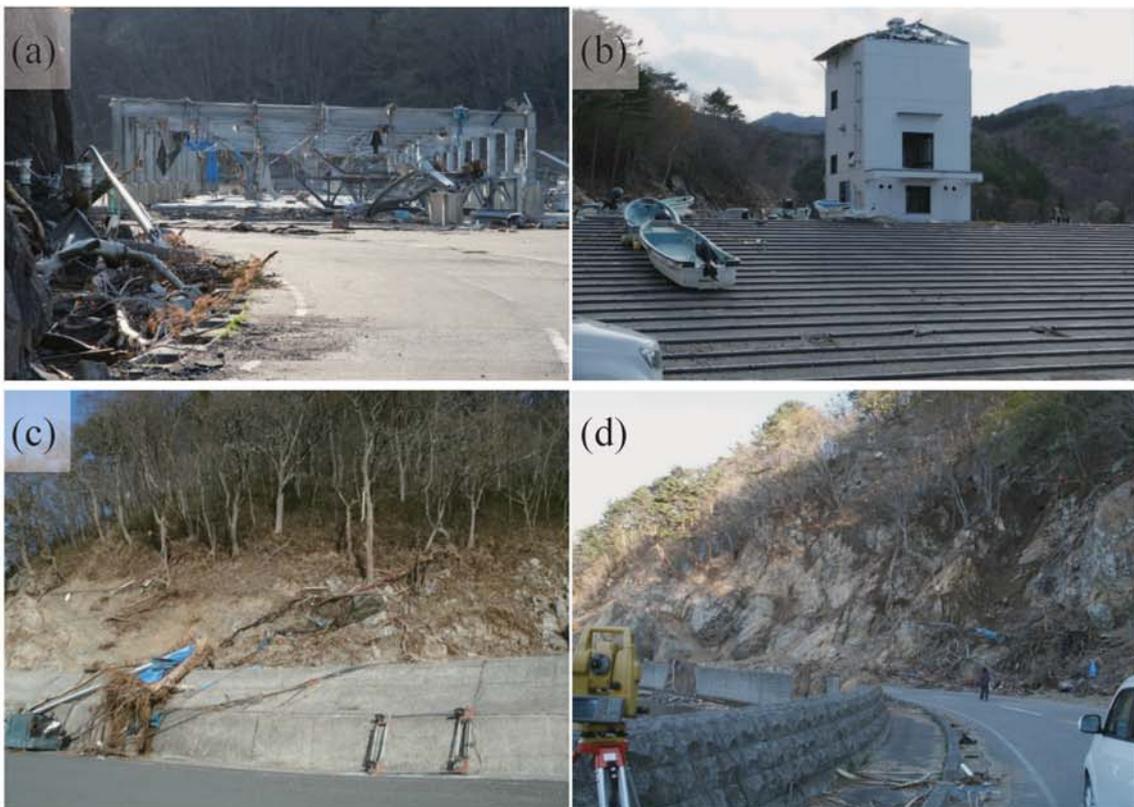
Fig. A104. (a)-(b) Damage at Omoe (Sato; Omoe Fishing Port). (c) Buoys that drifted to a tree at a slope (I103). (d) Tsunami trace survey point at a slope (I104)

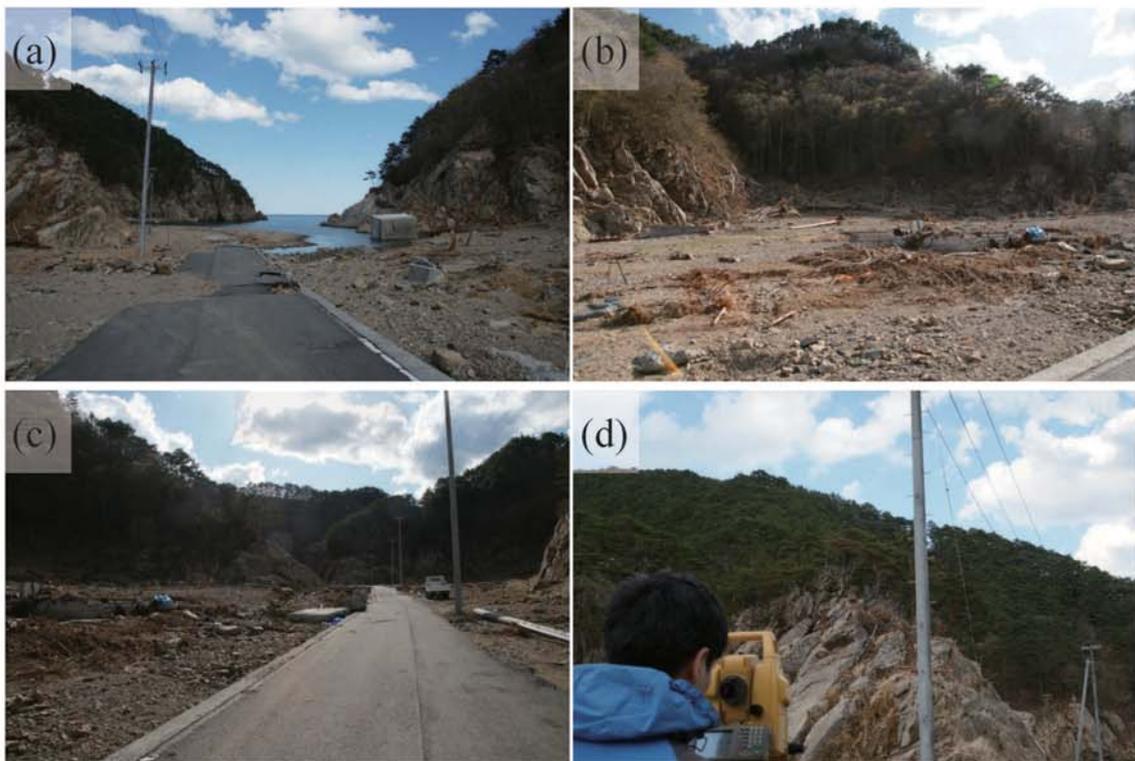
Fig. A106. (a)-(c) Damage at Omoe (Aneyoshi). (d) Tsunami trace survey point at the northern slope (I106).

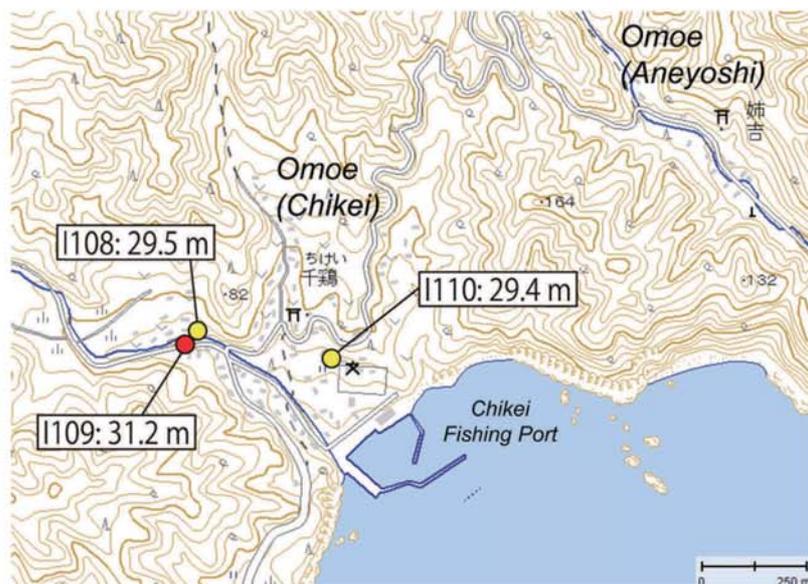
Fig. A107. Tsunami heights at Omoe (Chikei), Miyako City, Iwate Prefecture (added with digital topographic map 1/25,000 from the Geospatial Information Authority of Japan). The symbols and their meanings are the same as in Fig. 3.

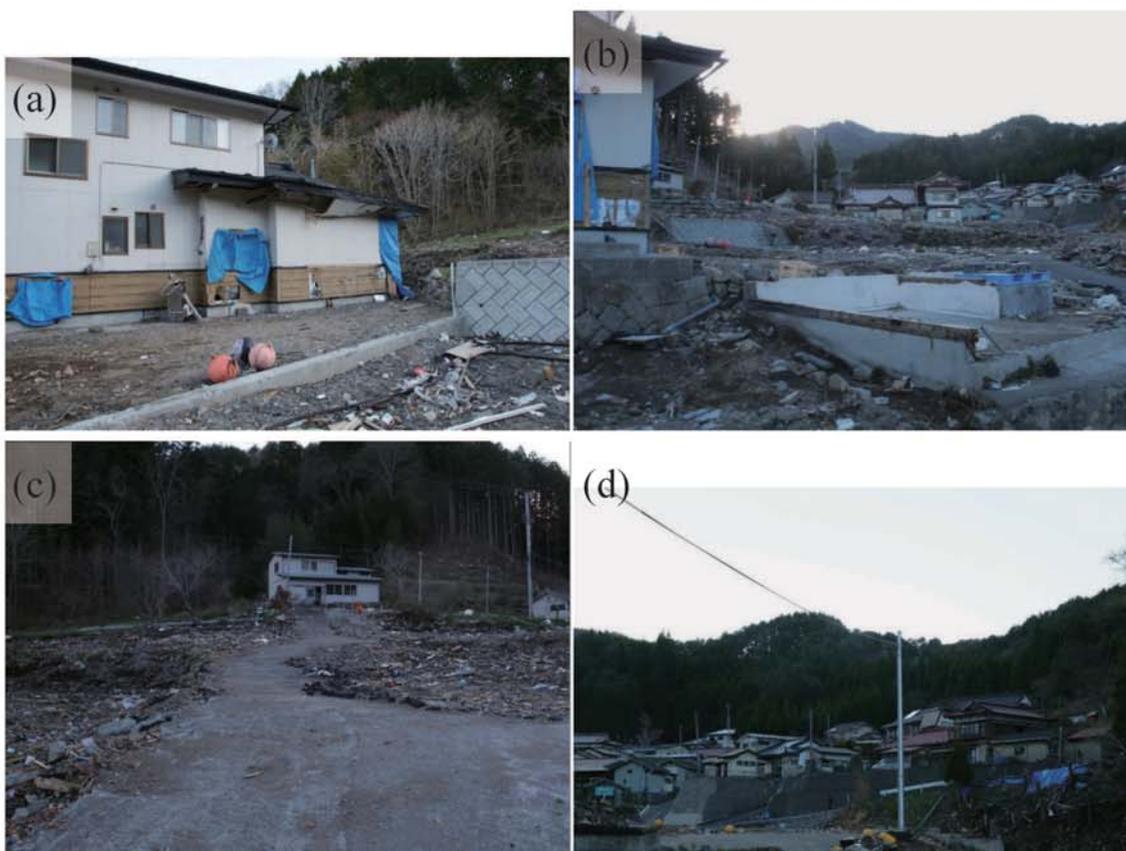
Fig. A108. (a)-(c) Damage at Omoe (Chikei). (d) Tsunami trace survey point at the slope (I109).

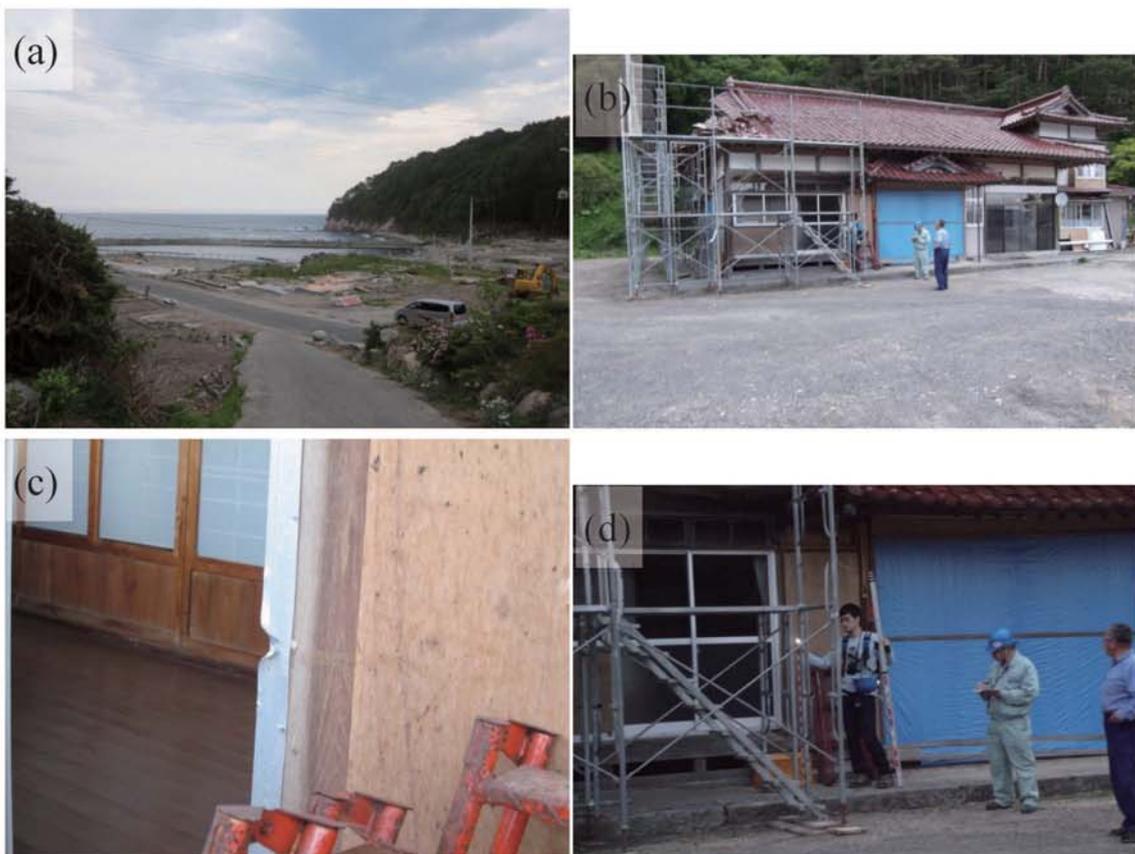
Fig. A110. (a)-(b) Damage at Omoe (Ishihama). (c)-(d) Watermark on a wall of Mr. Ishizaki's house (I111).

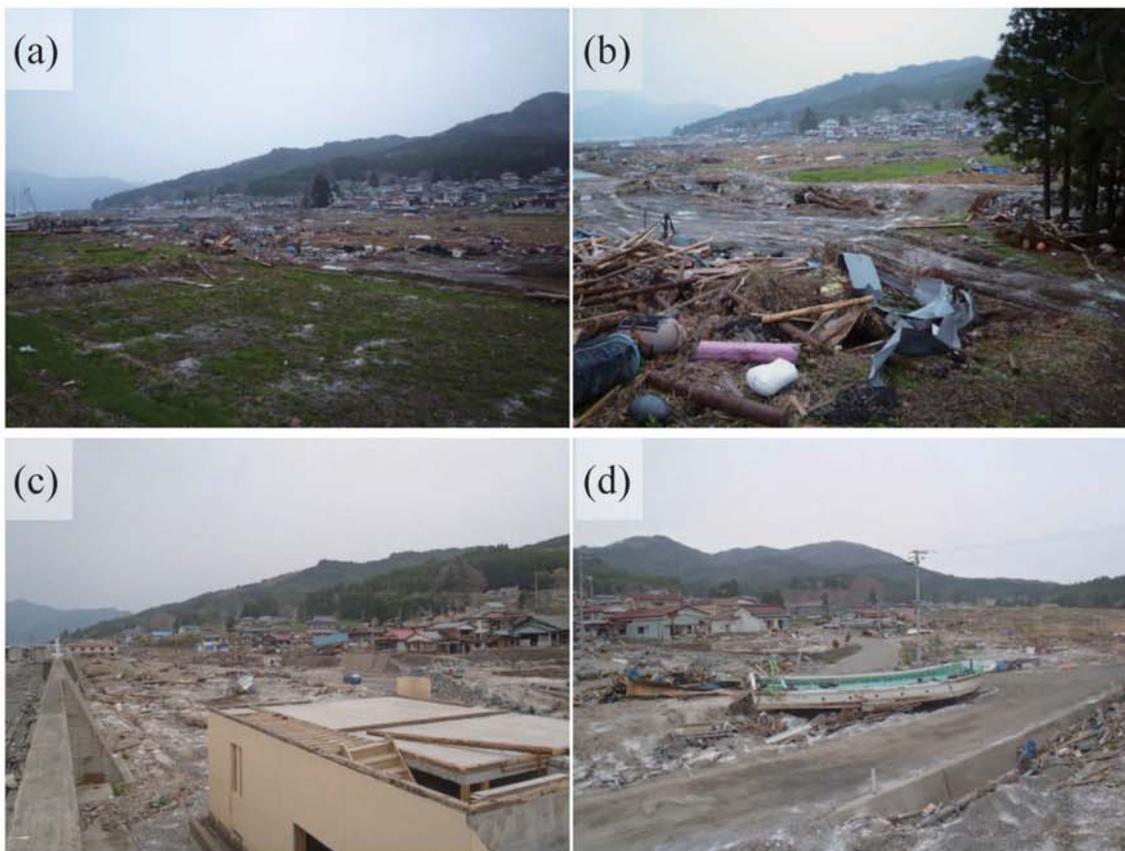
Fig. A112. (a)-(d) Damage at Funakoshi (Ohura). (e) Tsunami trace survey point at a residential district (I112). (f) Watermark on a glass window in a residential district (2.19 m above ground level; I113). (g) Tsunami trace survey point at the western slope (I114). (h) Tsunami trace survey point at the western slope (I115).

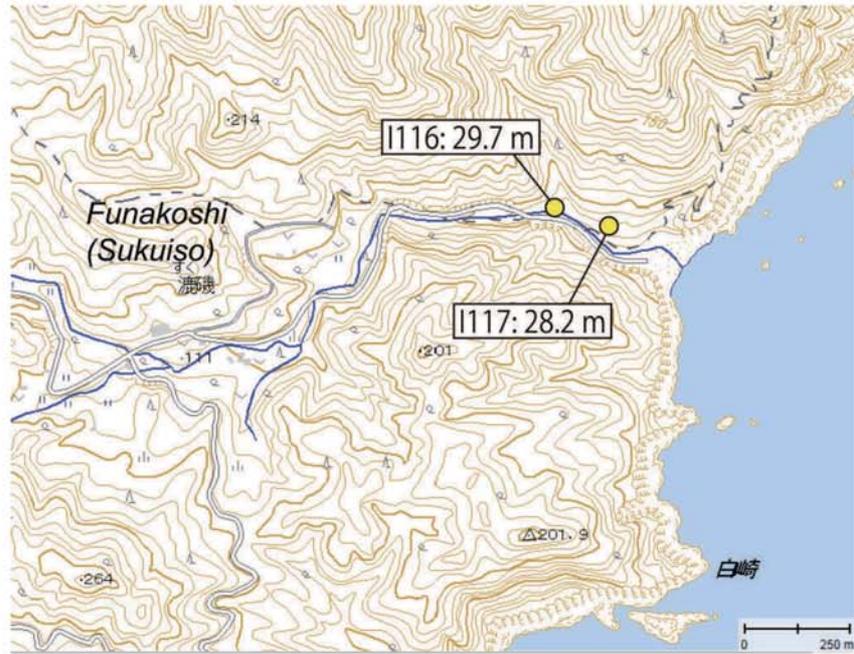
Fig. A113. Tsunami heights at Funakoshi (Sukuiso), Yamada Town, Iwate Prefecture (added with digital topographic map at a scale of 1/25,000 from the Geospatial Information Authority of Japan). The symbols and their meanings are the same as in Fig. 3.

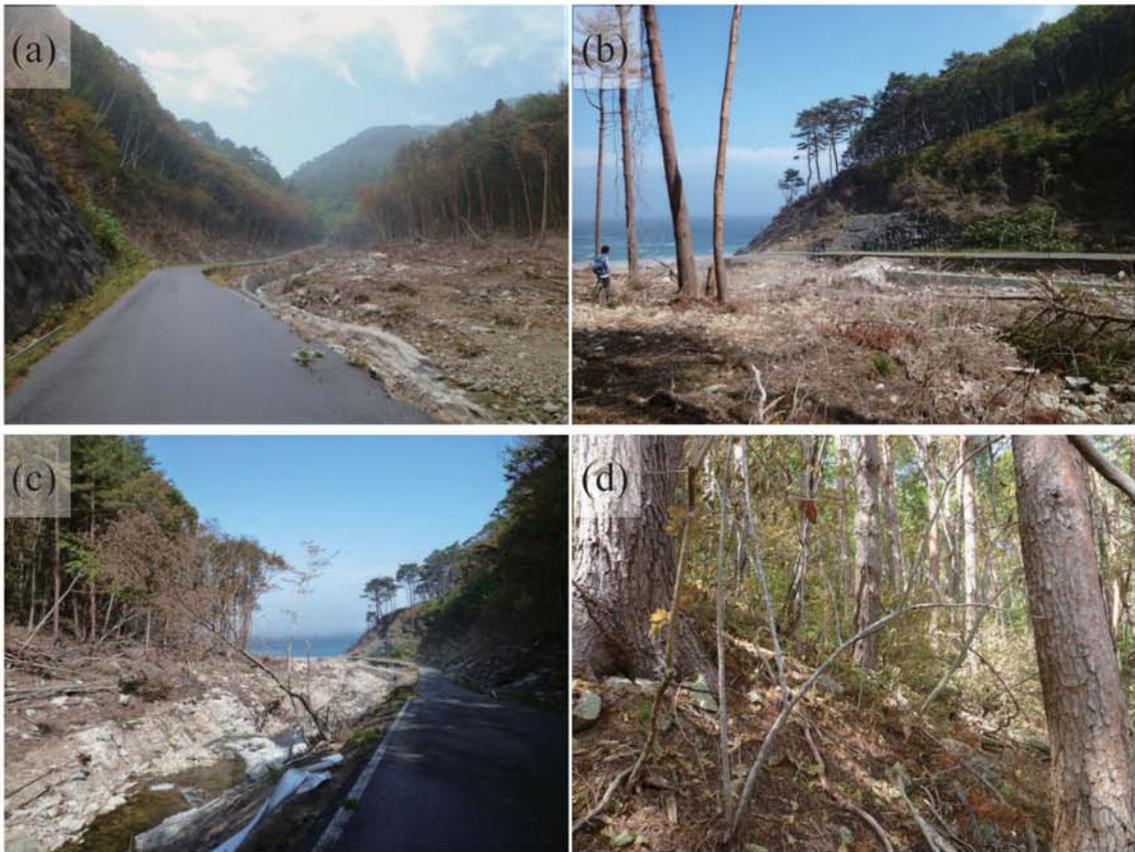
Fig. A114. (a)-(b) Damage at Funakoshi (Sukuiso). (c) Tsunami trace survey point at the side of the road (I116). (d) Tsunami trace survey point at the northern slope (I117).

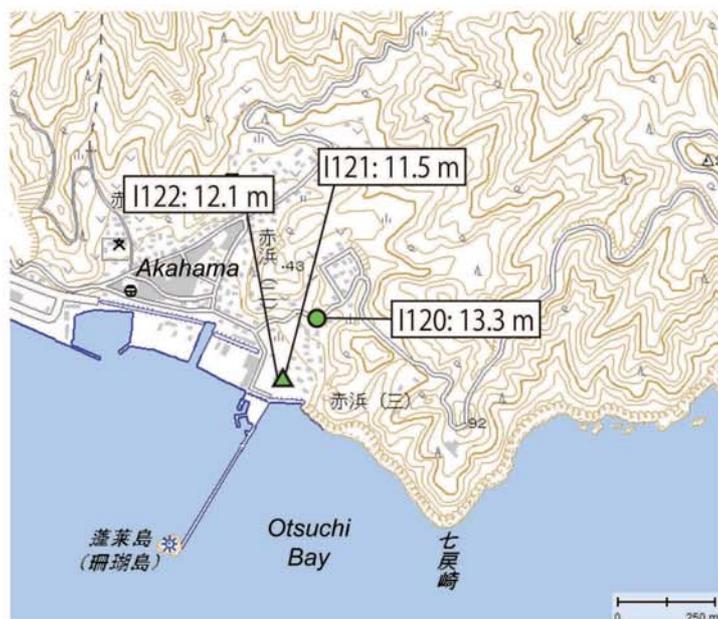
Fig. A117. Tsunami heights at Akahama, Otsuchi Town, Iwate Prefecture (added with digital topographic map at a scale of 1/25,000 from the Geospatial Information Authority of Japan). The symbols and their meanings are the same as in Fig. 4.

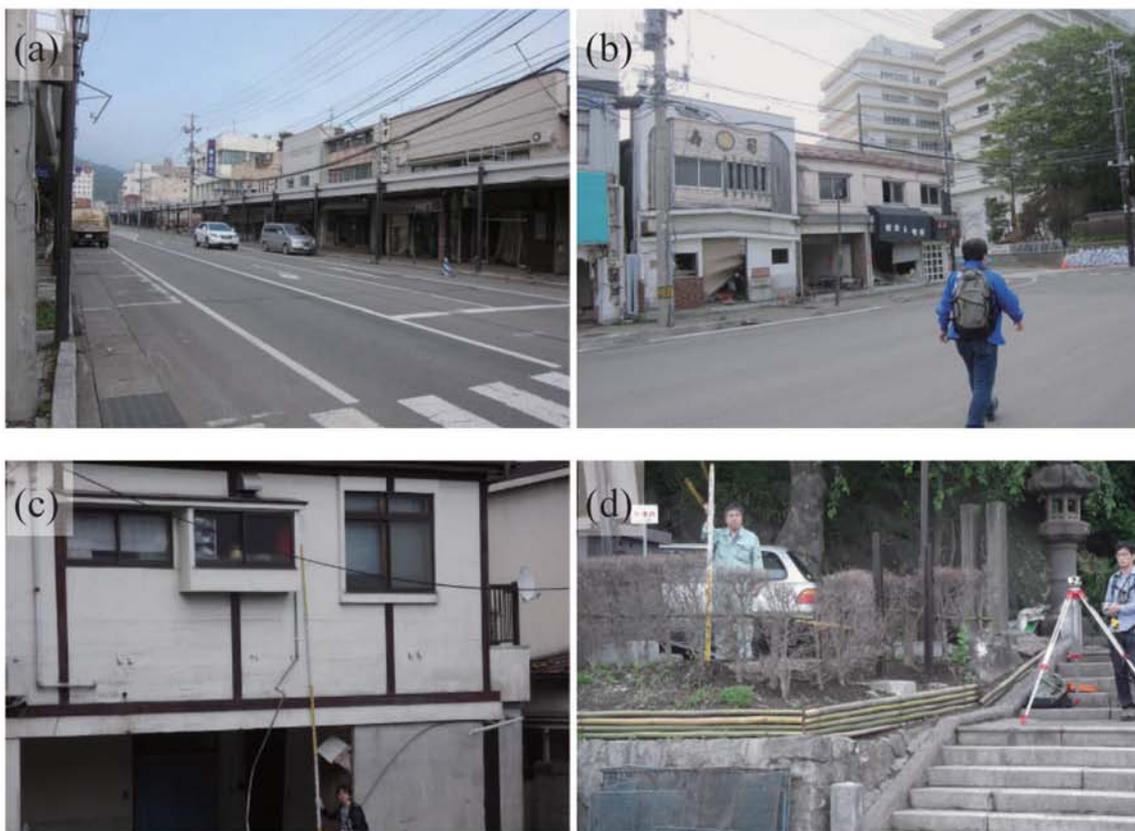
Fig. A120. (a)-(b) Damage at Omachi. (c) Watermark on the wall of the Japanese green tea shop Sachu (3.95 m above ground level, I123). (d) Benchmark (TP 4.0m), which is under the rod used to measure tsunami height.

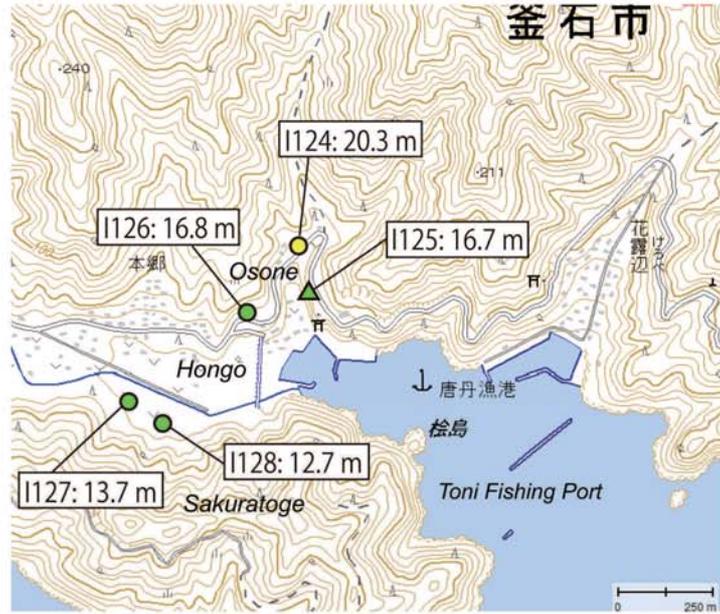
Fig. A121. Tsunami heights at Osone (I124, I125, and I126) and Sakuratoge (I127 and I128), Tonicho, Kamaishi City, Iwate Prefecture (added with digital topographic map at a scale of 1/25,000 from the Geospatial Information Authority of Japan). The symbols and their meanings are the same as in Fig. 4.

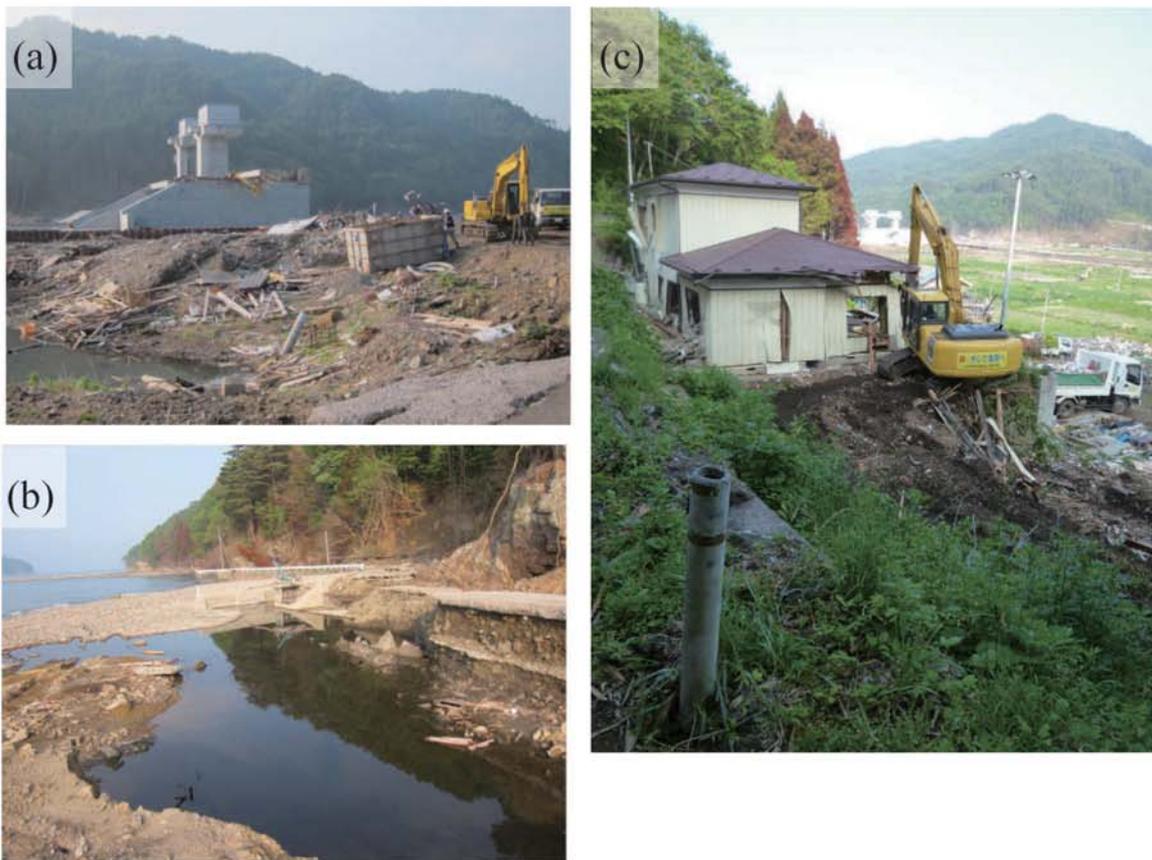
Fig. A124. (a)-(b) Damage at Arakawa. (c) Tsunami inundation limit in Arakawa (I129).

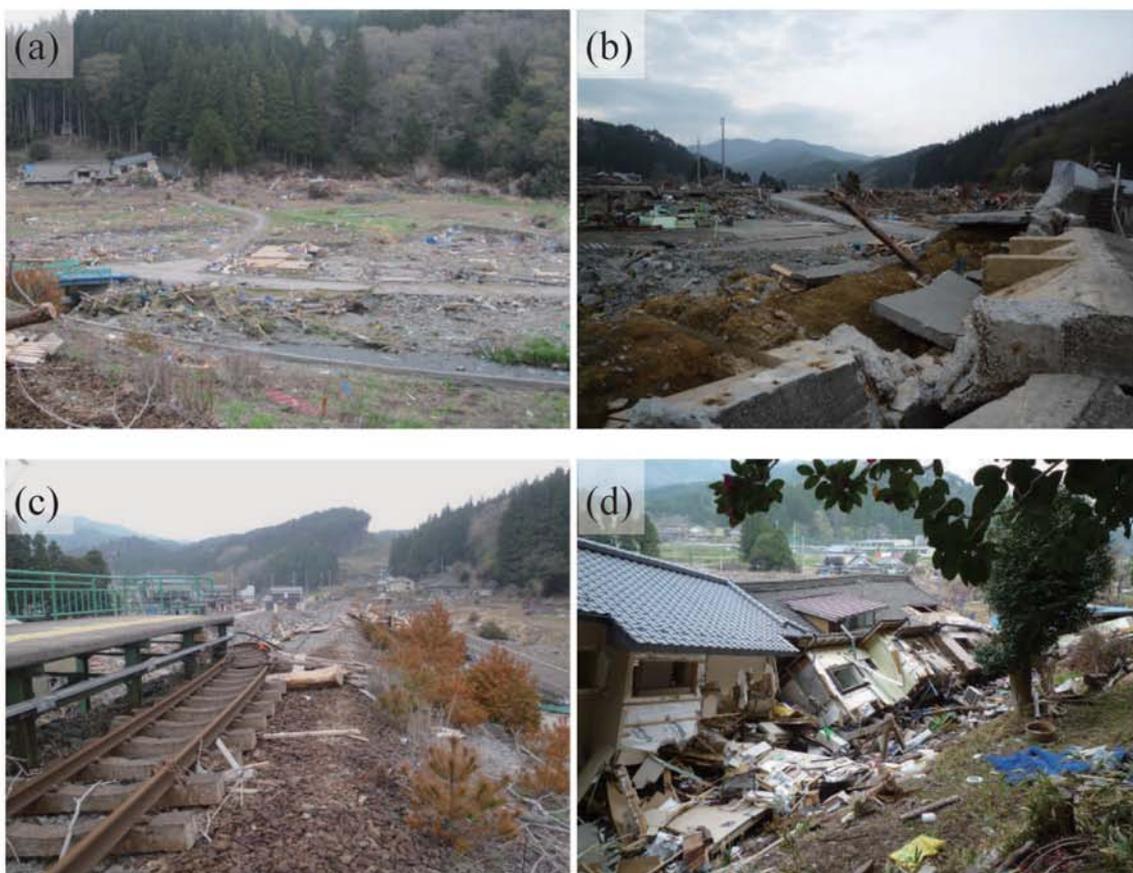
Fig. A126. (a)-(d) Damage at Horei. (e) Tsunami inundation limit on the northeastern slope at Horei station (I130). (f) Debris piled up around the survey point of I130. (g)-(h) Tsunami inundation limit at a field in front of a house (I131). (i)-(j) Tsunami trace survey point on the railroad of the Sanriku railway (I132).

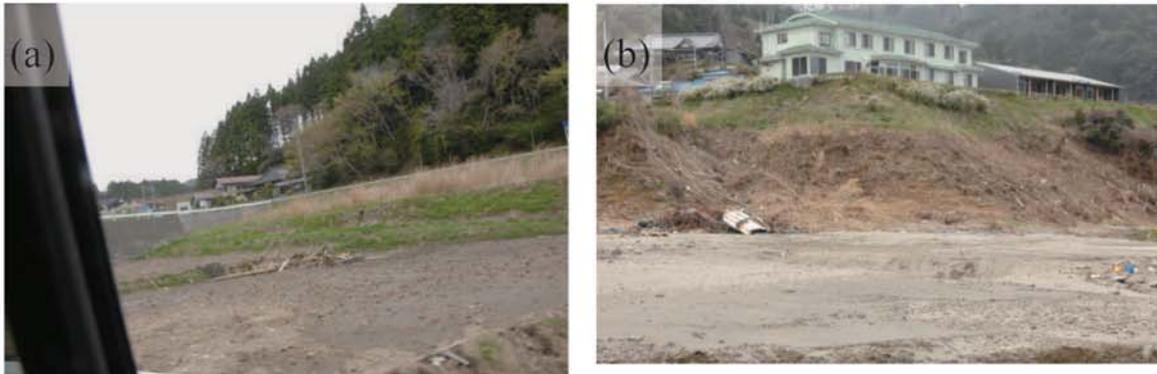
Fig. A128. (a) Tsunami inundation limit in a rice field at Shirahama based on scattered debris (I133). (b) Tsunami inundation limit at a slope in Okubo based on the border with live and dry grass (I134).

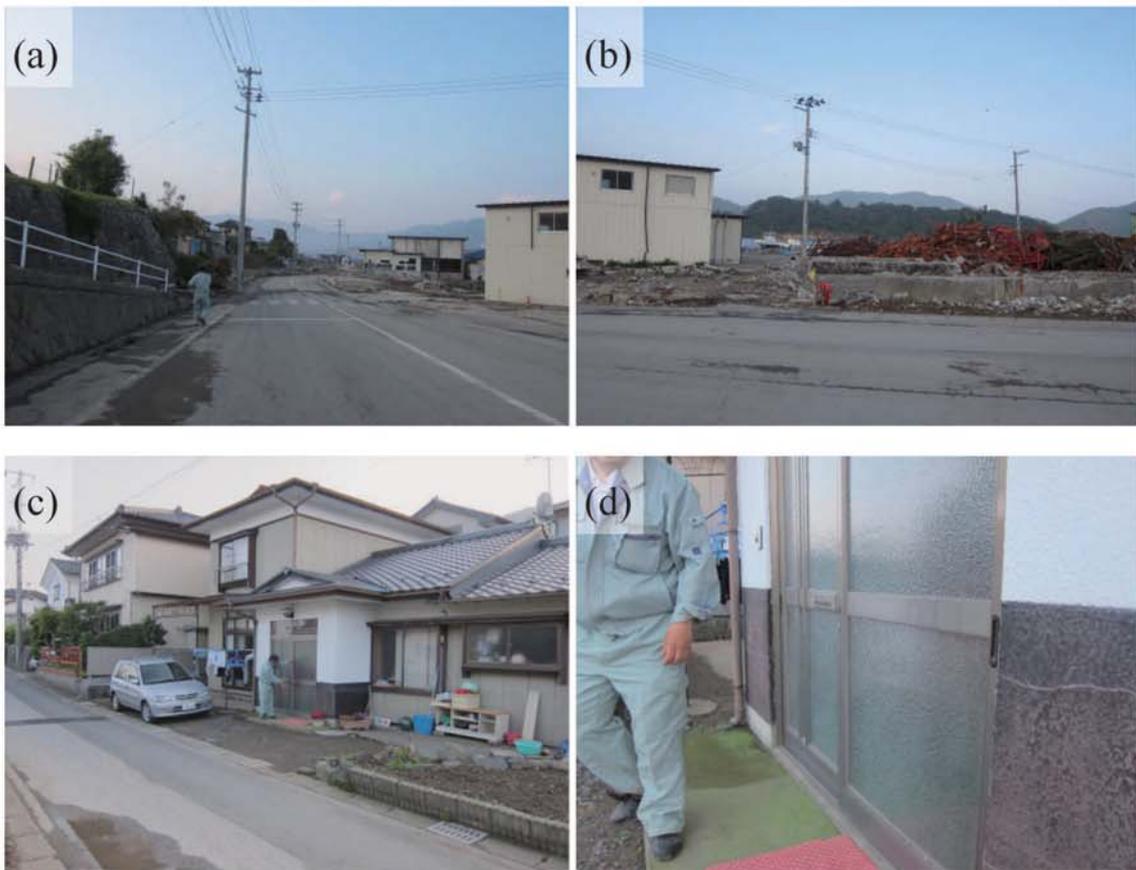
Fig. A130. (a)-(b) Damage at Miyanomae. (c) Mr. Kawahara's house at Miyanomae (tsunami trace survey point). (d) Watermark on the windowpanes of the sliding doors at the entrance of Mr. Kawahara's house (0.7 m above ground level, I135).

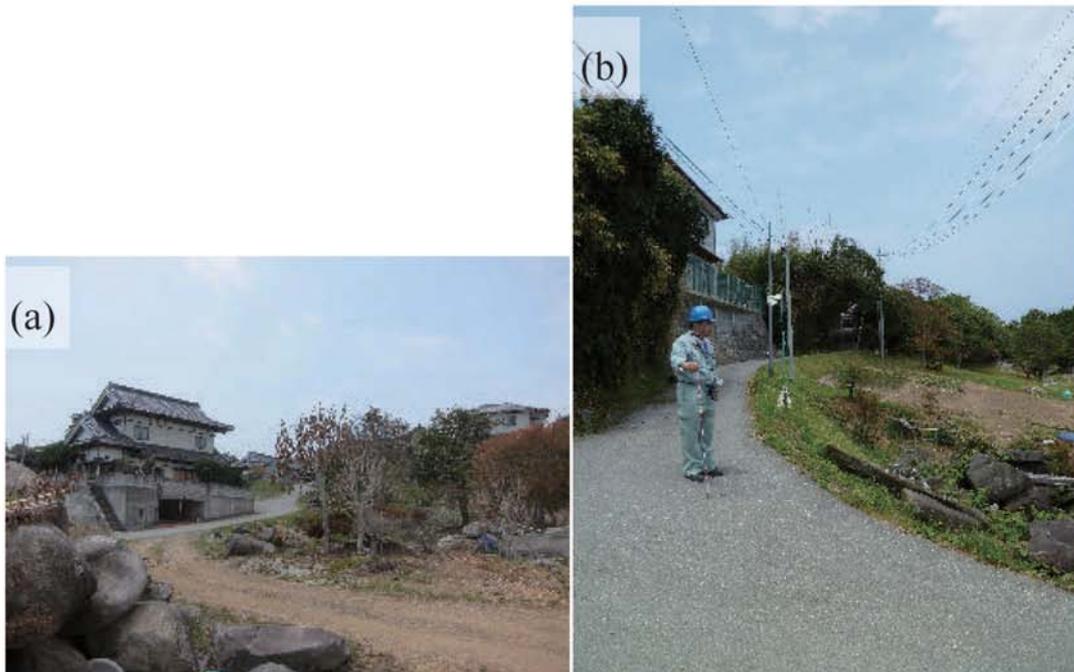
Fig. A134. (a) Damage at Karakuwacho-Baba. (b) Tsunami trace survey point at the southern slope (M1).

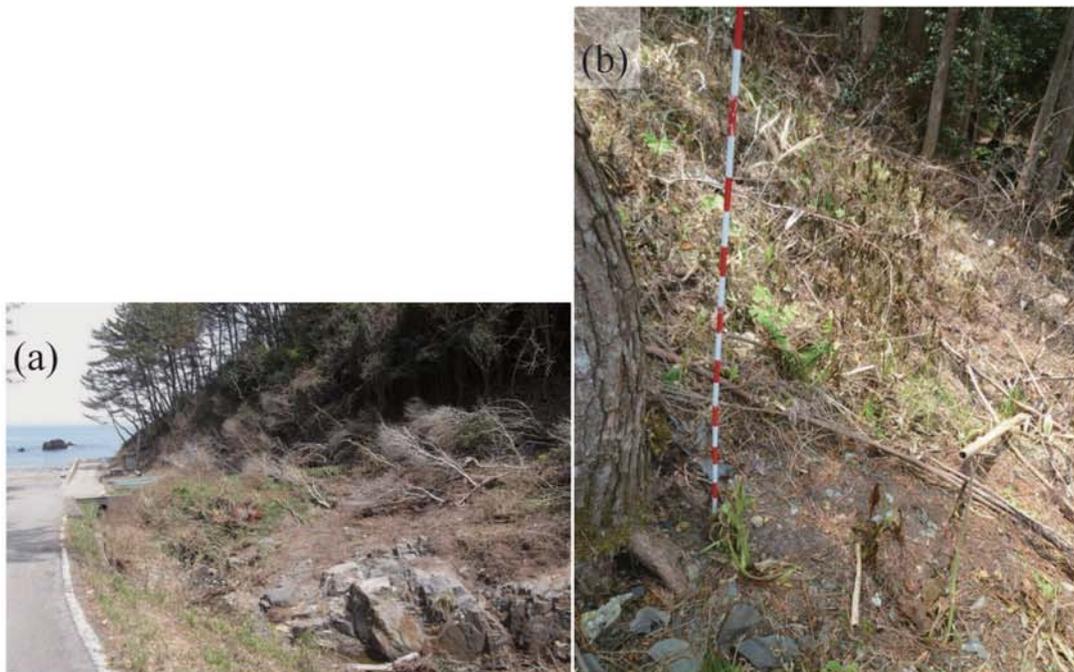
Fig. A136. (a) Tsunami trace in Karakuwacho-Naka. (b) Tsunami trace survey point at the southern slope (M2).

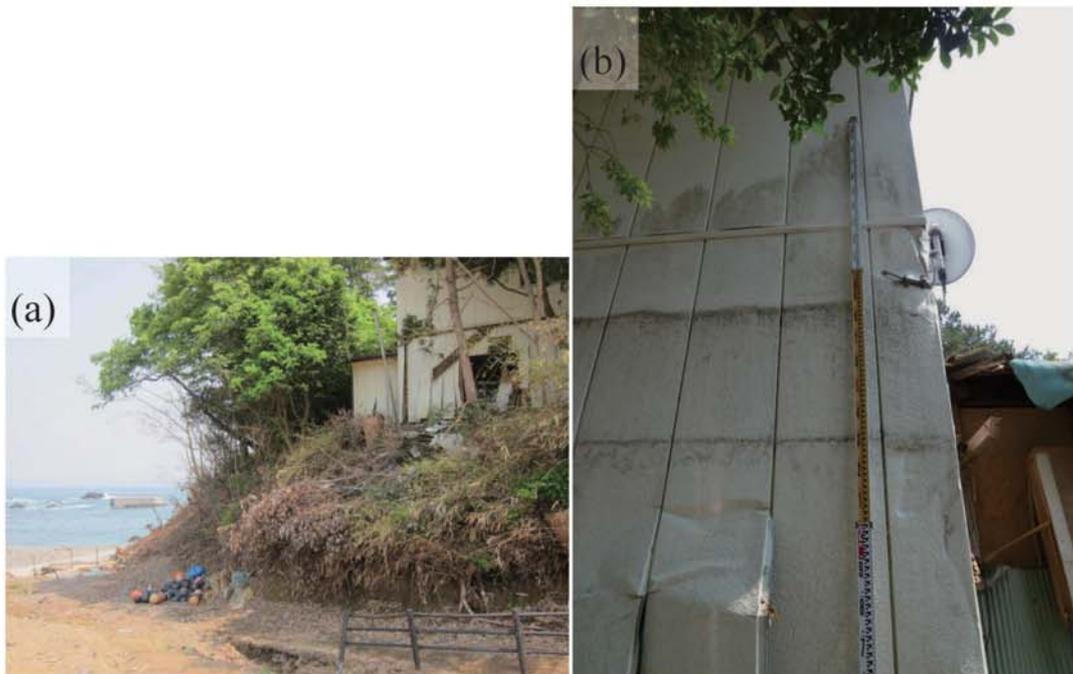
Fig. A138. (a) Damage at Karakuwacho-Kakehama. (b) Tsunami trace survey point on a wall of a house on the southern slope (2.85 m above ground level, M3).

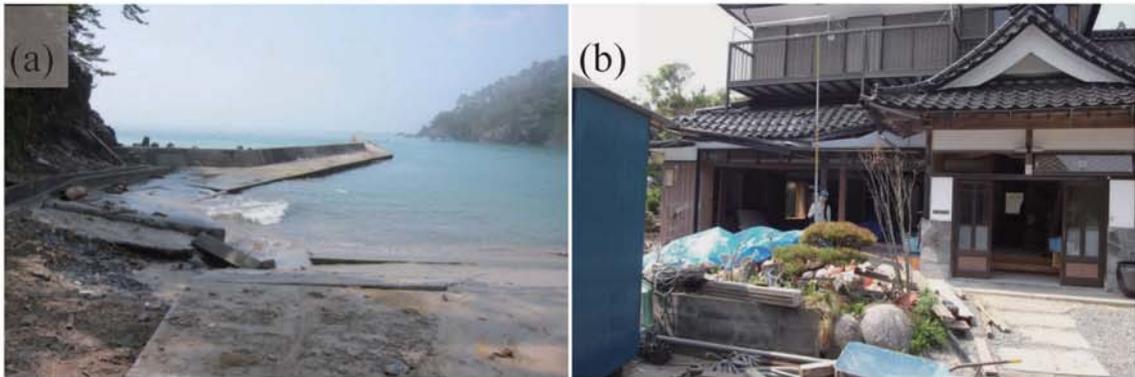
Fig. A140. (a) Damage at Karakuwacho-Tsumoto. (b) Tsunami trace survey point at the drying area on the second floor (4.70 m above ground level, M4).

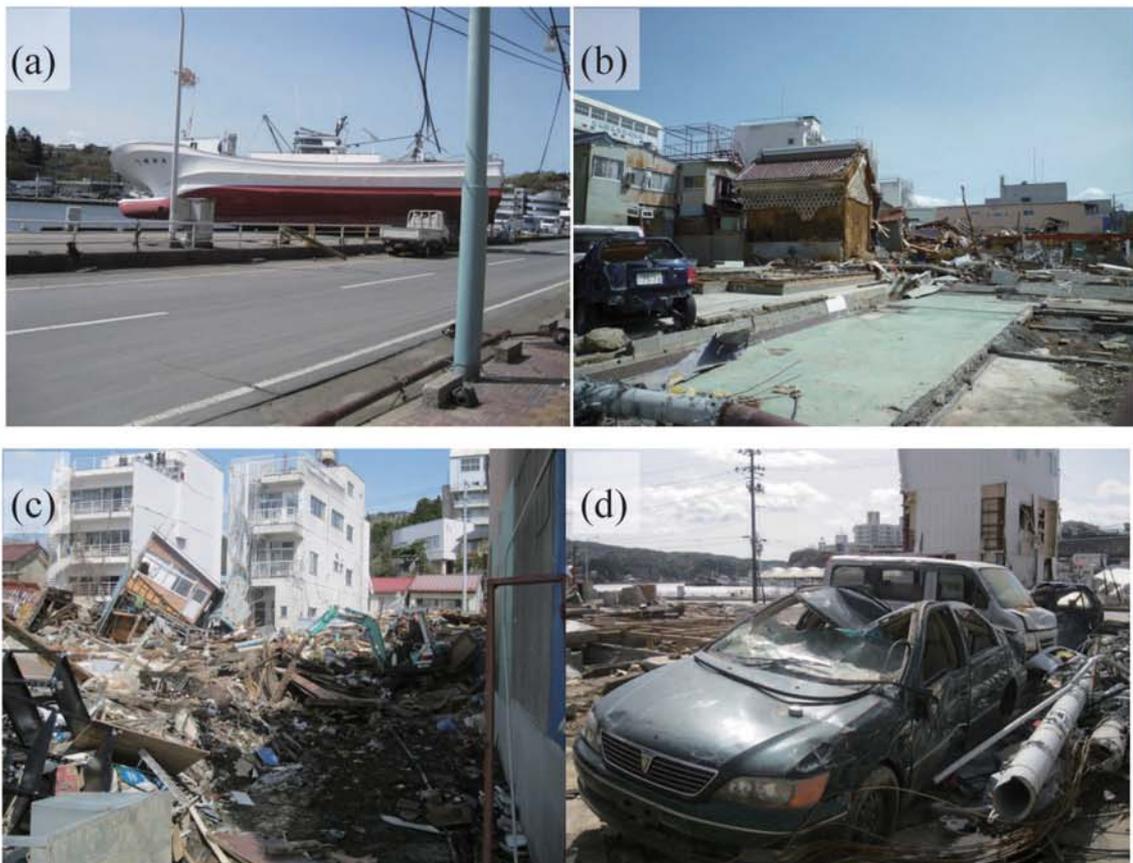
Fig. A142. (a)-(f) Damage at Minamimachikaigan (Kesennuma Port). (g)-(j) Watermark on a wall of the municipal parking and surrounding buildings (2.60 m, 3.12 m, 3.08 m, and 2.95 m above ground level, respectively, M6, M7, M8, M5).
