2011年東北地方太平洋沖地震の津波高調査

Field Surveys of Tsunami Heights from the 2011 off the Pacific Coast of Tohoku, Japan Earthquake

We report the results of field surveys conducted by the Earthquake Research Institute, to measure tsunami heights from the 2011 off the Pacific coast of Tohoku, Japan Earthquake (M 9.0), on March 11. Measurements were taken at 296 points on the Sanriku coasts of Aomori, Iwate, and Miyagi Prefectures, and the Pacific coasts of Ibaraki and Chiba Prefectures. The data are included in the results of the 2011 Tohoku Earthquake Tsunami Joint Survey Group. We did not cover the Sendai plain in the southern Miyagi Prefecture because other parties extensively measure there, nor Fukushima Prefecture because of the accident of the Fukushima Dai-ichi nuclear power plant. The twelve surveys first sought traces indicating tsunami runup or inundation heights. Reliability was classified into A (most reliable based on clear physical evidence and eyewitness accounts), B (mostly based on natural traces), and C (least reliable based on equivocal evidence). Most physical evidence obtained after June was not significant; therefore, reliance was mostly placed on eyewitness accounts. Loc

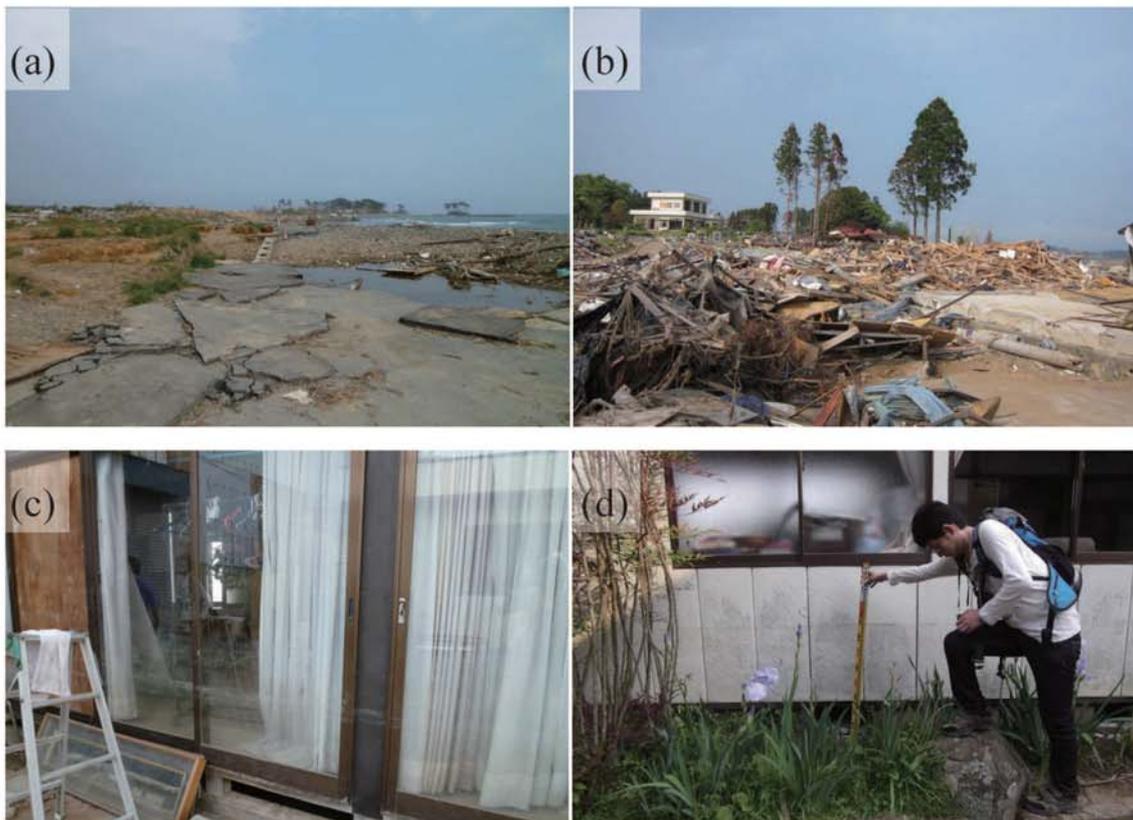
Fig. A144. (a)-(b) Damage at Hajikamisuginoshita. (c)-(d) Tsunami trace survey point on a wall of a house near Hatakeyama ironworks (0.90 m above ground level, M9).

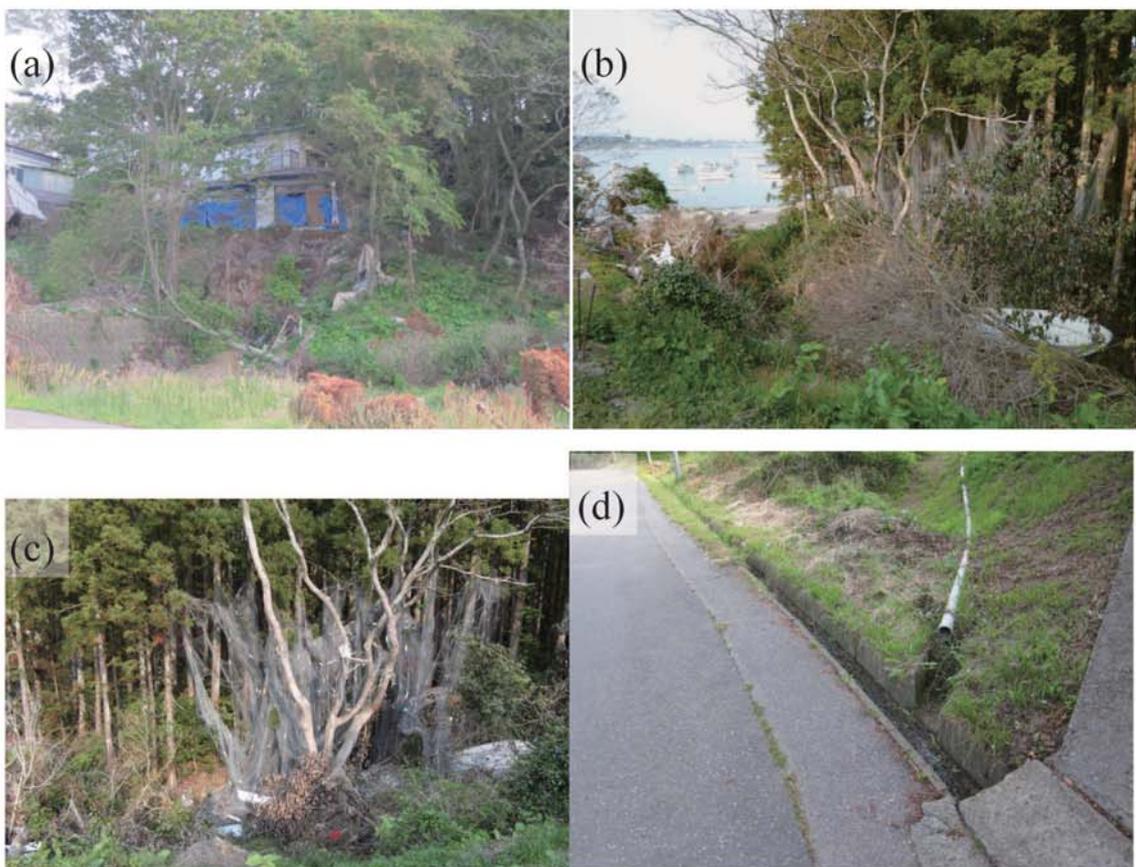
Fig. A146. (a)-(c) Damage at Motoyoshicho-Amagasawa (Hikado Fishing Port). (d) Tsunami trace survey point on a slope (M10).

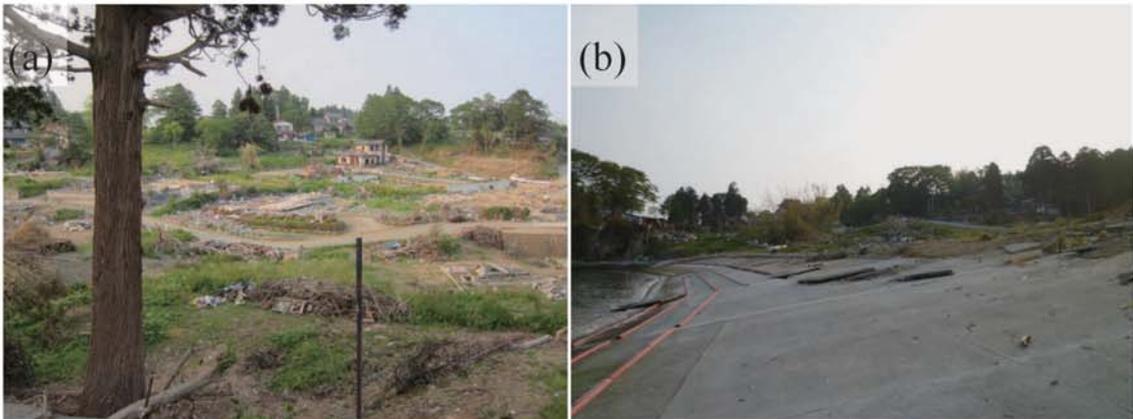
Fig. A148. (a)-(b) Damage at Motoyoshicho-Maehama.

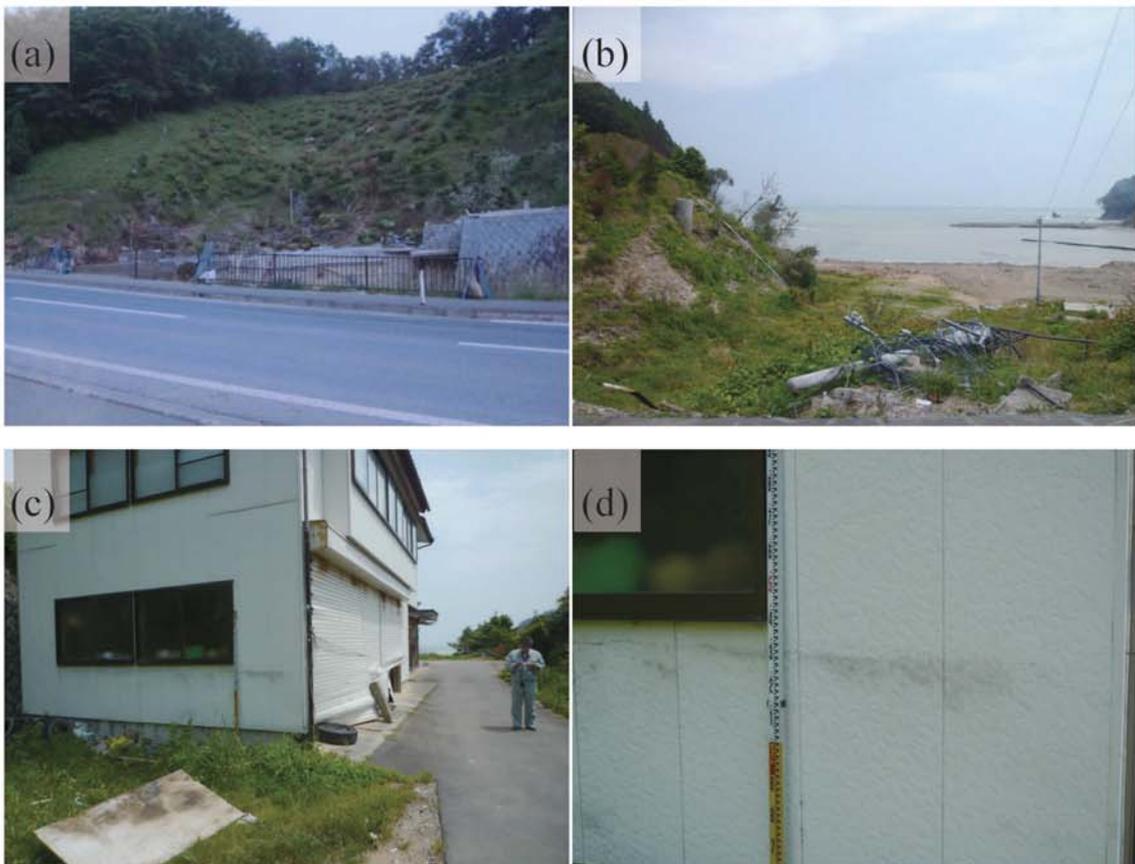
Fig. A152. (a)-(b) Damage at Motoyoshicho-Nijuichihama. (c)-(d) Tsunami trace survey point on a wall of Mr. Oikawa's house (1.27 m above ground level, M13).

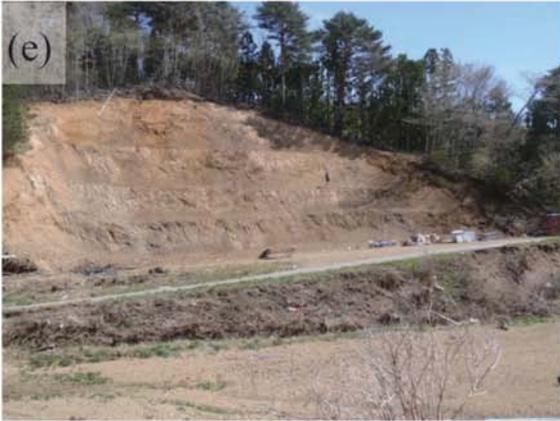
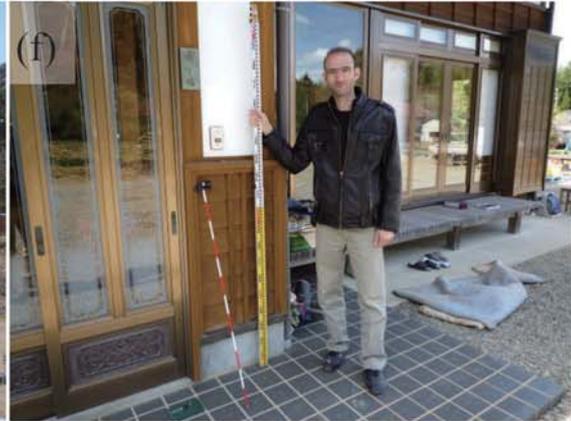
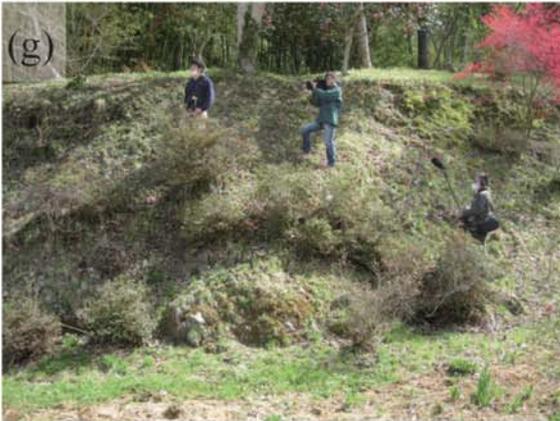
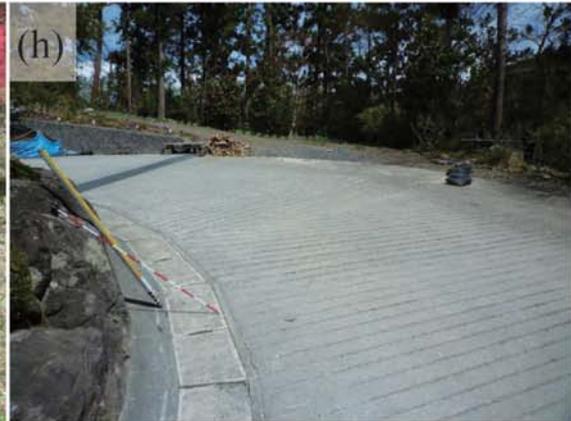
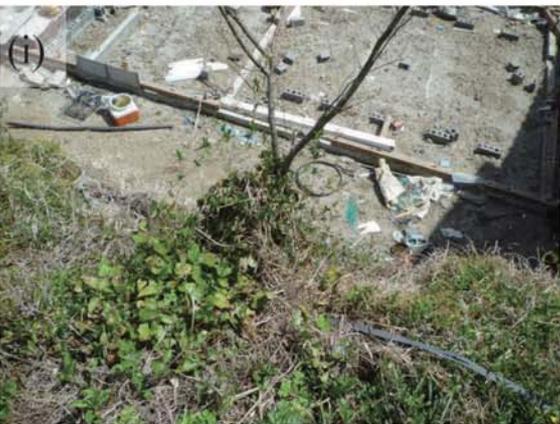
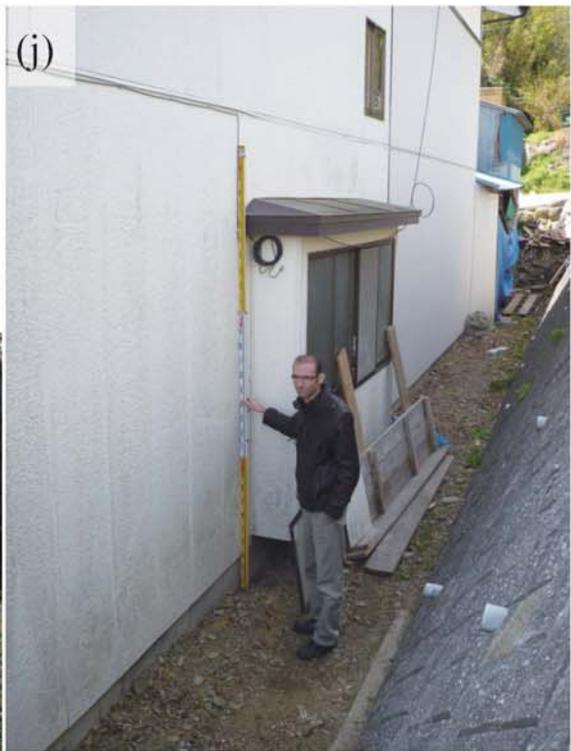
Fig. A154. (a)-(d) Damage at Utatsu-Namiita and Utatsu-Minato. (e) Tsunami trace survey point at a slope in the northern area (M15). (f) Tsunami trace survey point at the the entrance of house in the northern area (1.14 m above the dirt floor level, M16). (g) Tsunami trace survey point at the southern slope (M17). (h) Tsunami trace survey point at an eastern slope in the southern area (M18). (i) Tsunami trace survey point at the western slope (M19). (j) Watermark on a house in the northern area (2.75 m above ground level, M20).

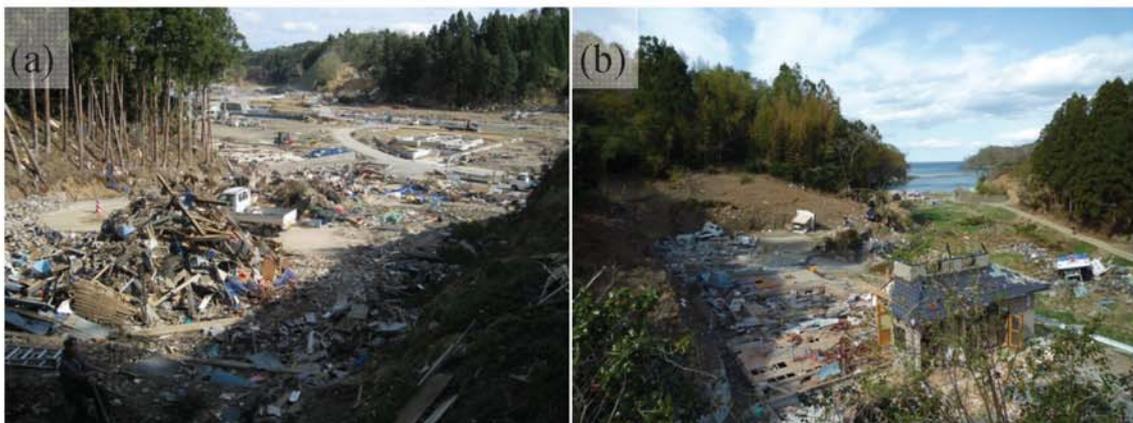
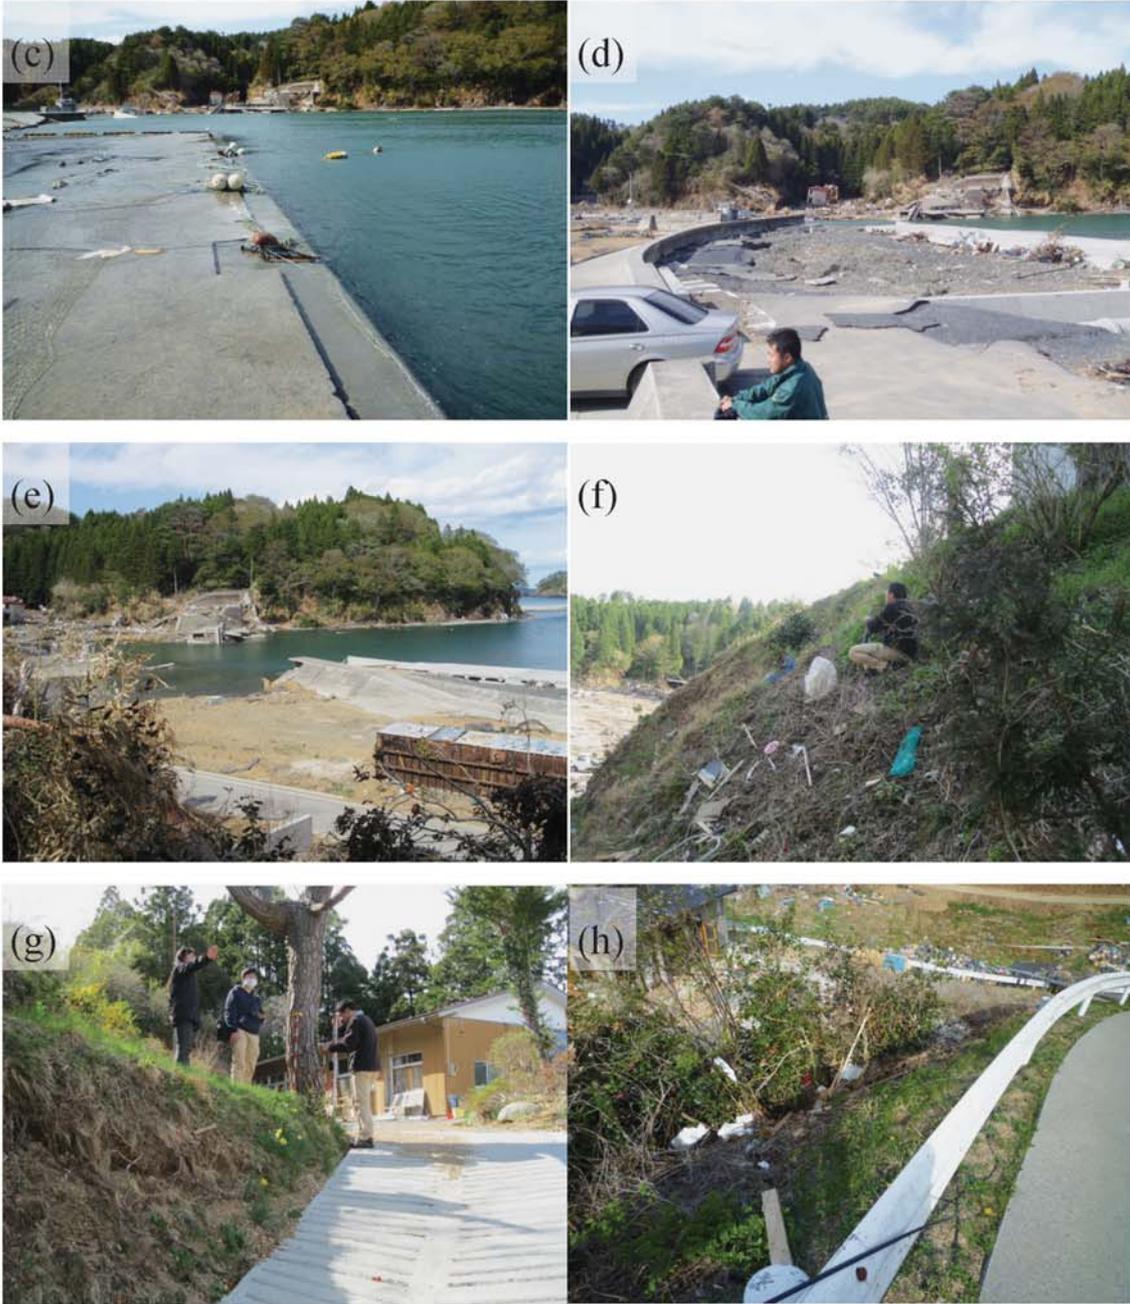
Fig. A156. (a)-(e) Damage at Utatsu-Tanoura and Utatsu-Kaminoyama. (f) Tsunami trace survey point at the northern slope (M21). (g) Tsunami trace survey point at the slope near Tanoura Fishing Port (M22). (h) Tsunami trace survey point at the southern slope (M23).

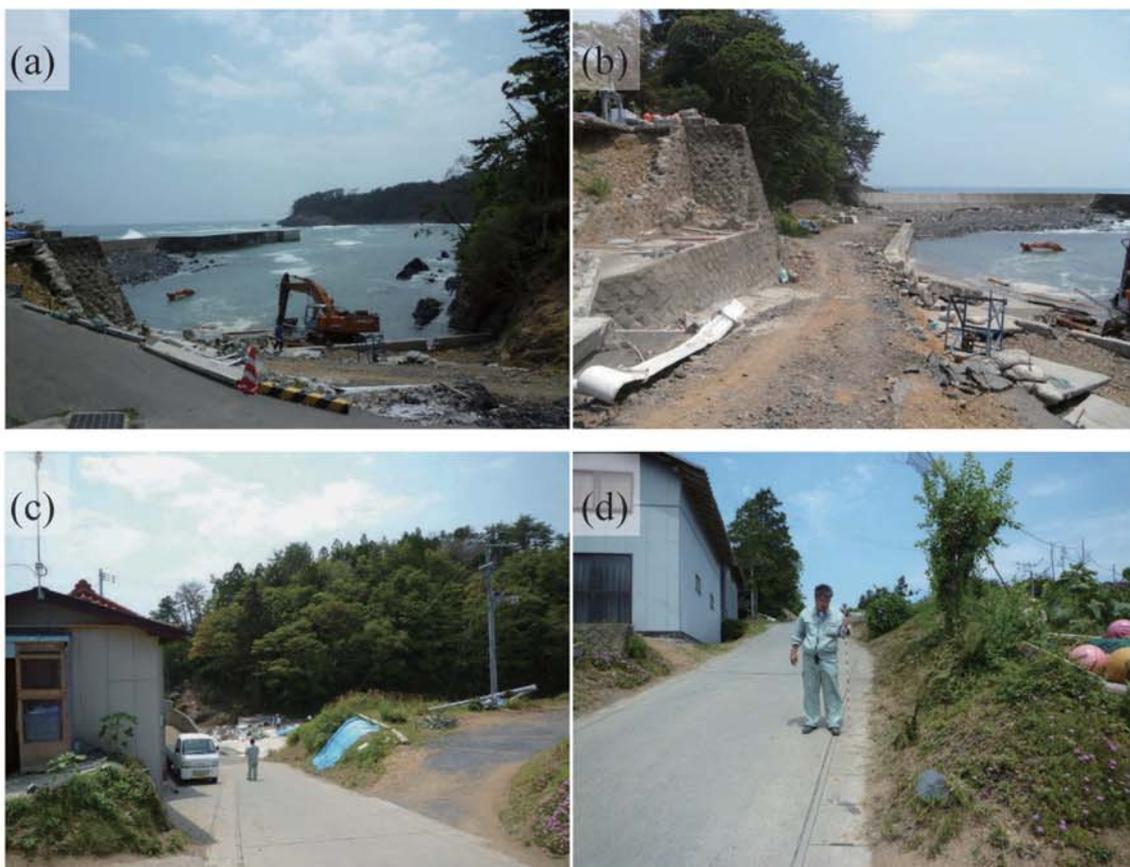
Fig. A158. (a)-(c) Damage at Utatsu-Hiradana. (d) Tsunami trace survey point at a slope beside Mr. Sato's house (M24).

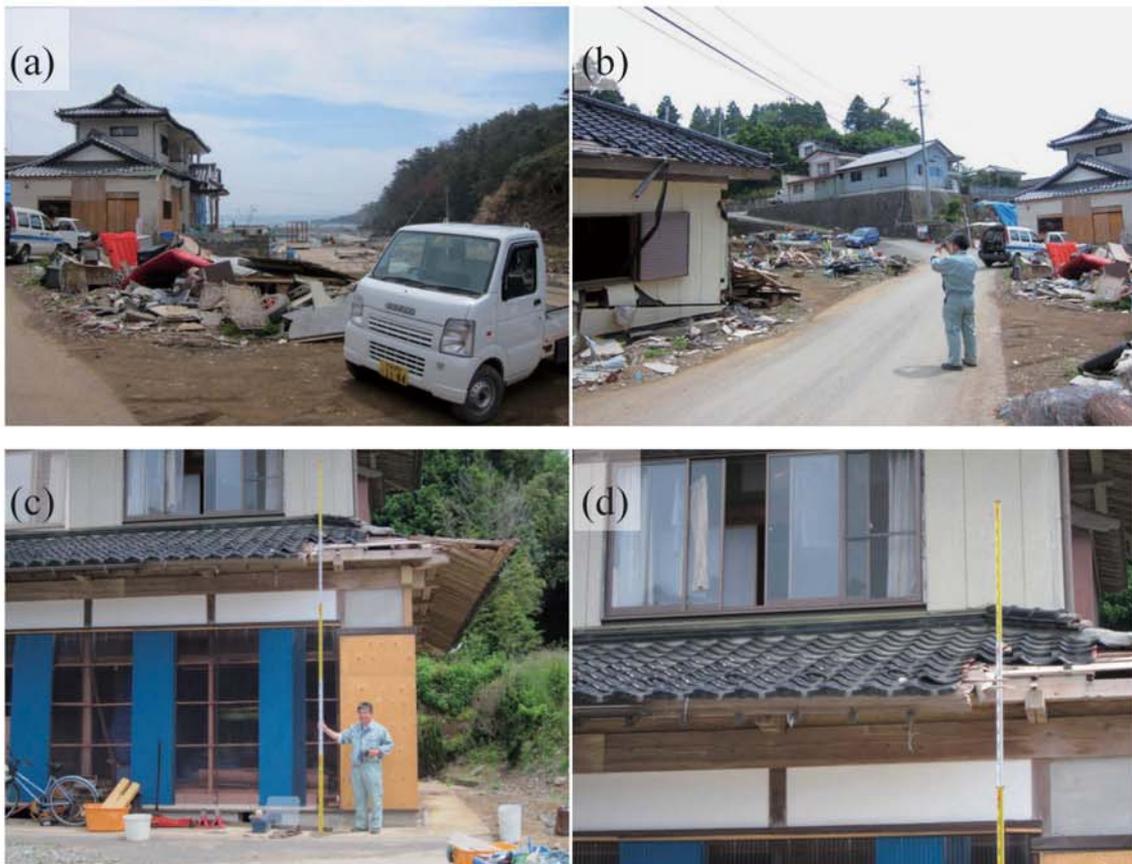
Fig. A160. (a)-(b) Damage at Utatsu-Ishihama. (c)-(d) Tsunami trace survey point on the the roof of Mr. Abe's house (4.10 m above ground level, M25).

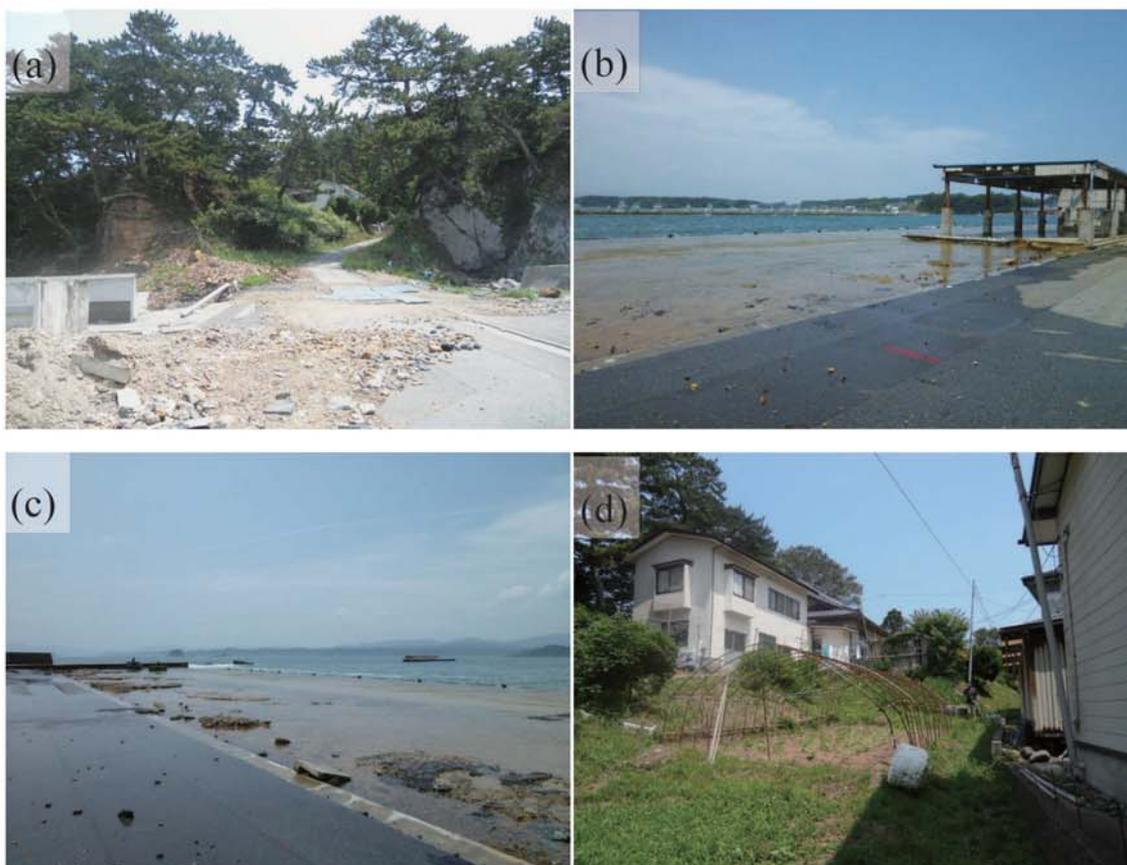
Fig. A162. (a)-(c) Damage at Utatsu-Osaki. (d) Tsunami trace survey point beside a water well near Mr. Iwaishi's house (M26).

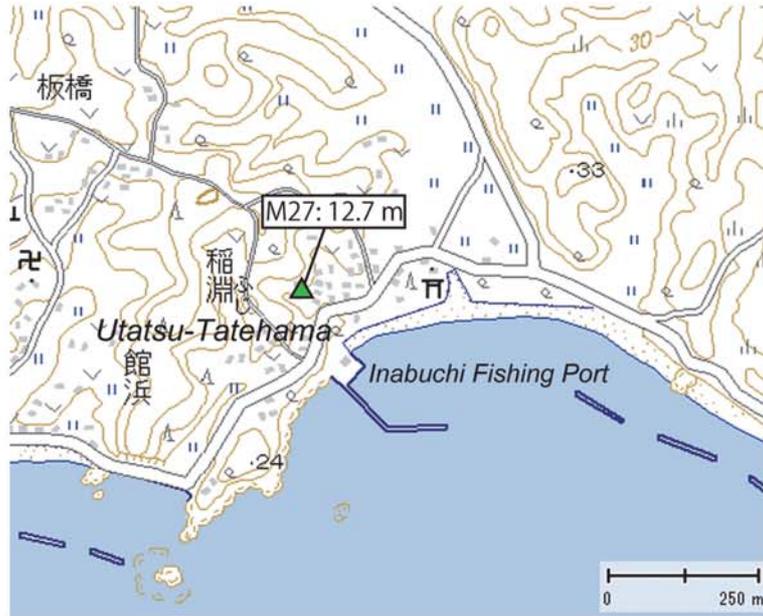
Fig. A163. Tsunami height at Utatsu-Tatehama, Minamisanriku Town, Miyagi Prefecture (added with a digital topographic map at a scale of 1/25,000 from the Geospatial Information Authority of Japan). The symbol and its meaning are the same as in Fig. 4.

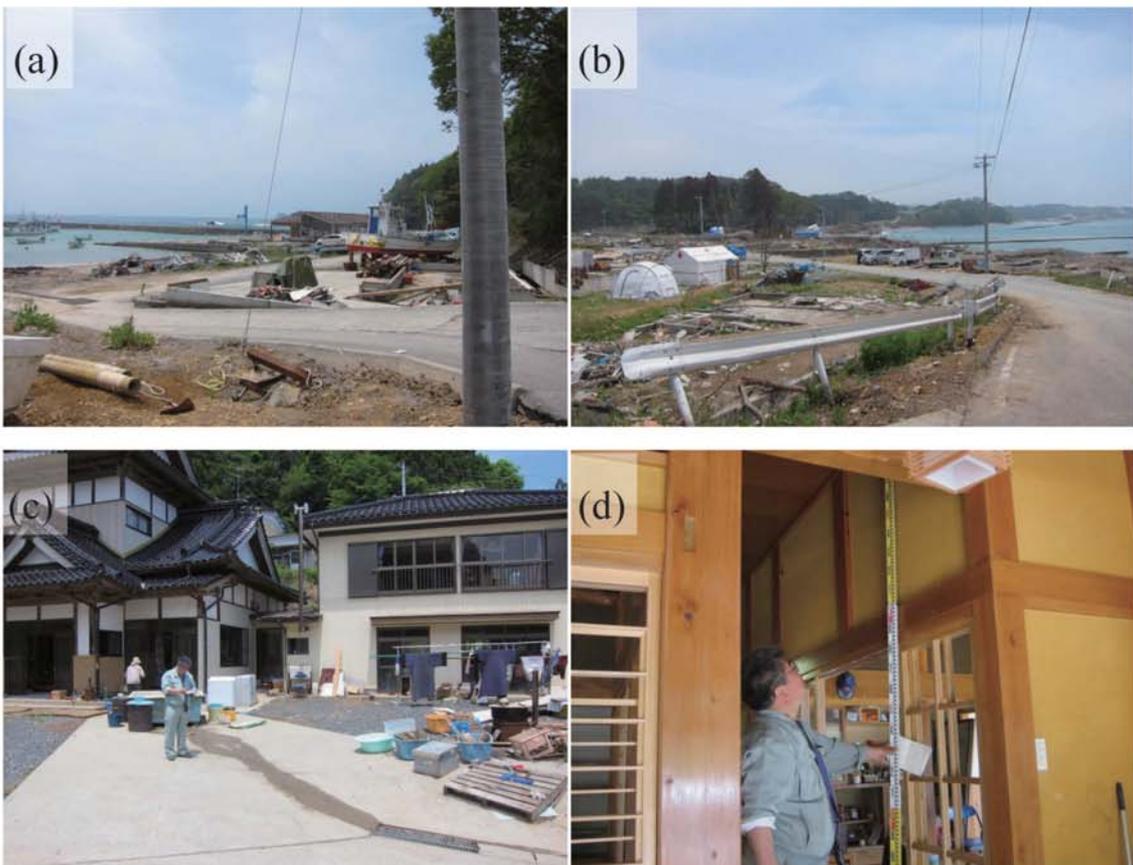
Fig. A164. (a)-(c) Damage at Utatsu-Tatehama. (d) Tsunami trace survey point on a wall of Mr. Chiba's house (3.04 m above the dirt floor, M27).

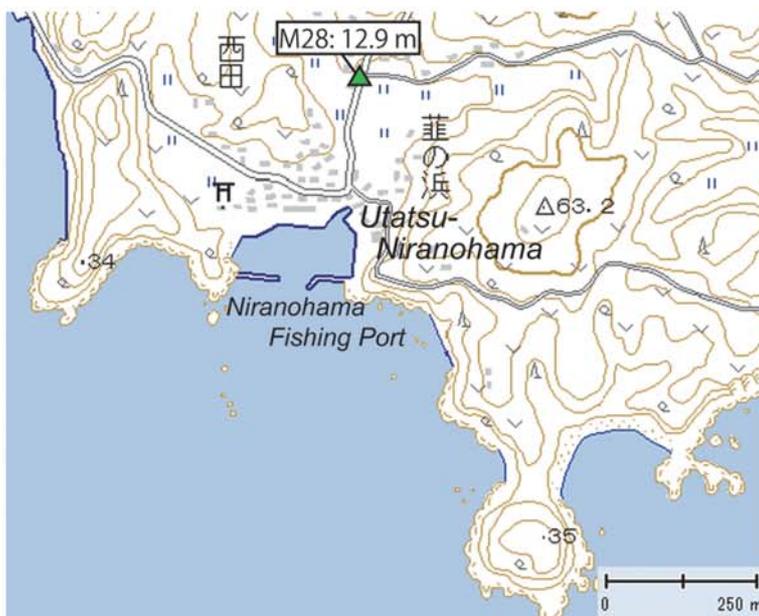
Fig. A165. Tsunami height at Utatsu-Nirano-hama, Minamisanriku Town, Miyagi Prefecture (added with a digital topographic map at a scale of 1/25,000 from the Geospatial Information Authority of Japan). The symbol and its meaning are the same as in Fig. 4.

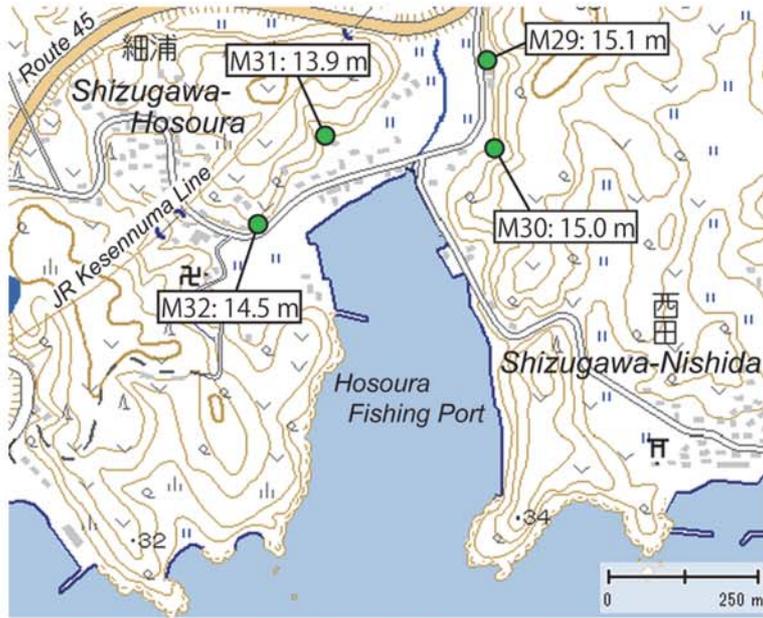
Fig. A167. Tsunami heights at Shizugawa-Nishida (M29 and M30) and Shizugawa-Hosoura, (M31 and M32) Minamisanriku Town, Miyagi Prefecture (added with a digital topographic map at a scale of 1/25,000 from the Geospatial Information Authority of Japan). The symbols and their meanings are the same as in Fig. 4.

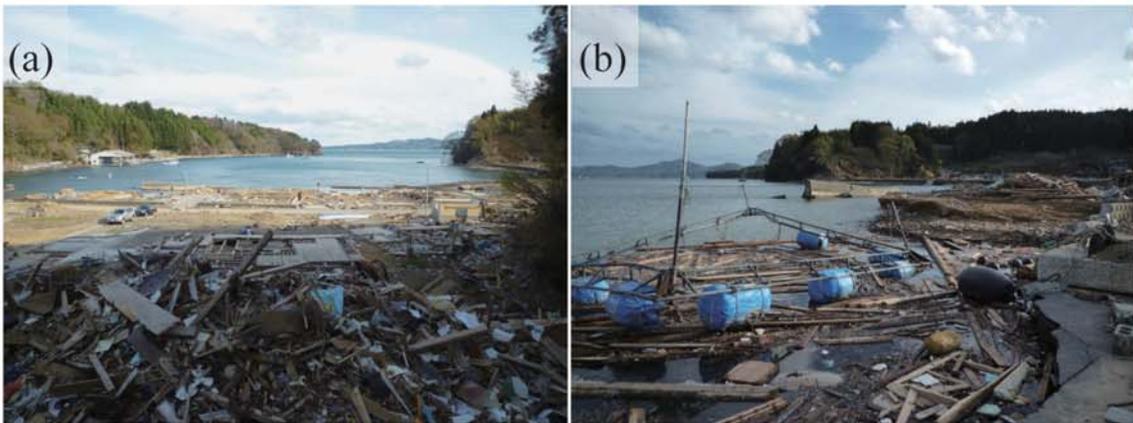
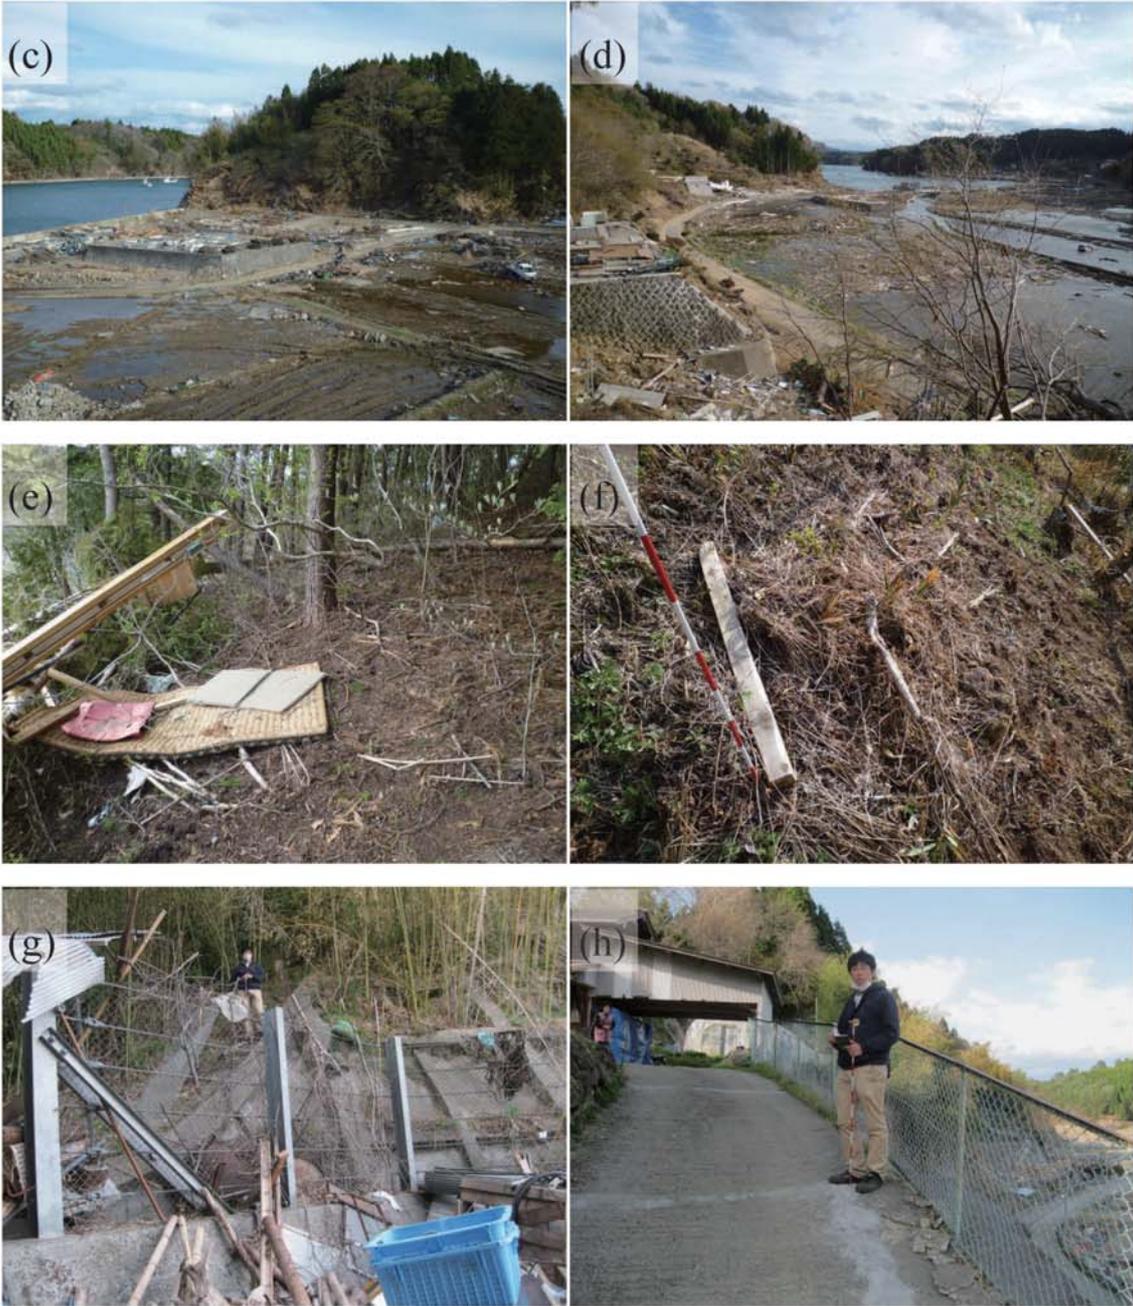
Fig. A168. (a)-(d) Damage at Shizugawa-Nishida and Shizugawa-Hosoura. (e) Tsunami trace survey point at the eastern slope (M29). (f) Tsunami trace survey point at the eastern slope (M30). (g) Tsunami trace survey point at the northern slope in the western area (M31). (h) Tsunami trace survey point at a slope near a house (M32).

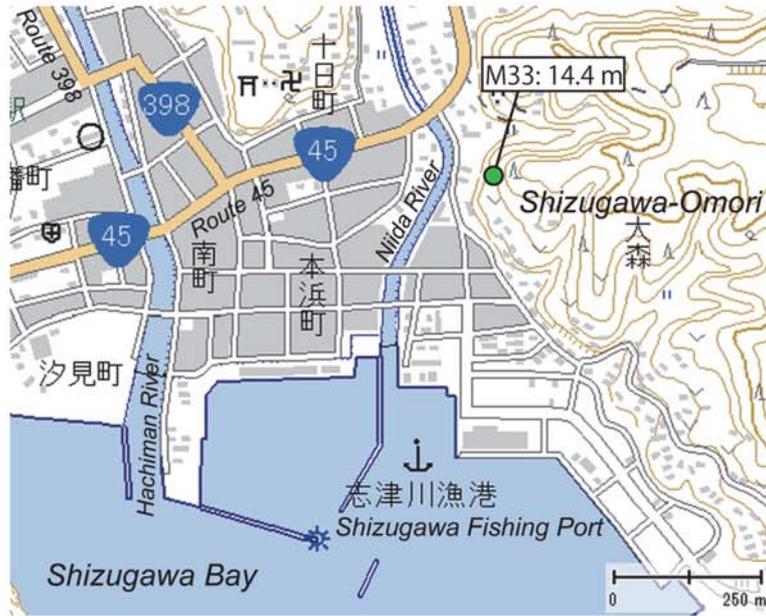
Fig. A169. Tsunami height at Shizugawa-Omori, Minamisanriku Town, Miyagi Prefecture (added with a digital topographic map at a scale of 1/25,000 from the Geospatial Information Authority of Japan). The symbol and its meaning are the same as in Fig. 4.

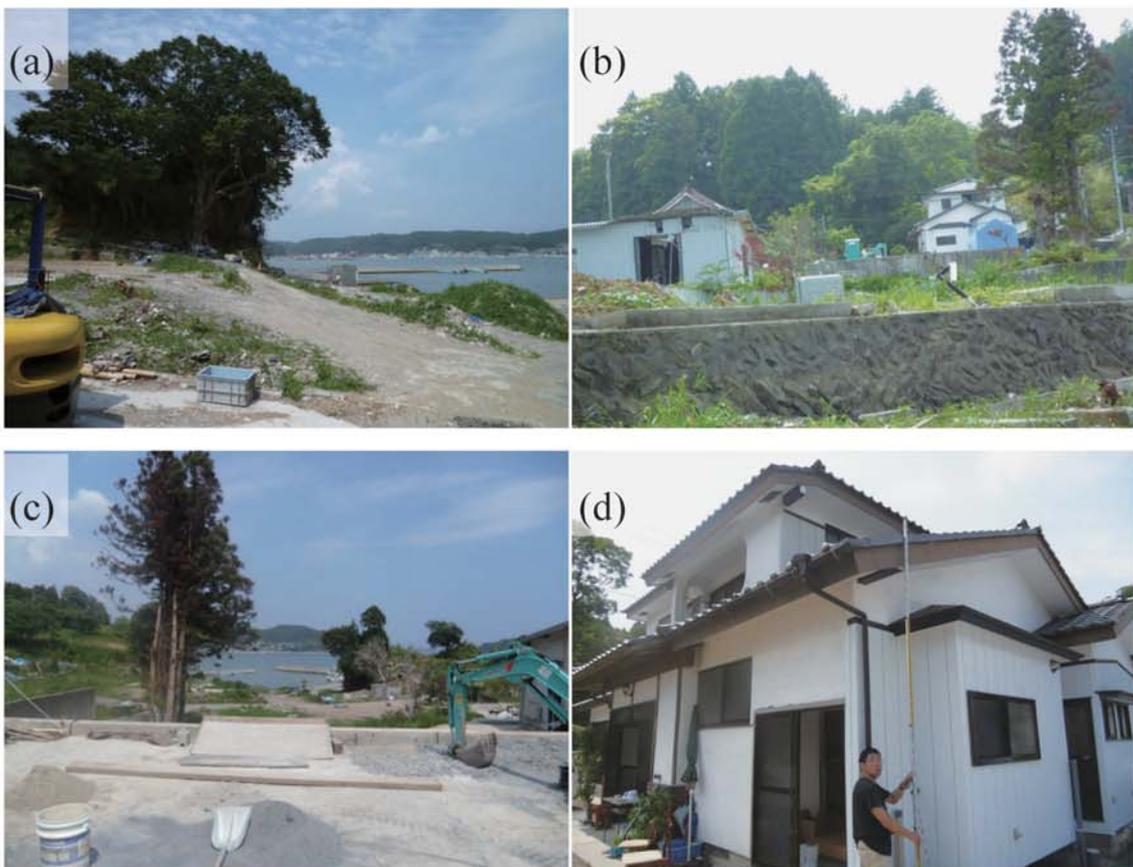
Fig. A172. (a)-(c) Damage at Shizugawa-Hayashi. (d) Tsunami trace survey point on a wall of Mr.Watanabe's house (Testimony of an inhabitant, 3.55 m above ground level, M34).

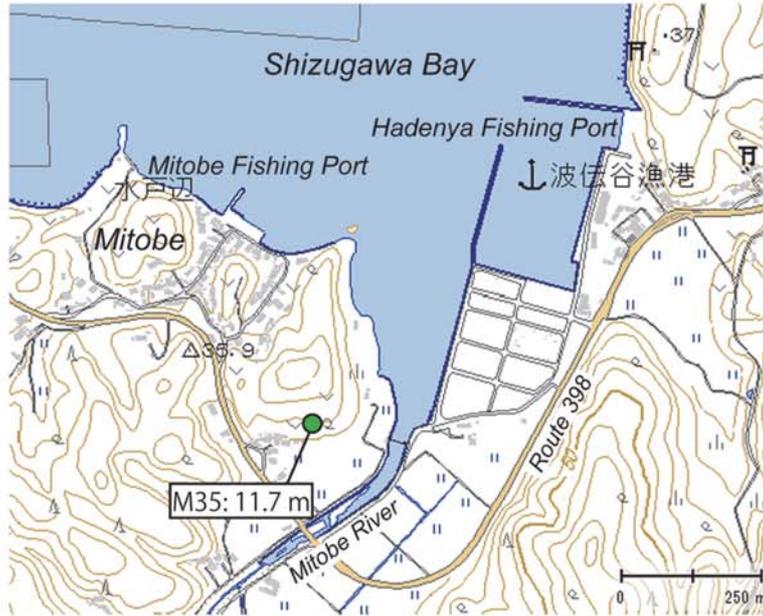
Fig. A173. Tsunami height at Mitobe, Tokura, Minamisanriku Town, Miyagi Prefecture (added with a digital topographic map at a scale of 1/25,000 from the Geospatial Information Authority of Japan). The symbol and its meaning are the same as in Fig. 4.

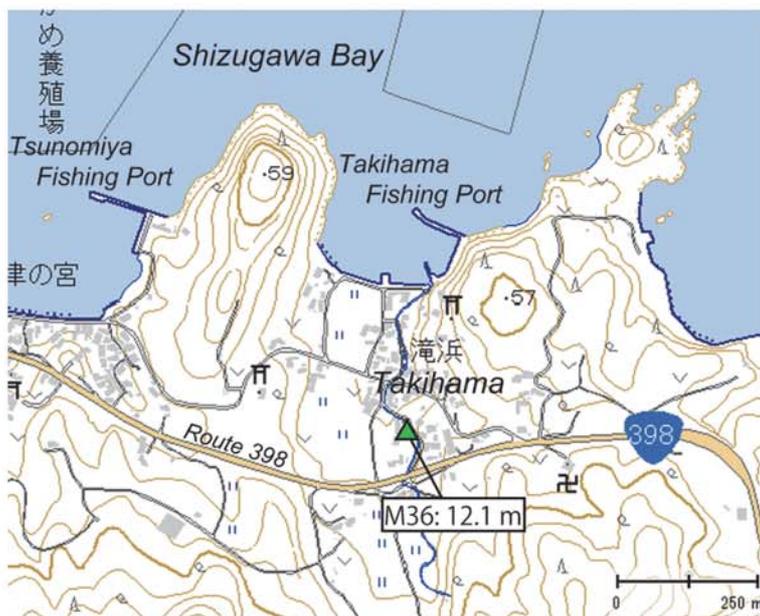
Fig. A175. Tsunami height at Takihama, Tokura, Minamisanriku Town, Miyagi Prefecture (added with a digital topographic map at a scale of 1/25,000 from the Geospatial Information Authority of Japan). The symbol and its meaning are the same as in Fig. 4.

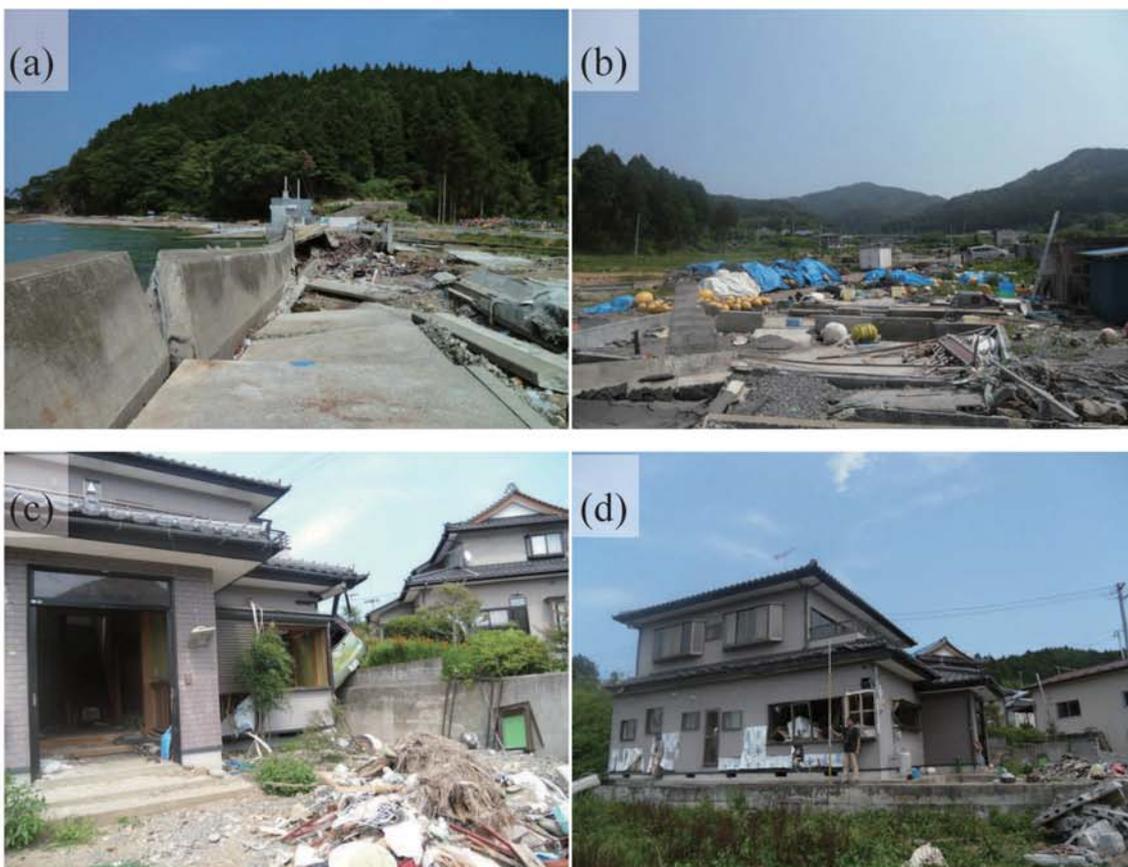
Fig. A176. (a)-(c) Damage at Takihama. (d) Tsunami trace survey point on the roof of a house (2.75 m above ground level, M36).

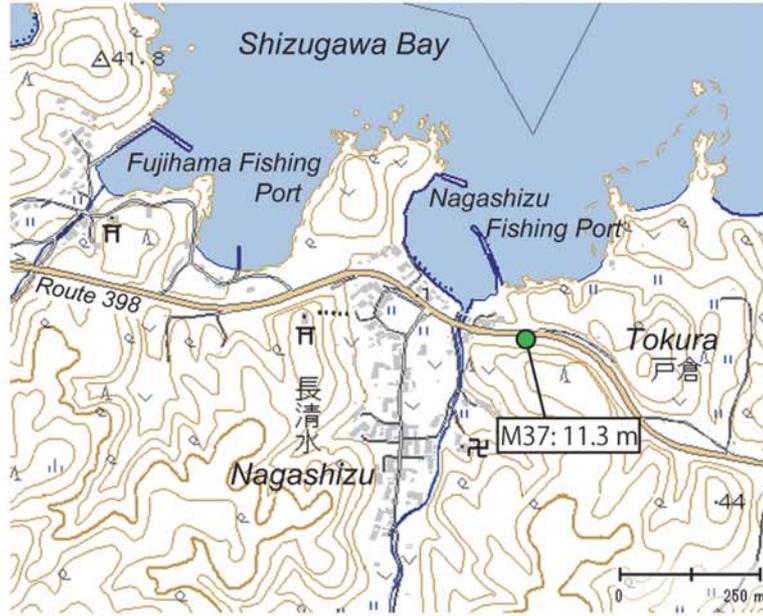
Fig. A177. Tsunami height at Nagashizu, Tokura, Minamisanriku Town, Miyagi Prefecture (added with a digital topographic map at a scale of 1/25,000 from the Geospatial Information Authority of Japan). The symbol and its meaning are the same as in Fig. 4.

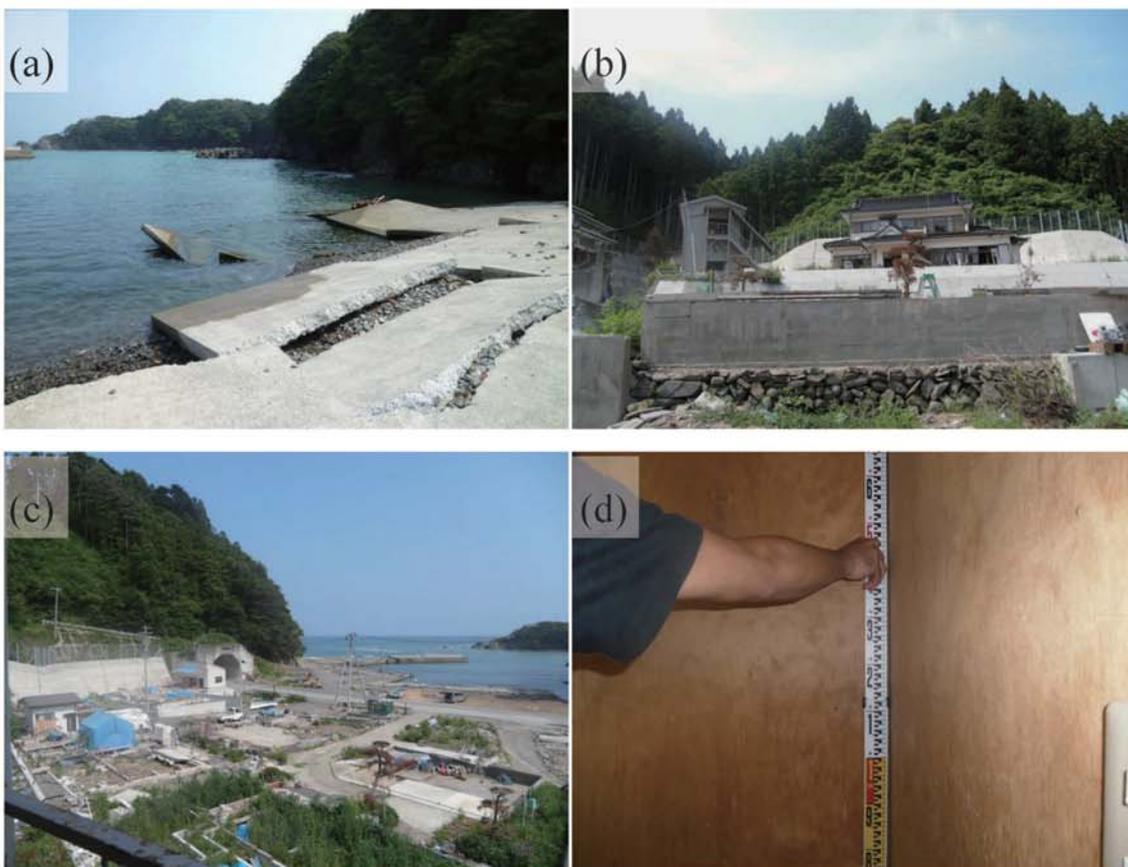
Fig. A180. (a)-(c) Damage at Kozashi. (d) Tsunami trace survey point on a wall of a house (1.15m above the second floor, M38)

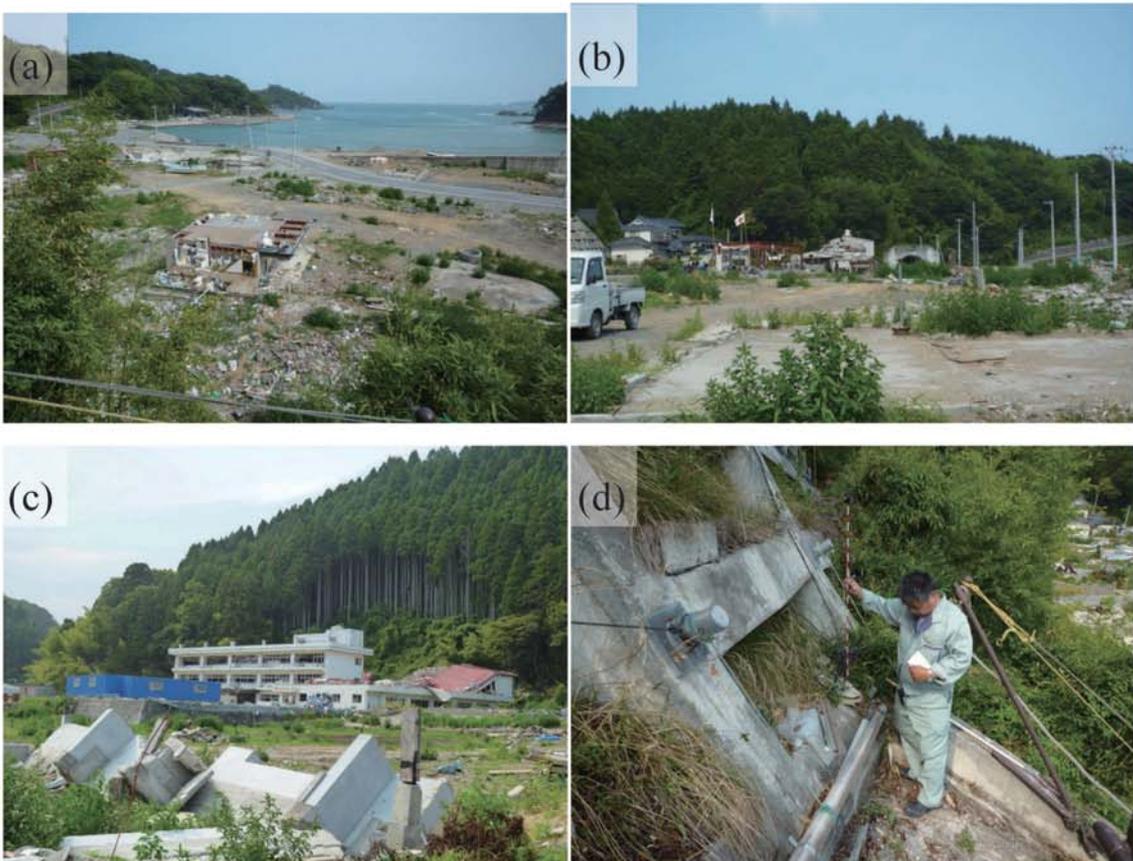
Fig. A182. (a)-(c) Damage at Aikawa. (d) Tsunami trace survey point on a slope (M39).

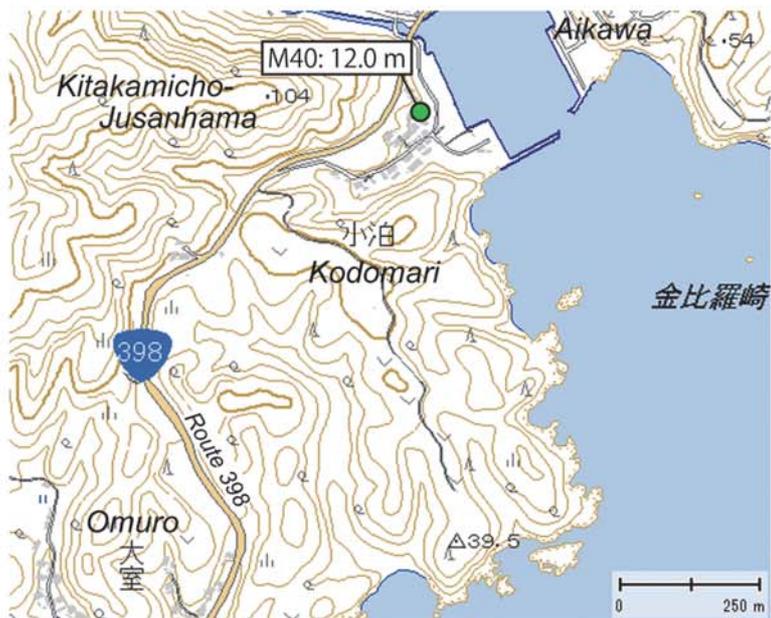
Fig. A183. Tsunami height at Kodomari, Kitakamicho-Jusanhama, Ishinomaki City, Miyagi Prefecture (added with a digital topographic map at a scale of 1/25,000 from the Geospatial Information Authority of Japan). The symbol and its meaning are the same as in Fig. 4.
