2011年東北地方太平洋沖地震の津波高調査

Field Surveys of Tsunami Heights from the 2011 off the Pacific Coast of Tohoku, Japan Earthquake

We report the results of field surveys conducted by the Earthquake Research Institute, to measure tsunami heights from the 2011 off the Pacific coast of Tohoku, Japan Earthquake (M 9.0), on March 11. Measurements were taken at 296 points on the Sanriku coasts of Aomori, Iwate, and Miyagi Prefectures, and the Pacific coasts of Ibaraki and Chiba Prefectures. The data are included in the results of the 2011 Tohoku Earthquake Tsunami Joint Survey Group. We did not cover the Sendai plain in the southern Miyagi Prefecture because other parties extensively measure there, nor Fukushima Prefecture because of the accident of the Fukushima Dai-ichi nuclear power plant. The twelve surveys first sought traces indicating tsunami runup or inundation heights. Reliability was classified into A (most reliable based on clear physical evidence and eyewitness accounts), B (mostly based on natural traces), and C (least reliable based on equivocal evidence). Most physical evidence obtained after June was not significant; therefore, reliance was mostly placed on eyewitness accounts. Loc

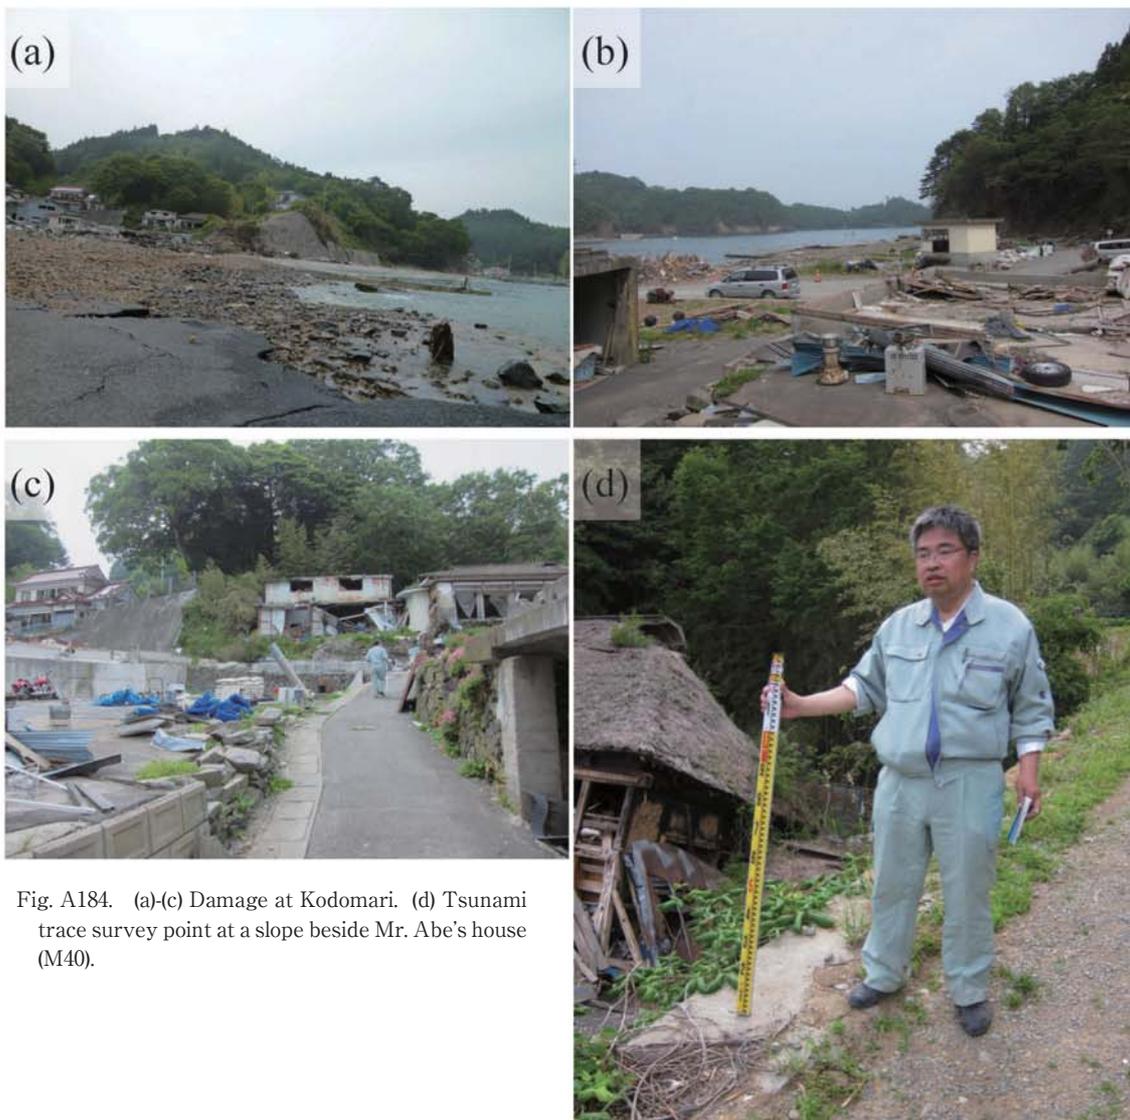
北上町十三浜小泊(津波高: 図 A183, 被害状況ならびに津波痕跡調査地点: 図 A184) では、低地の家屋数軒が流失したほか、多くの家屋に浸水被害が生じた。集落北側の阿部一也氏宅に至る小道上において、落ち葉の有無や土壌の削剥、ならびに住民の目撃証言に基づいて測定された遡上高は、12.0mであった(M40, 図 A184d)。

Fig. A184. (a)-(c) Damage at Kodomari. (d) Tsunami trace survey point at a slope beside Mr. Abe's house (M40).

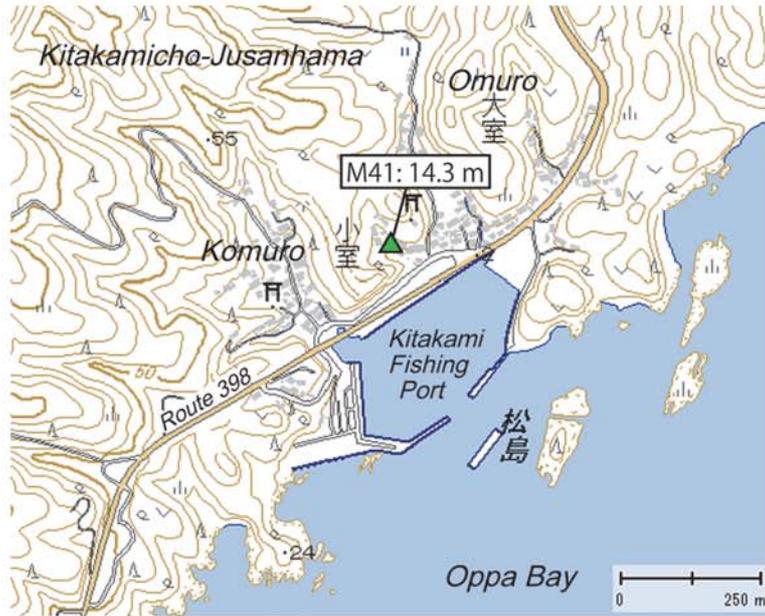
Fig. A185. Tsunami height at Omuro, Kitakamicho-Jusanhama, Ishinomaki City, Miyagi Prefecture (added with a digital topographic map at a scale of 1/25,000 from the Geospatial Information Authority of Japan). The symbol and its meaning are the same as in Fig. 4.

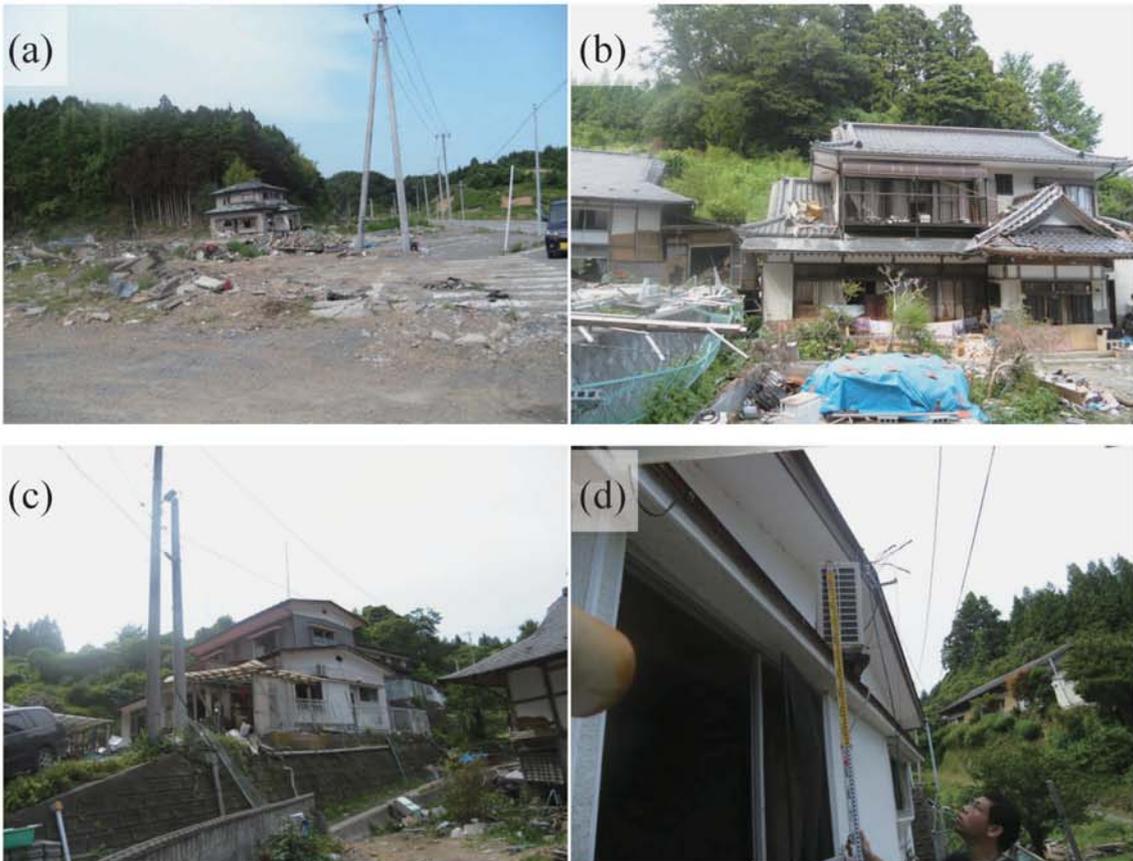
Fig. A186. (a)-(c) Damage at Omuro. (d) Tsunami trace survey point at an outdoor unit of an air conditioner on an eave of Mr. Sasaki's house (2.75 m above ground level, M41)

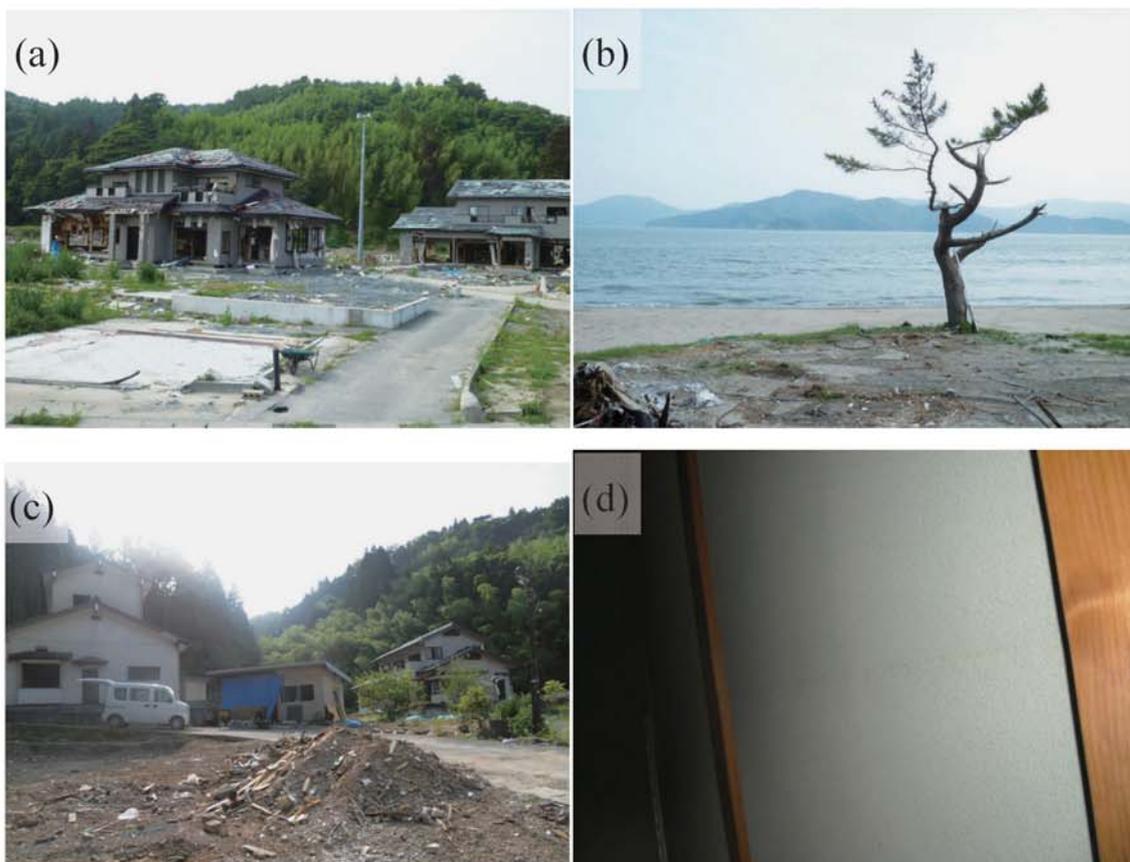
Fig. A188. (a)-(c) Damage at Shirahama. (d) Tsunami trace survey point on a wall of the second floor of Mr. Sato's house (6.09 m above ground level, M42).

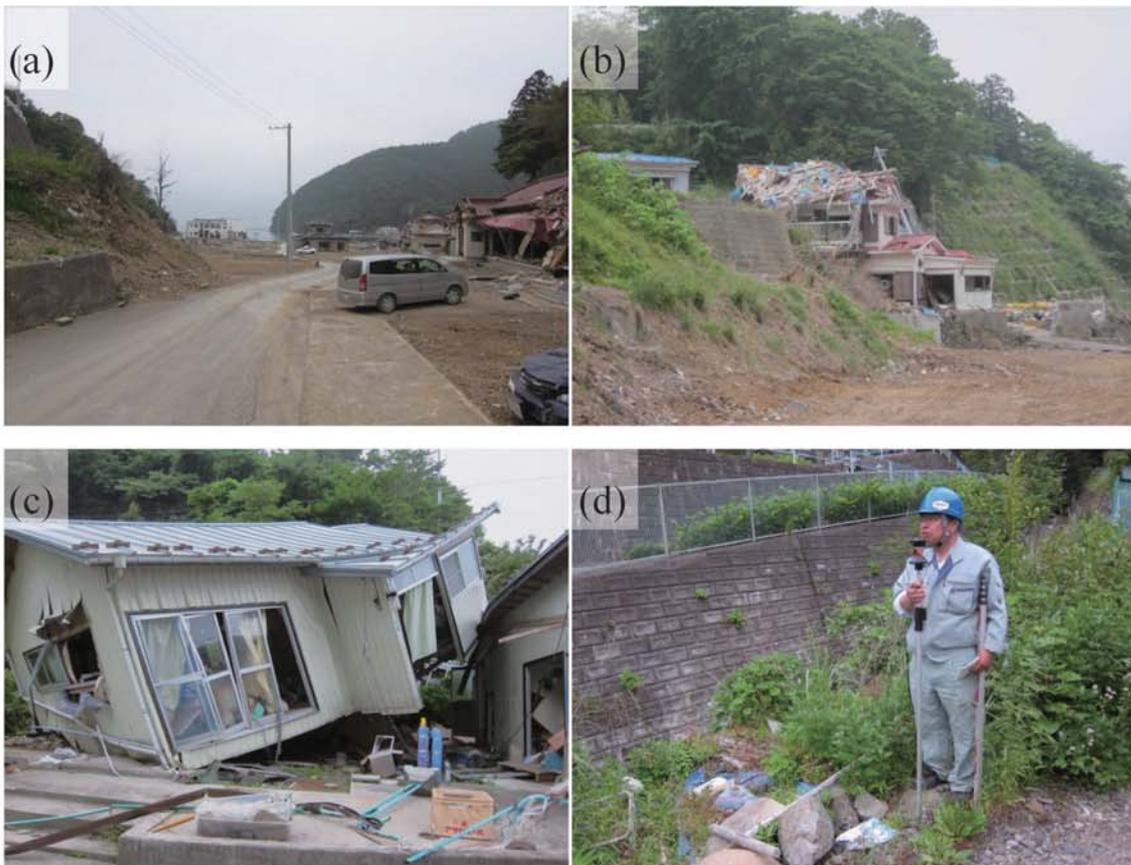
Fig. A196. (a)-(c) Damage at Ogatsucho-Funakoshi. (d) Tsunami trace survey point on a southern slope beside a grave (M51).

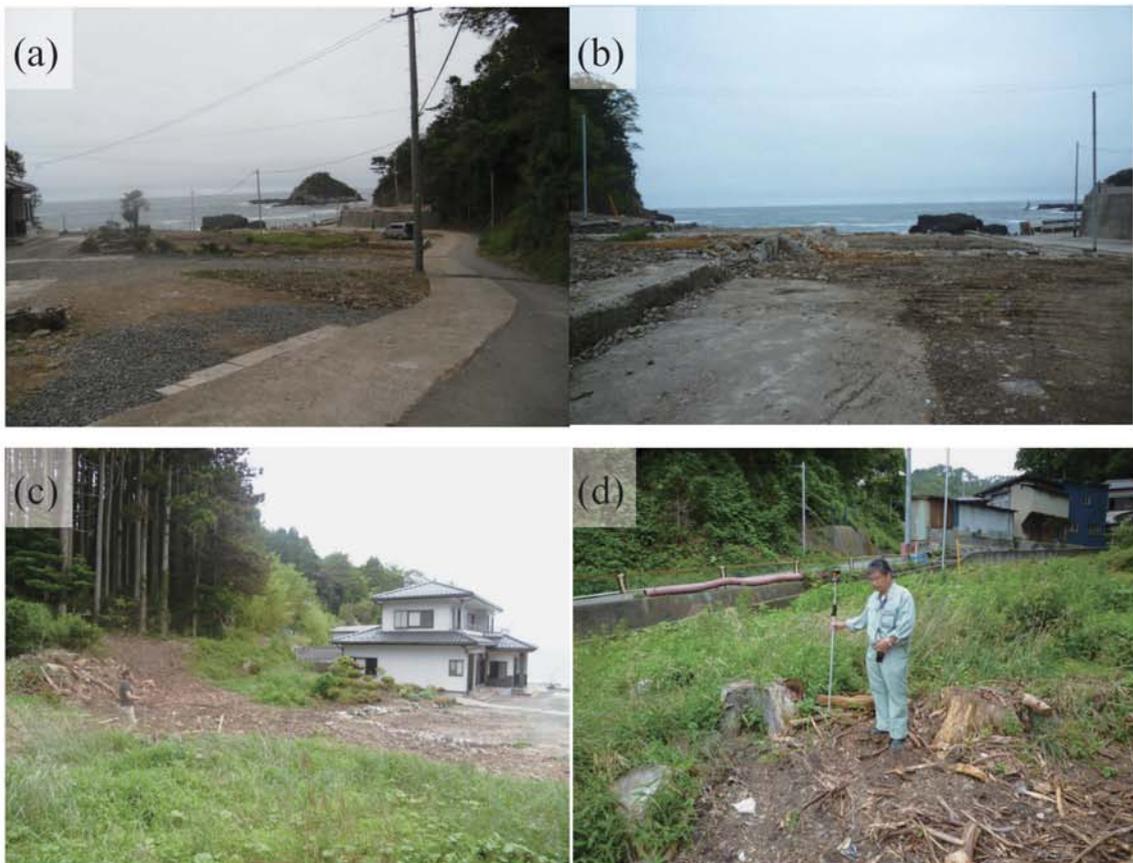
Fig. A198. (a)-(c) Damage at Ogatsucho-Osu. (d) Tsunami trace survey point on the slope (M52).

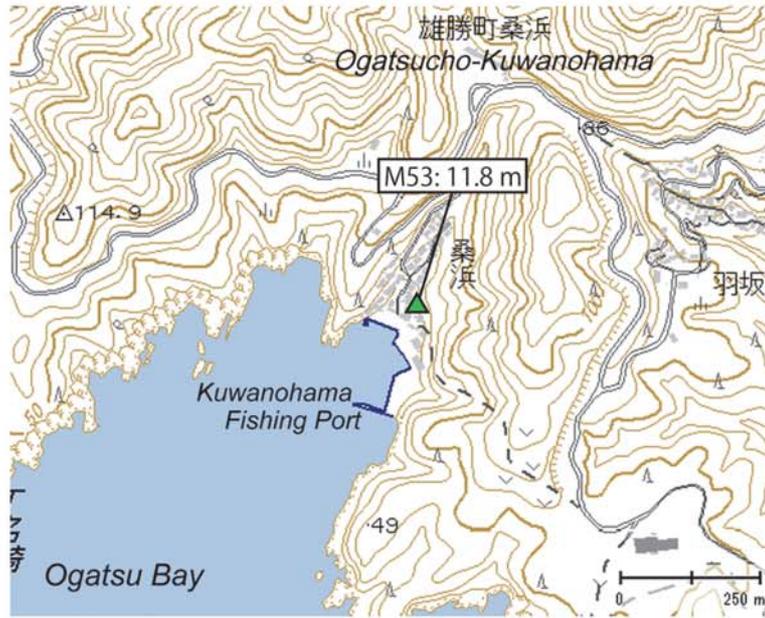
Fig. A199. Tsunami height at Ogatsuchō-Kuwanohama, Ishinomaki City, Miyagi Prefecture (added with a digital topographic map at a scale of 1/25,000 from the Geospatial Information Authority of Japan). The symbol and its meaning are the same as in Fig. 4.

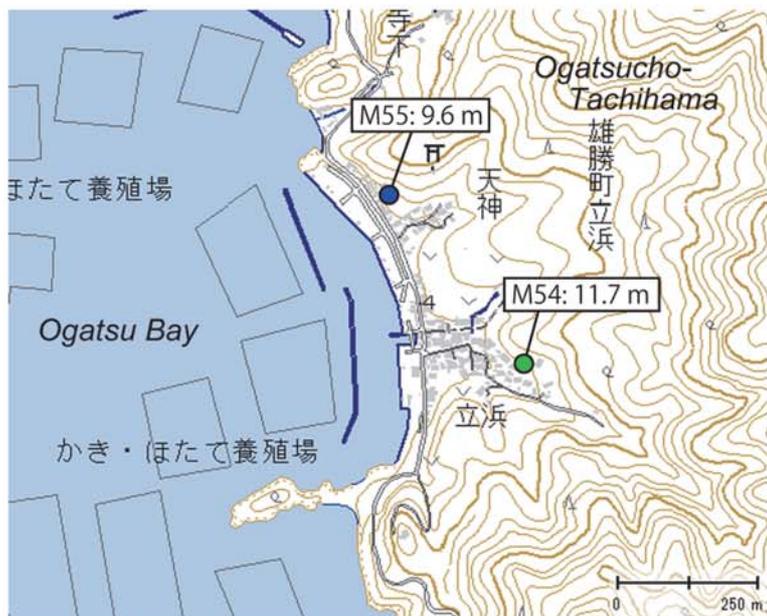
Fig. A201. Tsunami heights at Ogatsucho-Tachihama, Ishinomaki City, Miyagi Prefecture (added with a digital topographic map at a scale of 1/25,000 from the Geospatial Information Authority of Japan). The symbols and their meanings are the same as in Fig. 4.

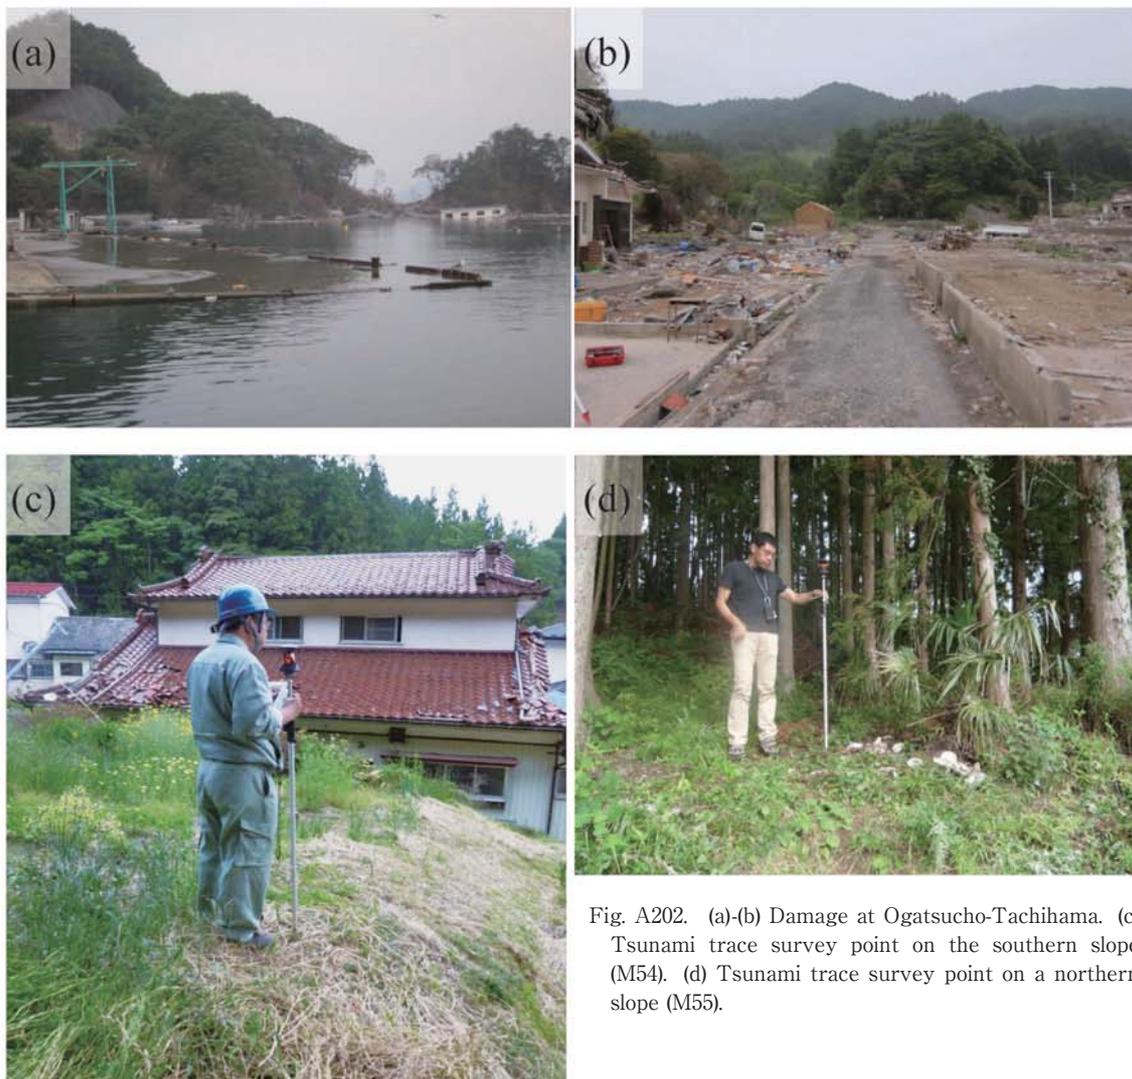
Fig. A202. (a)-(b) Damage at Ogatsucho-Tachihama. (c) Tsunami trace survey point on the southern slope (M54). (d) Tsunami trace survey point on a northern slope (M55).

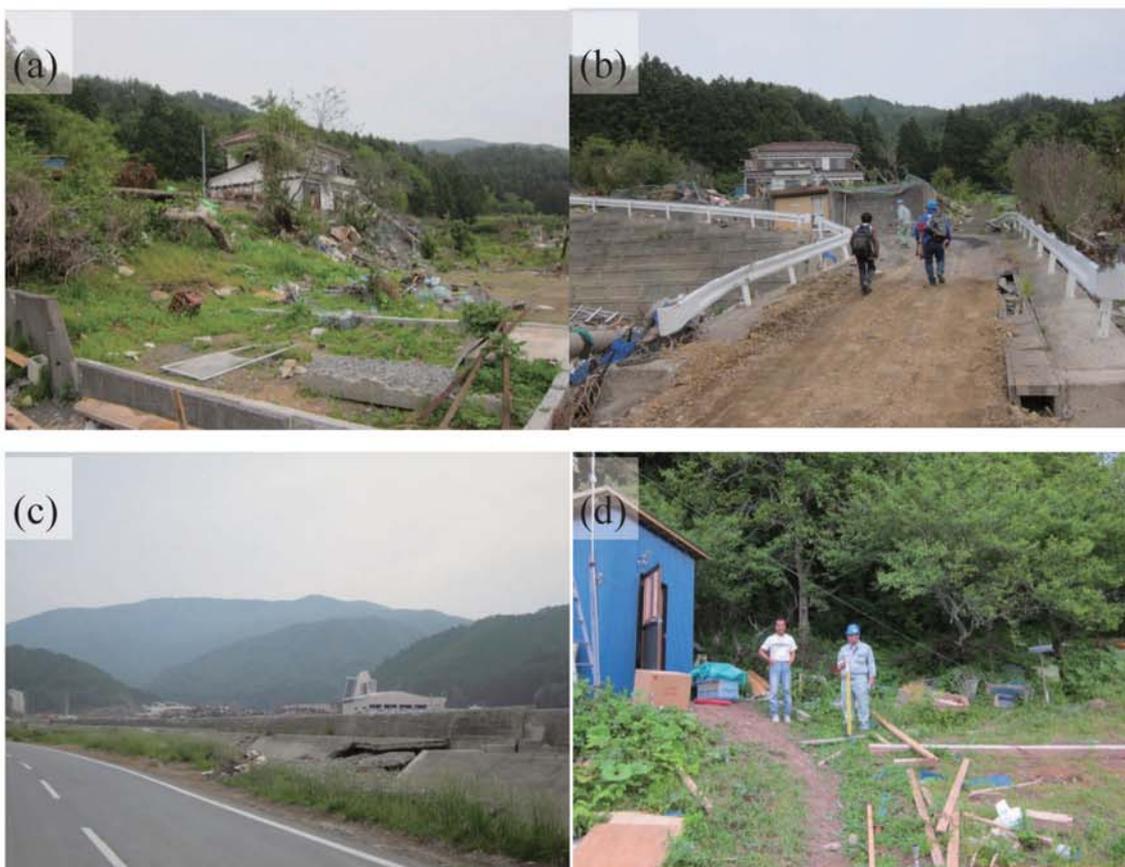
Fig. A206. (a)-(c) Damage at Funatoshinmei. (d) Tsunami trace survey point at a slope behind Mr. Sugiyama's house (M57).

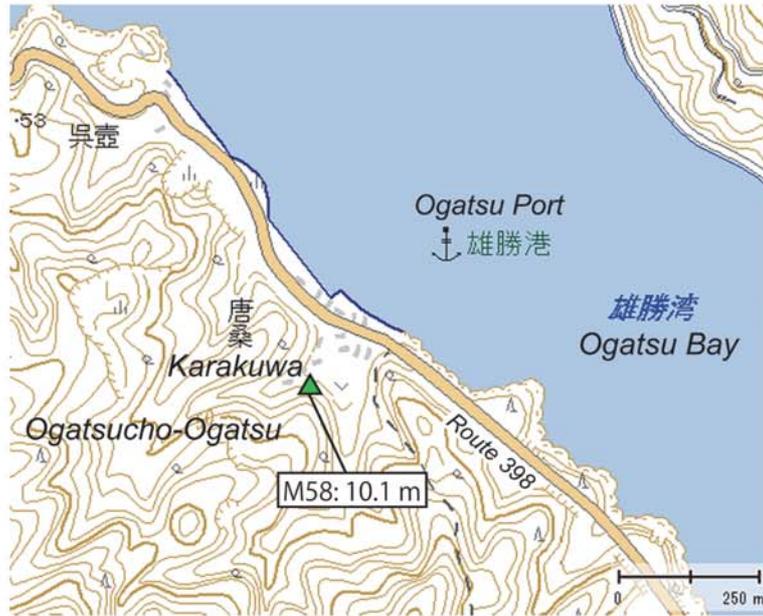
Fig. A207. Tsunami height at Karakuwa, Ogatsucho-Ogatsu, Ishinomaki City, Miyagi Prefecture (added with a digital topographic map at a scale of 1/25,000 from the Geospatial Information Authority of Japan). The symbol and its meaning are the same as in Fig. 4.

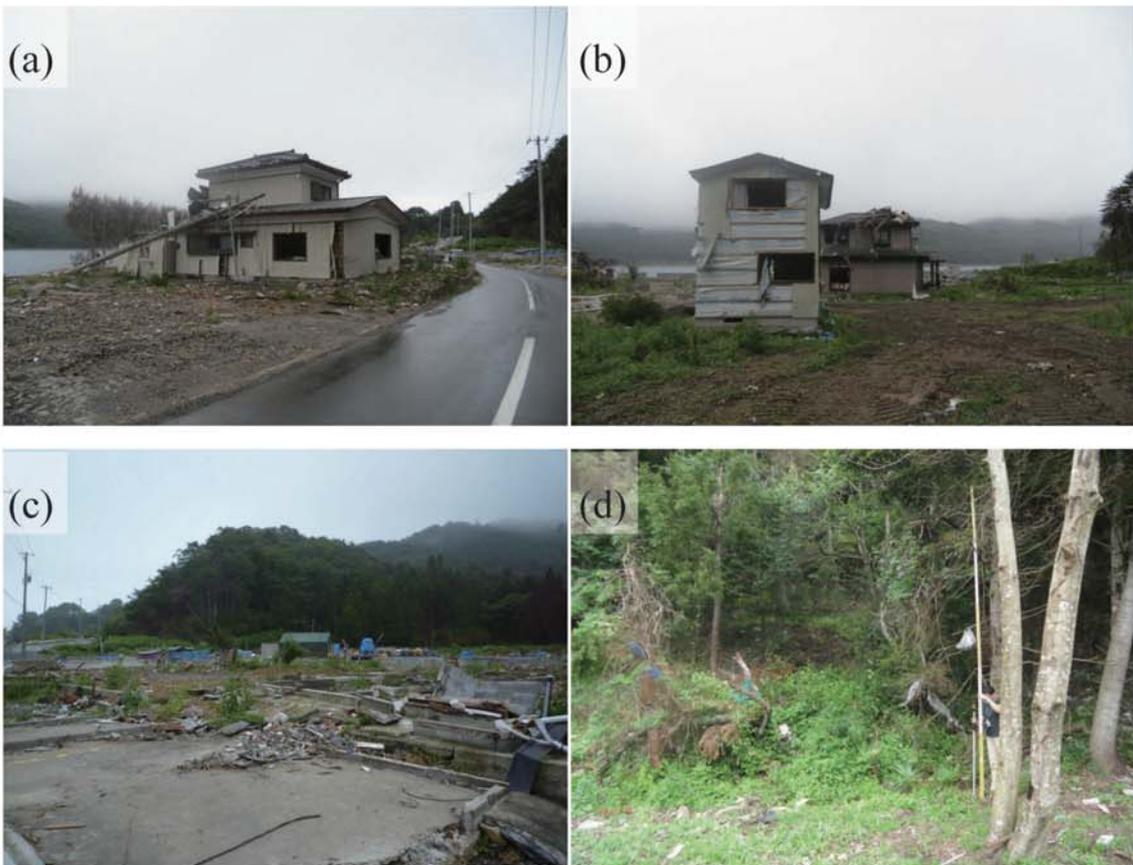
Fig. A208. (a)-(c) Damage at Karakuwa. (d) Tsunami trace survey point on the southern slope (4.90 m above ground level, M58).

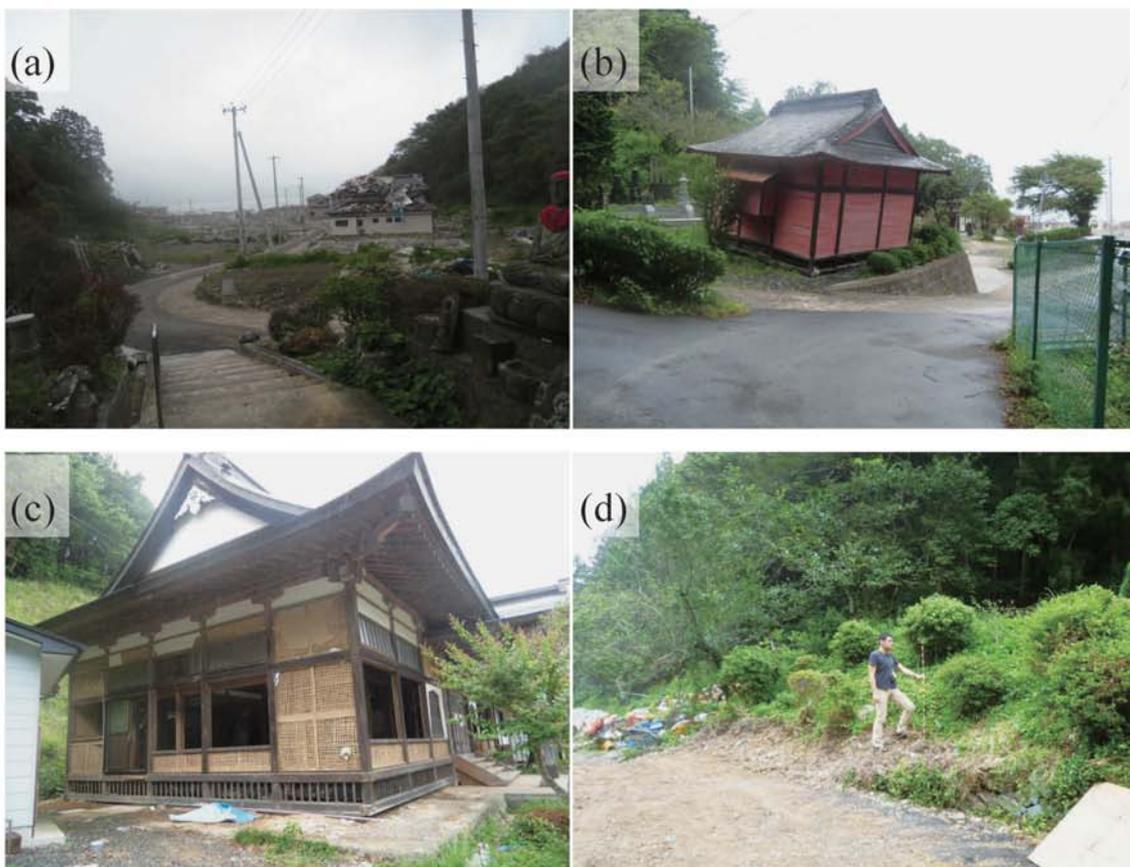
Fig. A210. (a)-(c) Damage at Wakehama. (d) Tsunami trace survey point on a slope beside the Kogenin (M59).

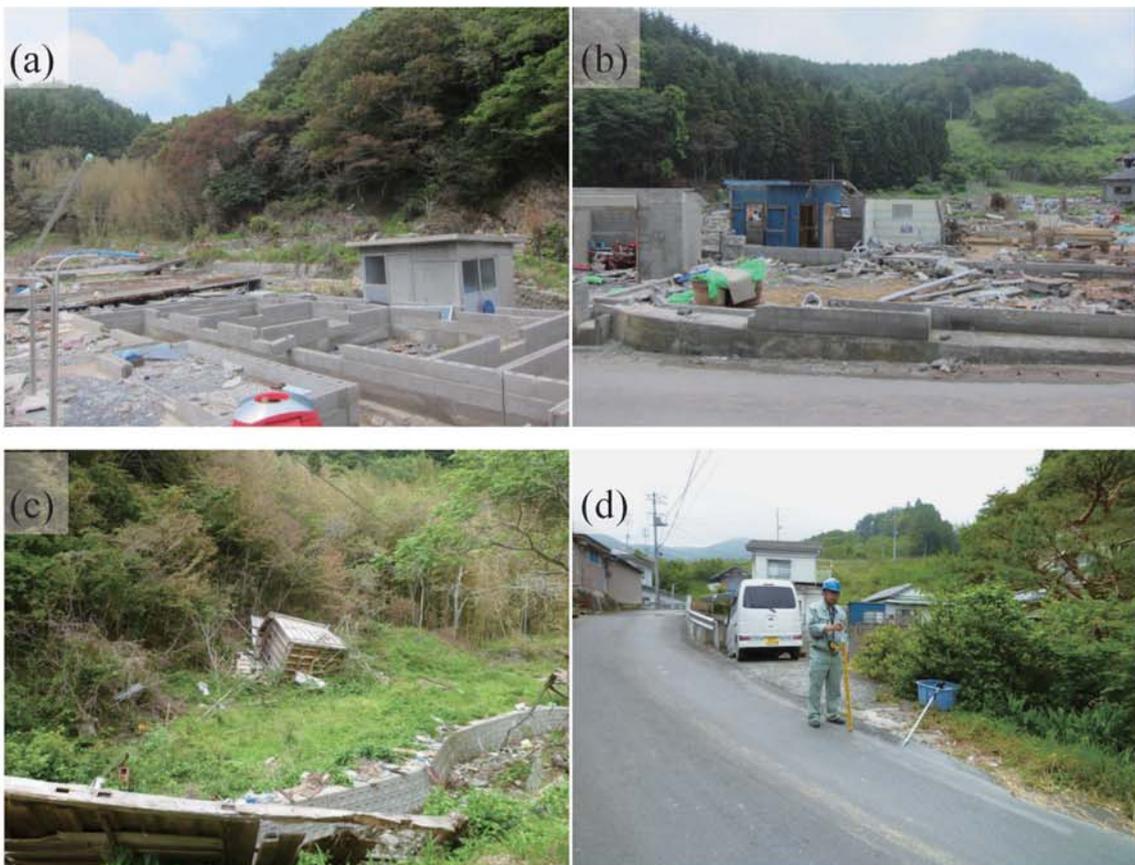
Fig. A212. (a)-(c) Damage at Namiita. (d) Tsunami trace survey point on a western slope (M60).

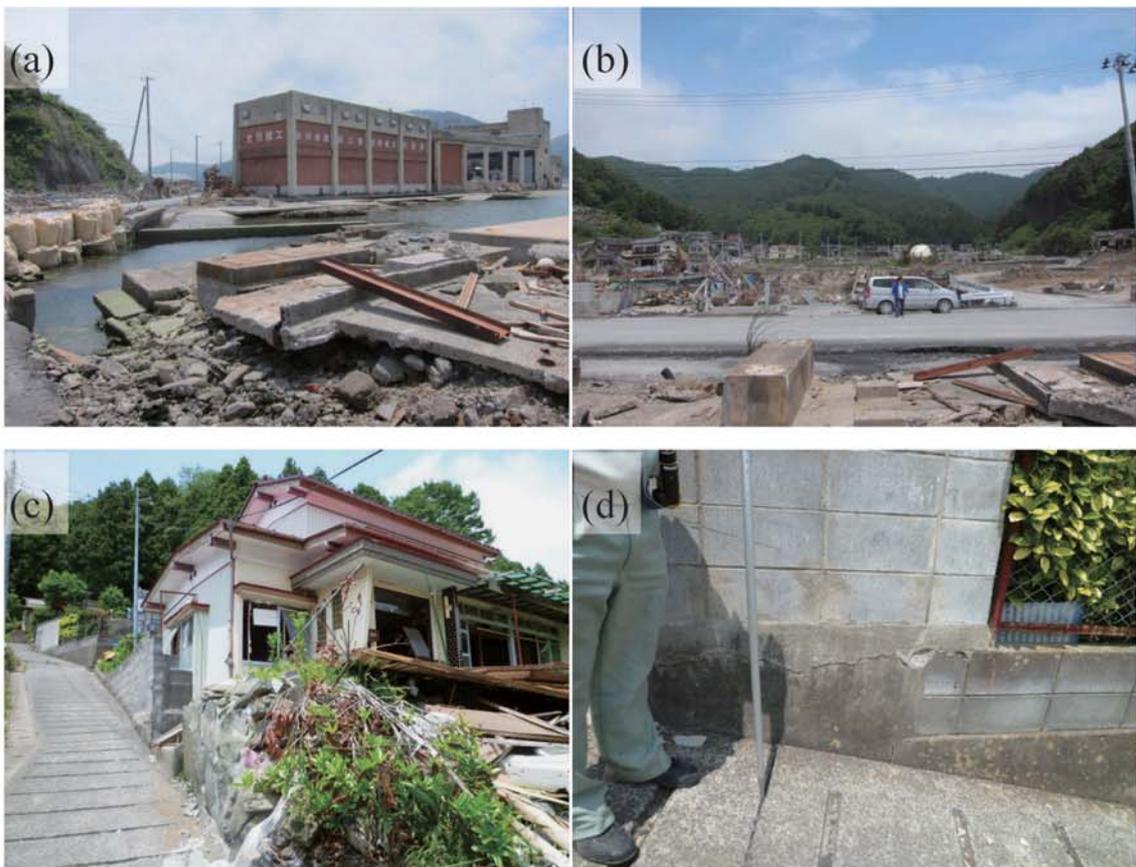
Fig. A214. (a)-(b) Damage at Ishihama. (c)-(d) Tsunami trace survey point at a slope beside the entrance to a grave site (M61).

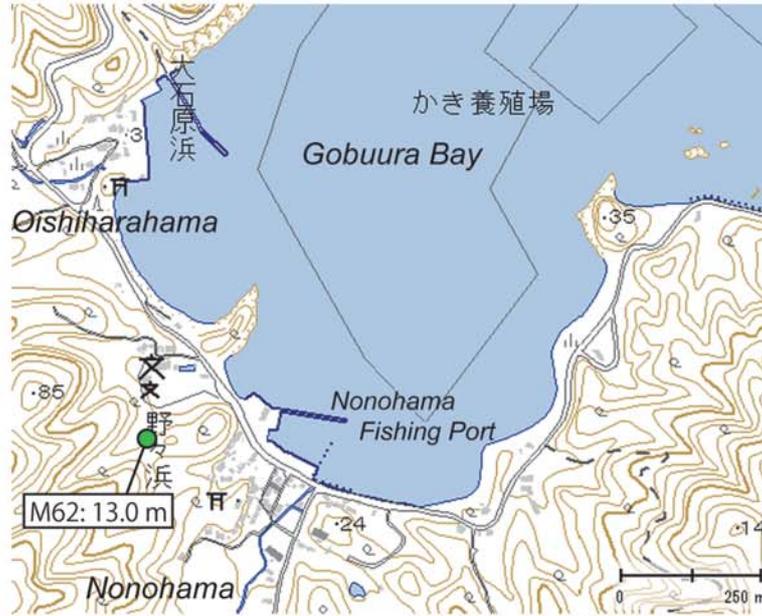
Fig. A215. Tsunami height at Oishiharahama, Onagawa Town, Miyagi Prefecture (added with a digital topographic map at a scale of 1/25,000 from the Geospatial Information Authority of Japan). The symbol and its meaning are the same as in Fig. 4.

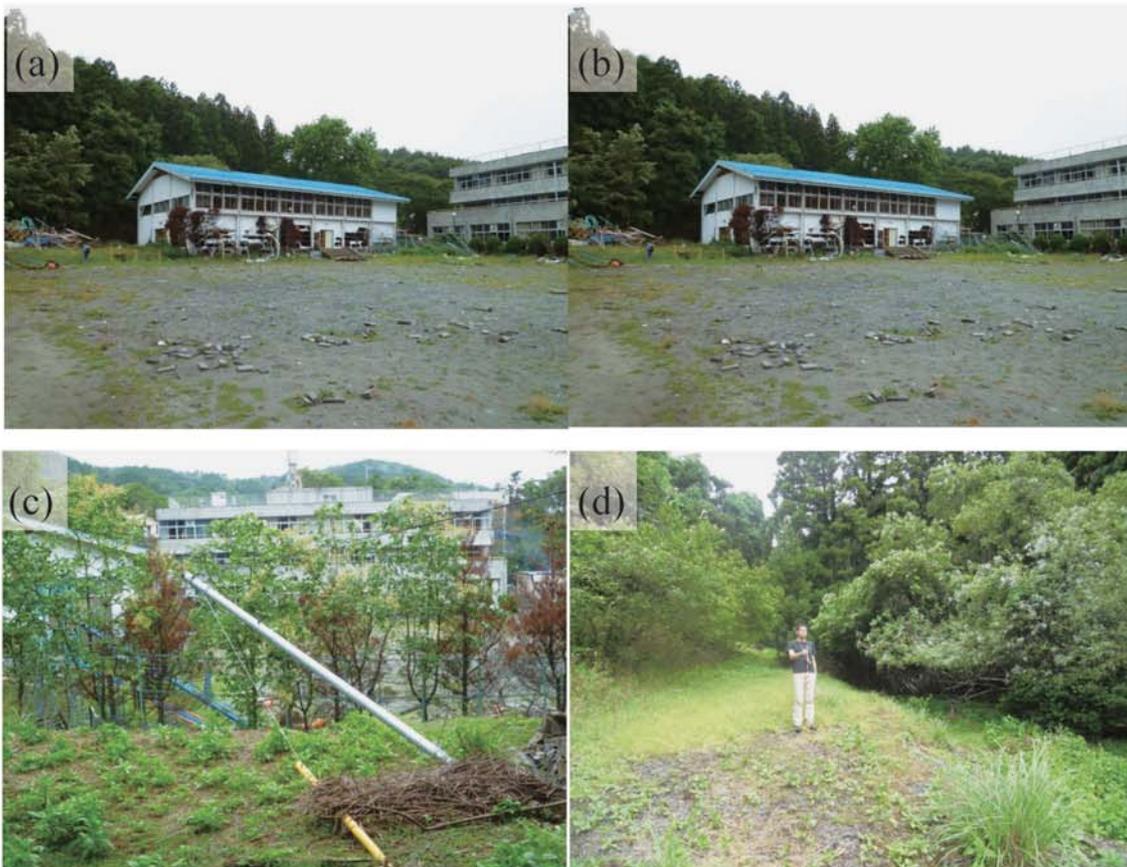
Fig. A216. (a)-(c) Damage at Oishiharahama. (d) Tsunami trace survey point at a slope behind the sixth Onagawa elementary school and the fourth junior high school (M62).

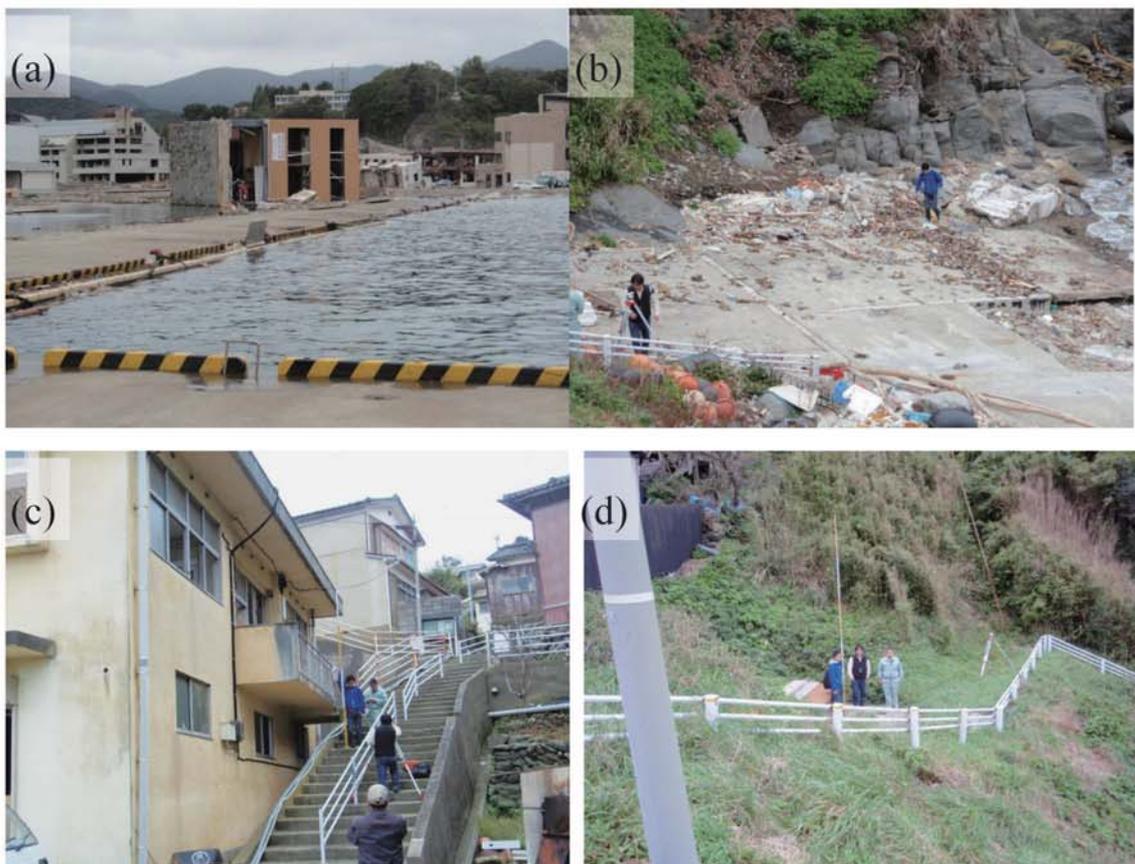
Fig. A218. (a)-(b) Damage at Enoshima. (c) Tsunami trace survey point on a wall of the fishermen's cooperative building (M63). (d) Tsunami trace survey point near a well (M64).

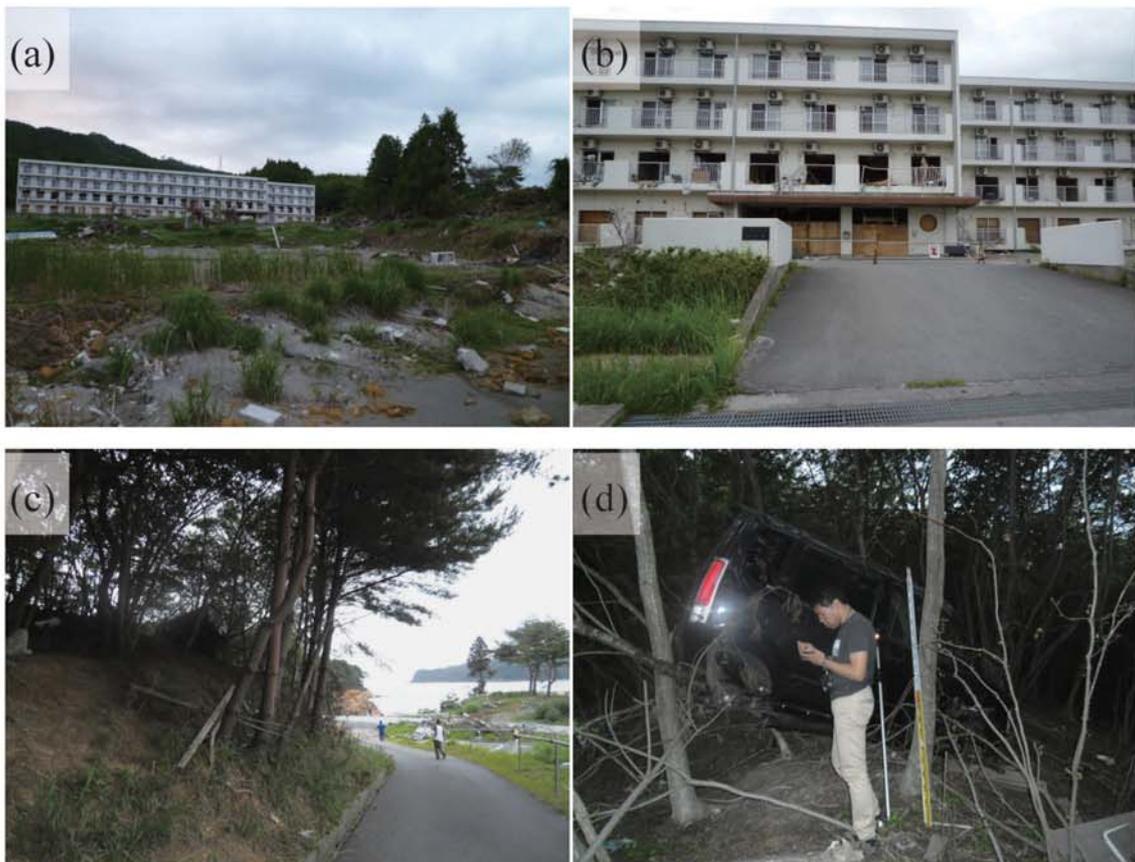
鮫浦(津波高; 図A219, 被害状況ならびに津波痕跡調査地点; 図A220)では、東北発電工業株式会社所有の鮫浦寮の2階まで窓ガラスが破壊されていた。鮫浦寮近くの池には大量の自動車が沈んでおり、また背後の丘陵上には軽自動車も打ち上げられていた。浸水痕跡は地面からの高さ1.10mにあり、これに基づき測定された浸水高は、17.9mであった(M65, 図A220d)。

Fig. A220. (a)-(b) Damage at Samenoura. (c)-(d) Tsunami trace survey point on a hill behind the Samenoura dormitory of Tohoku Electric Power Engineering (1.10 m above ground level, M65).

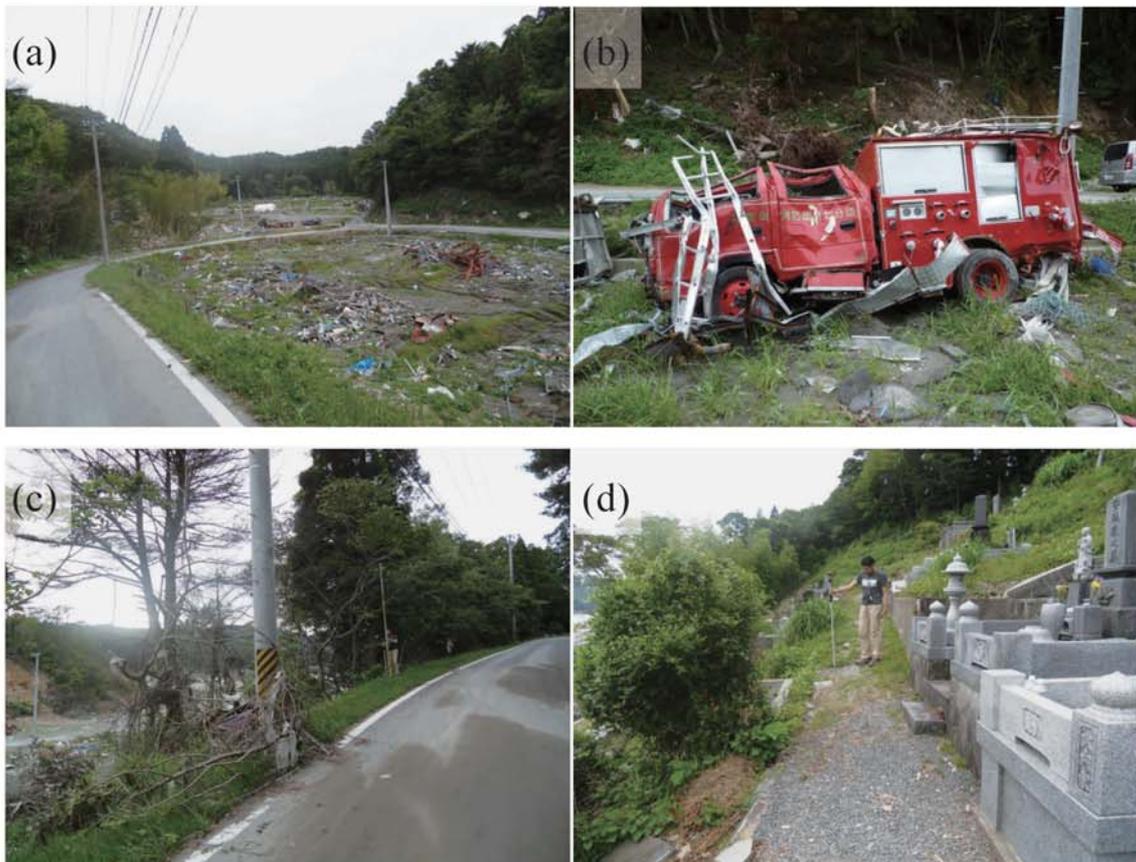
Fig. A224. (a)-(b) Damage at Yagawahama. (c) Tsunami trace survey point on a tree on the eastern slope (2.80 m above ground level, M67). (d) Tsunami trace survey point at a grave site beside the temple Dofukudera (M68).

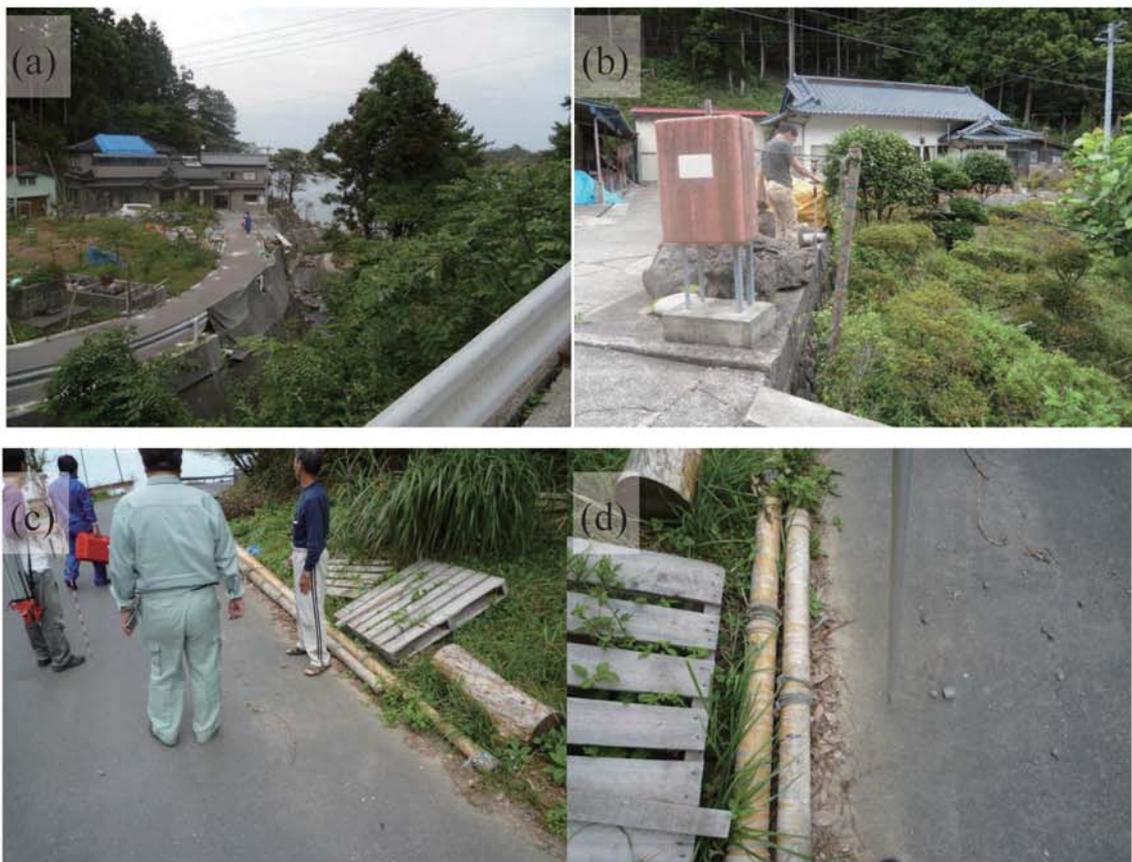
Fig. A226. (a) Damage at Tomarihama. (b) Tsunami trace survey point on the slope (M69). (c)-(d) Tsunami trace survey point on the slope (M70).

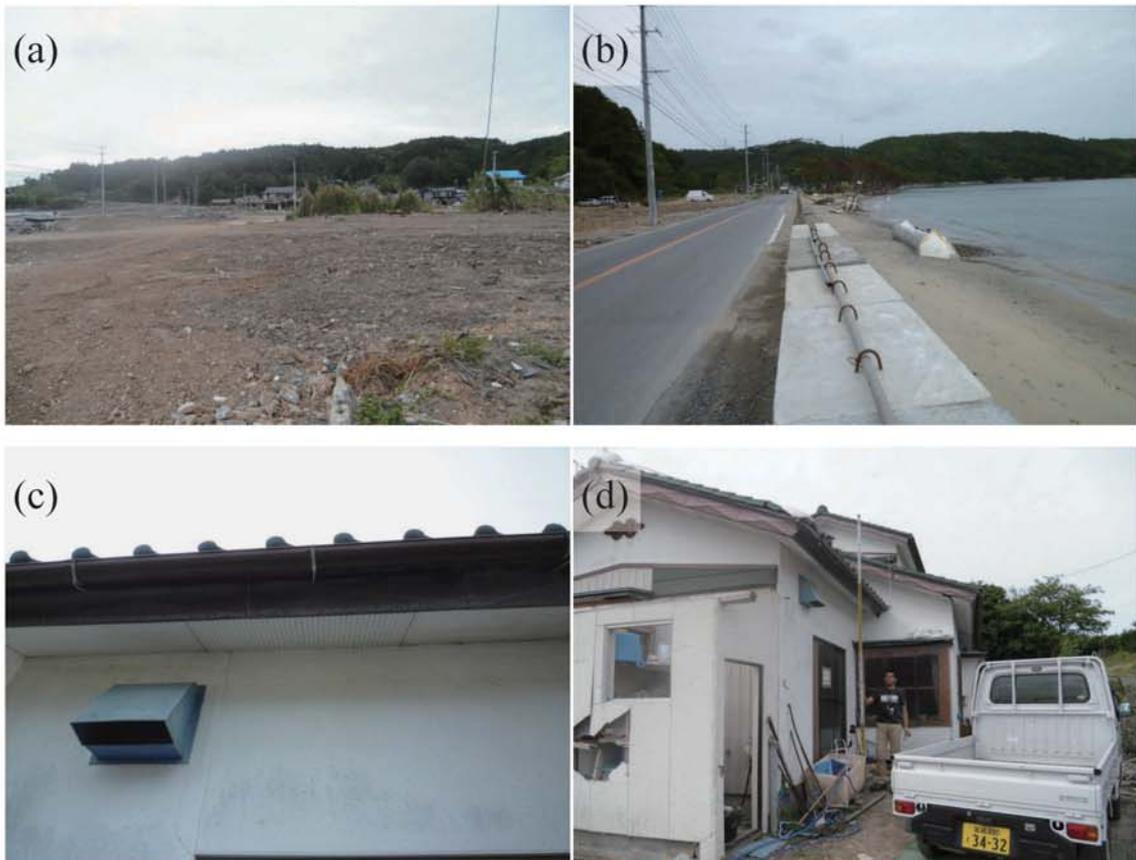
Fig. A228. (a)-(b) Damage at Kugunarihama. (c)-(d) Tsunami trace survey point on a wall of Mr. Sato's house (3.10 m above ground level, M71).

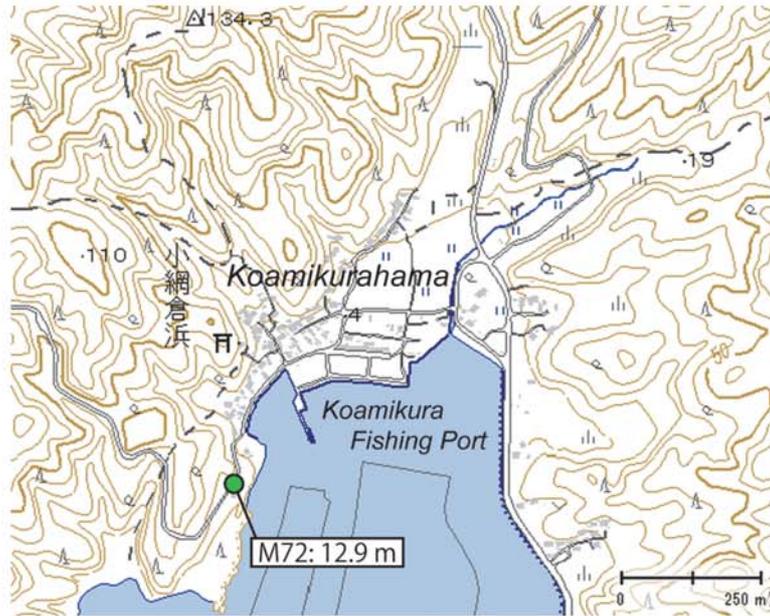
Fig. A229. Tsunami height at Koamikurahama, Ishinomaki City, Miyagi Prefecture (added with a digital topographic map at a scale of 1/25,000 from the Geospatial Information Authority of Japan). The symbol and its meaning are the same as in Fig. 4.

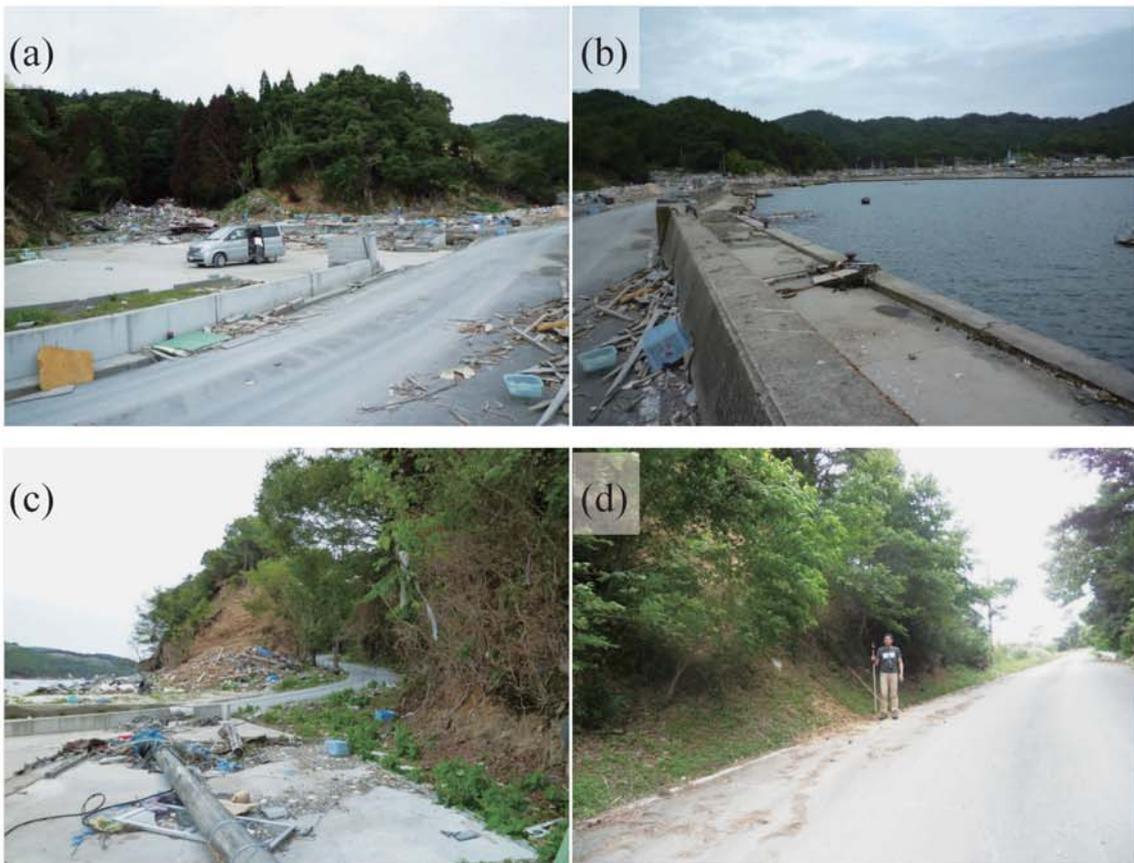
Fig. A230. (a)-(c) Damage at Koamikurahama. (d) Tsunami trace survey point at a slope (M72).
