2011年東北地方太平洋沖地震の津波高調査

Field Surveys of Tsunami Heights from the 2011 off the Pacific Coast of Tohoku, Japan Earthquake

We report the results of field surveys conducted by the Earthquake Research Institute, to measure tsunami heights from the 2011 off the Pacific coast of Tohoku, Japan Earthquake (M 9.0), on March 11. Measurements were taken at 296 points on the Sanriku coasts of Aomori, Iwate, and Miyagi Prefectures, and the Pacific coasts of Ibaraki and Chiba Prefectures. The data are included in the results of the 2011 Tohoku Earthquake Tsunami Joint Survey Group. We did not cover the Sendai plain in the southern Miyagi Prefecture because other parties extensively measure there, nor Fukushima Prefecture because of the accident of the Fukushima Dai-ichi nuclear power plant. The twelve surveys first sought traces indicating tsunami runup or inundation heights. Reliability was classified into A (most reliable based on clear physical evidence and eyewitness accounts), B (mostly based on natural traces), and C (least reliable based on equivocal evidence). Most physical evidence obtained after June was not significant; therefore, reliance was mostly placed on eyewitness accounts. Loc

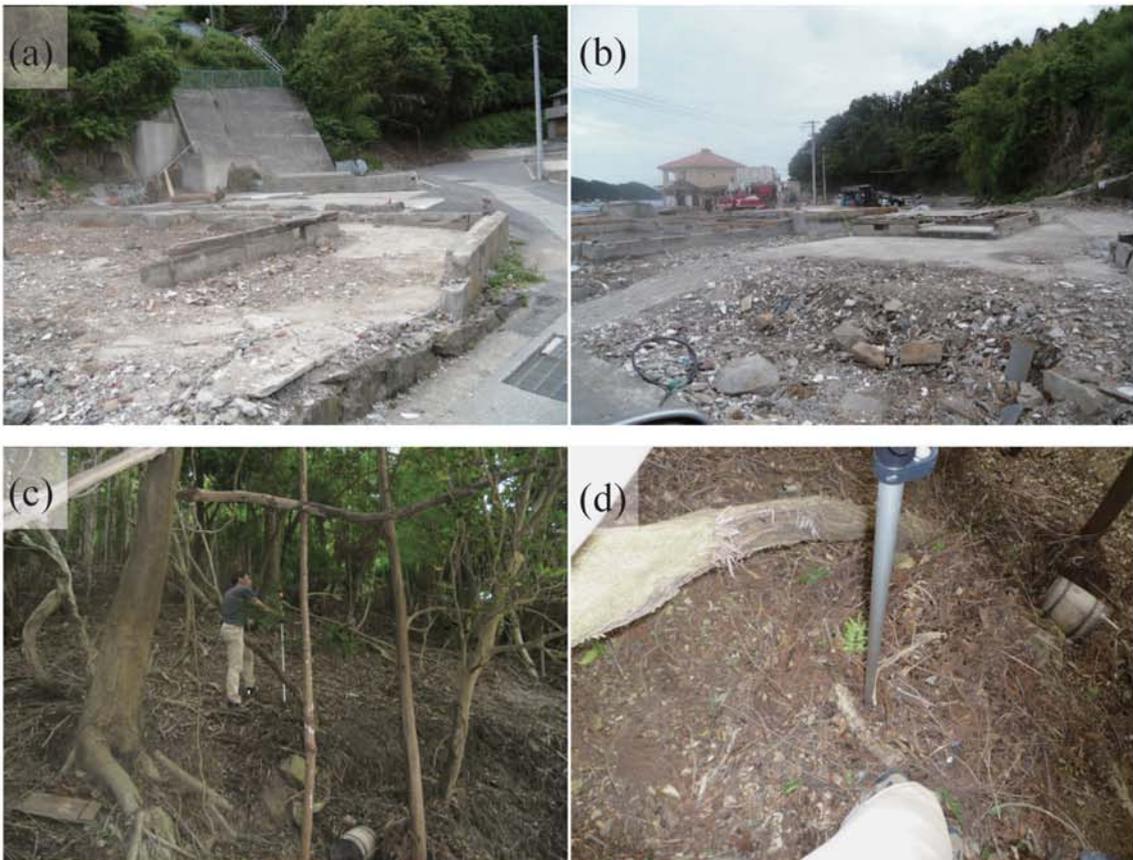
Fig. A232. (a)-(b) Damage at Fukkiura. (c)-(d) Tsunami trace survey point at an eastern slope (M73).

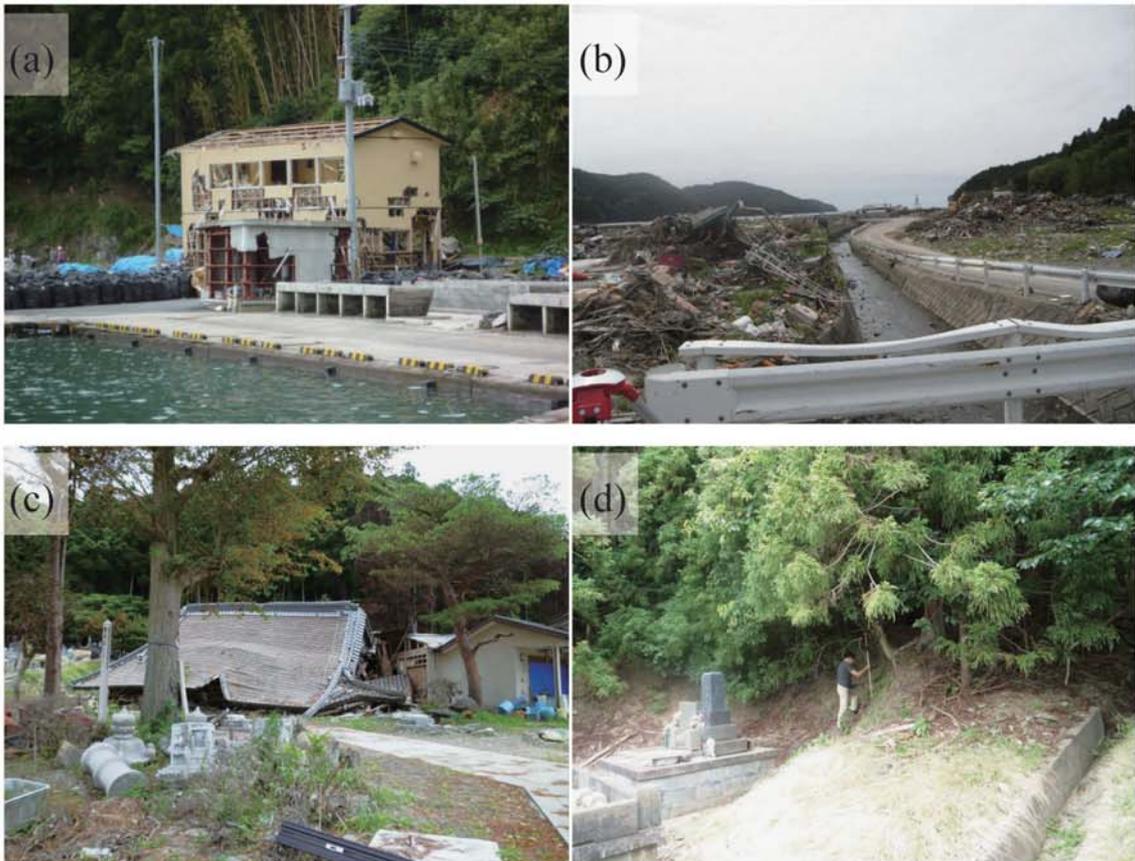
Fig. A238. (a)-(c) Damage at Momonoura. (d) Tsunami trace survey point at the northern slope behind the temple Tosenin (M76).

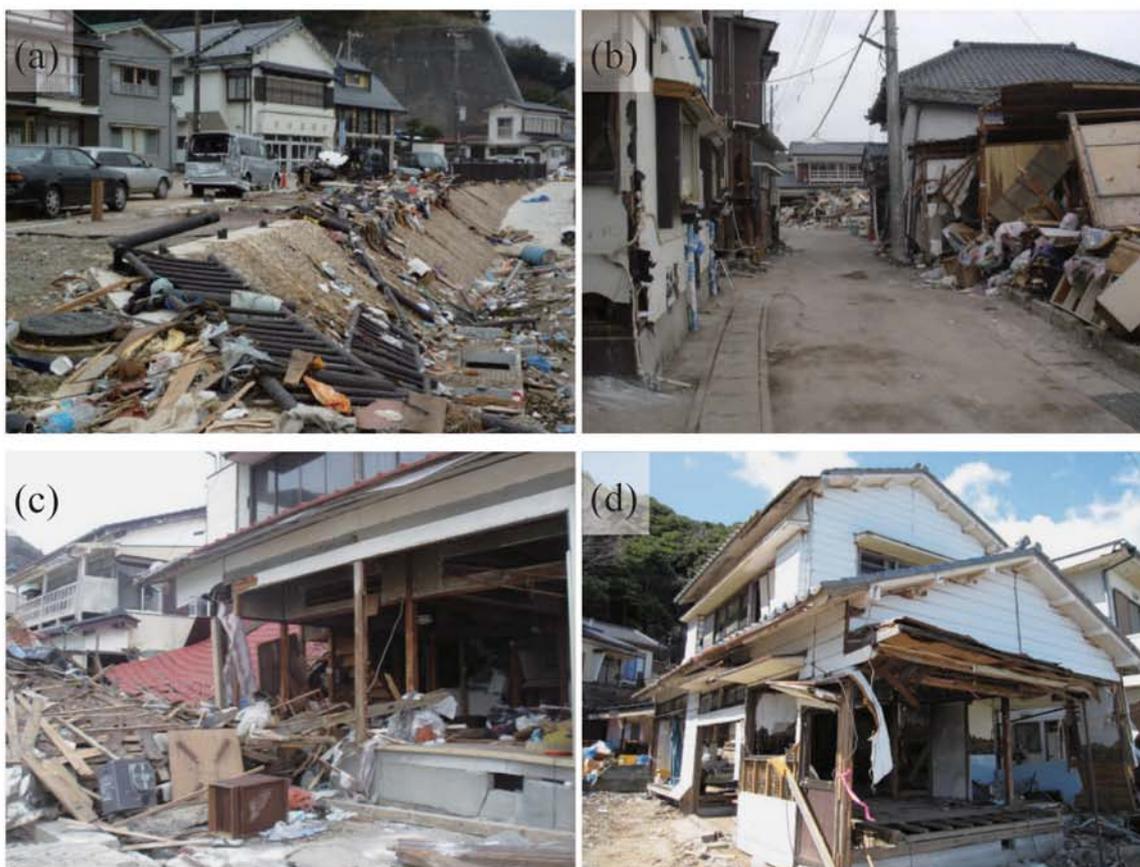
平潟町(平潟漁港周辺)(津波高; 図 A239, 被害状況ならびに津波痕跡調査地点; 図 A240)では, 漁港周辺の道路においてコンクリート製の柵の倒壊等の被害があり, 破壊された自動車数台が放置されていた(図 A240a). 平潟漁港より南東の住宅地における被害は甚大であり, 全壊した家も数軒あった(図 A240b, c). 倒壊を免れた家の多くも1階部分は津波によって破壊されていた(図 A240d). 平潟漁港付近の住宅の窓ガラスに残されていた明瞭な浸水痕跡(地面からの高さ1.95m)を測定し, 6.6mの浸水高が得られた(B1, 図 A240e). また, 割烹民宿「柳屋」の道向かいにある民家の窓枠にも浸水痕跡(地面からの高さ1.435m)が残されており, 7.1mの浸水高が測定された(B2, 図 A240f). 柳屋の入り口のガラス戸には明瞭な浸水痕跡(地面からの高さ0.89m)が残されており, これに基づき測定された浸水高は, 7.2mであった(B3, 図 A240g). 海に面した住宅地の南東外れにある墓地の裏山斜面では, 漂着物の浸水限界が確認された. この地点を, 柳屋の浸水痕跡の調査地点の高さを起点として測定したところ, 8.1mの遡上高であった(B4, 図 A240h). 海に面した住宅地の南東端付近では, 民家にいたる階段の1段目まで津波が来たという証言が得られたので, 同様に柳屋の浸水痕跡の調査地点の高さを起点として, 7.9mの遡上高が測定された(B5, 図 A240i).

Fig. A240. (a)-(d) Damage at Hirakatacho. (e) Watermark on windowpanes of a house near Hirakata Fishing Port (1.95 m above ground level, B1). (f) Watermark on a window frame of the house at the right side of the figure (1.435 m above ground level, B2). (g) Watermark on windowpanes of entrance doors of Minshuku Yanagiya (0.89 m above ground level, B3). (h) Tsunami inundation limit at a slope behind a grave site (B4). (i) Tsunami inundated on the first step of a concrete stairway in a southern coastal residential area (B5).

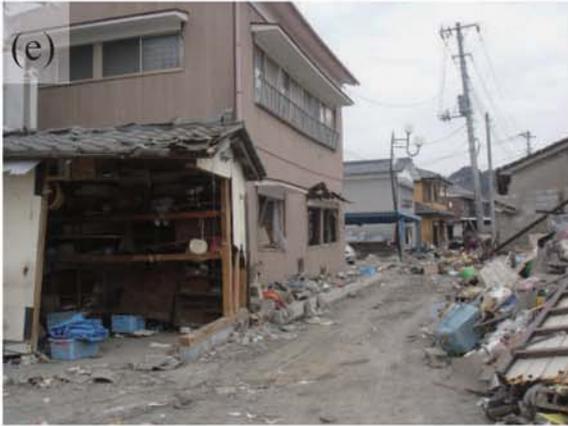
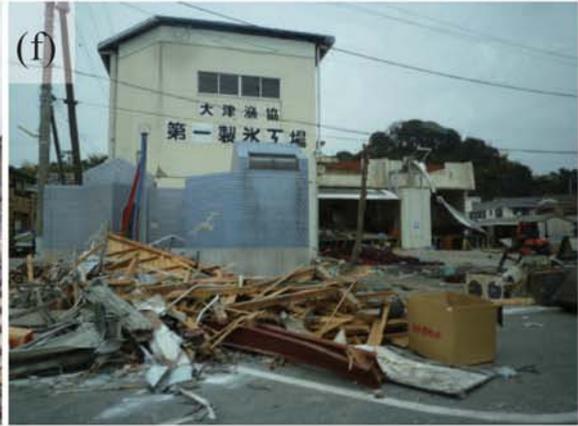
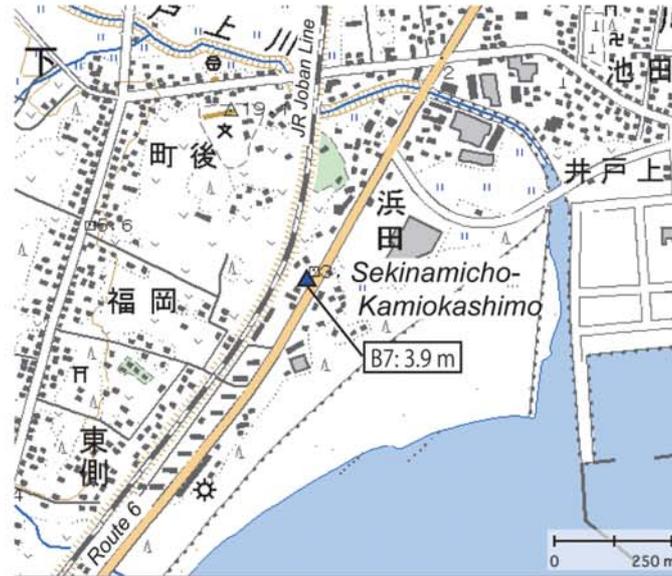
Fig. A242. (a)-(e) Damage at Otsucho (Otsu Fishing Port). (f) Ice plant of Otsu Fishermen's Association in the port (tsunami trace survey point). (g)-(h) Watermark on a wall of the ice plant (2.25 m above ground level, B6).

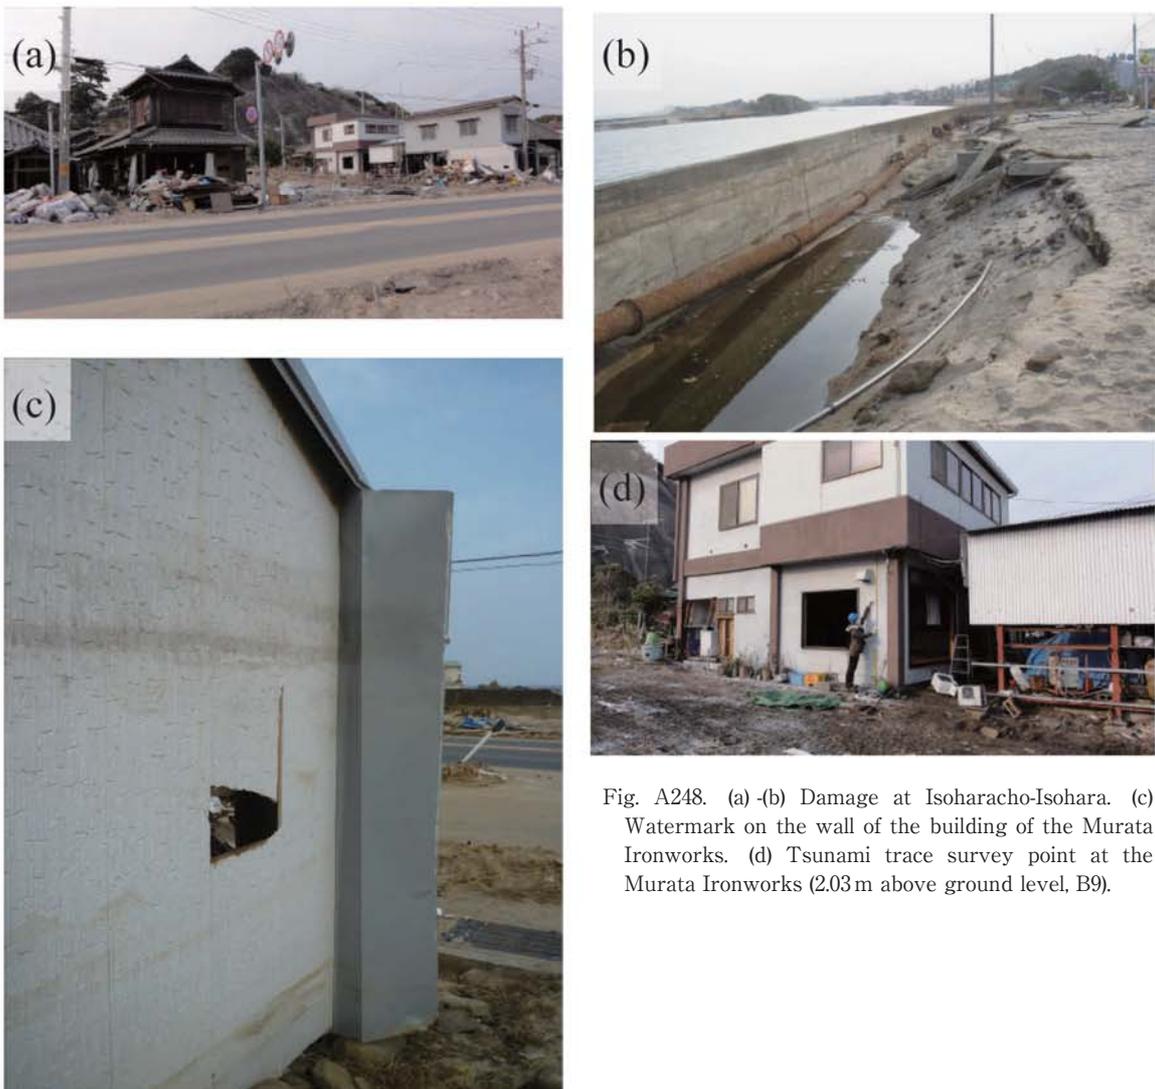
Fig. A248. (a)-(b) Damage at Isoharacho-Isohara. (c) Watermark on the wall of the building of the Murata Ironworks. (d) Tsunami trace survey point at the Murata Ironworks (2.03m above ground level, B9).

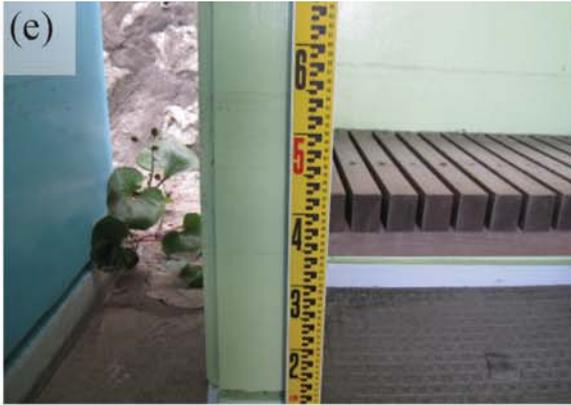
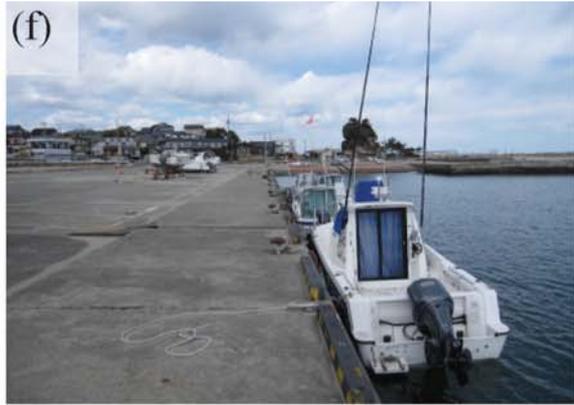
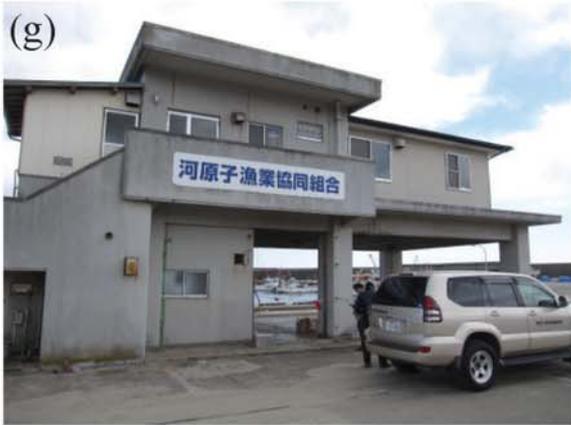
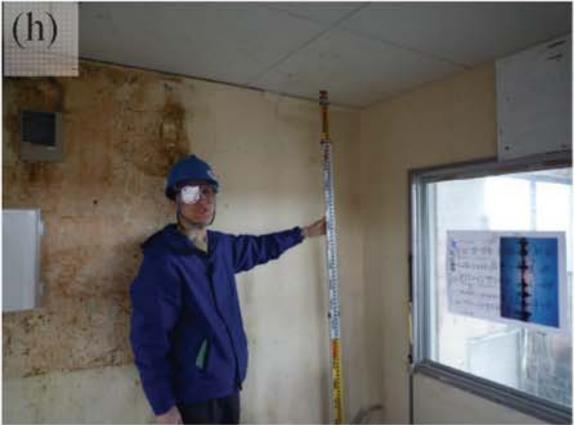
Fig. A270. (a)-(b) Damage at Kawaragocho. (c) Kawarago Beach. (d) Public lavatory beside Kawarago Beach (tsunami trace survey point). (e) Watermark on an inner wall of the public lavatory (0.55 m above ground level, B22). (f) Kawarago Fishing Port. (g) Building of the fishery association in Kawarago Fishing Port (tsunami trace survey point). (h) Watermark on an inner wall at the first floor of the fishery association building (2.035 m above the floor level, B23).

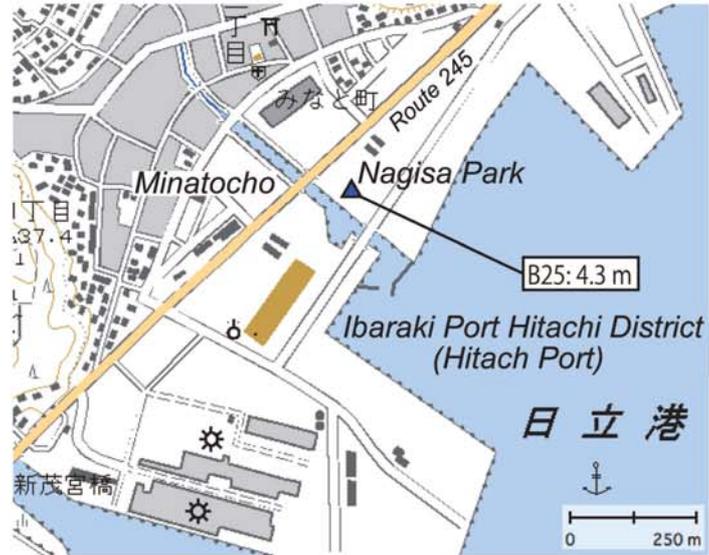
Fig. A273. Tsunami height at Minatocho (Ibaraki Port Hitachi District), Hitachi City, Ibaraki Prefecture (added with a digital topographic map at a scale of 1/25,000 from the Geospatial Information Authority of Japan). The symbol and its meaning are the same as in Fig. 5.

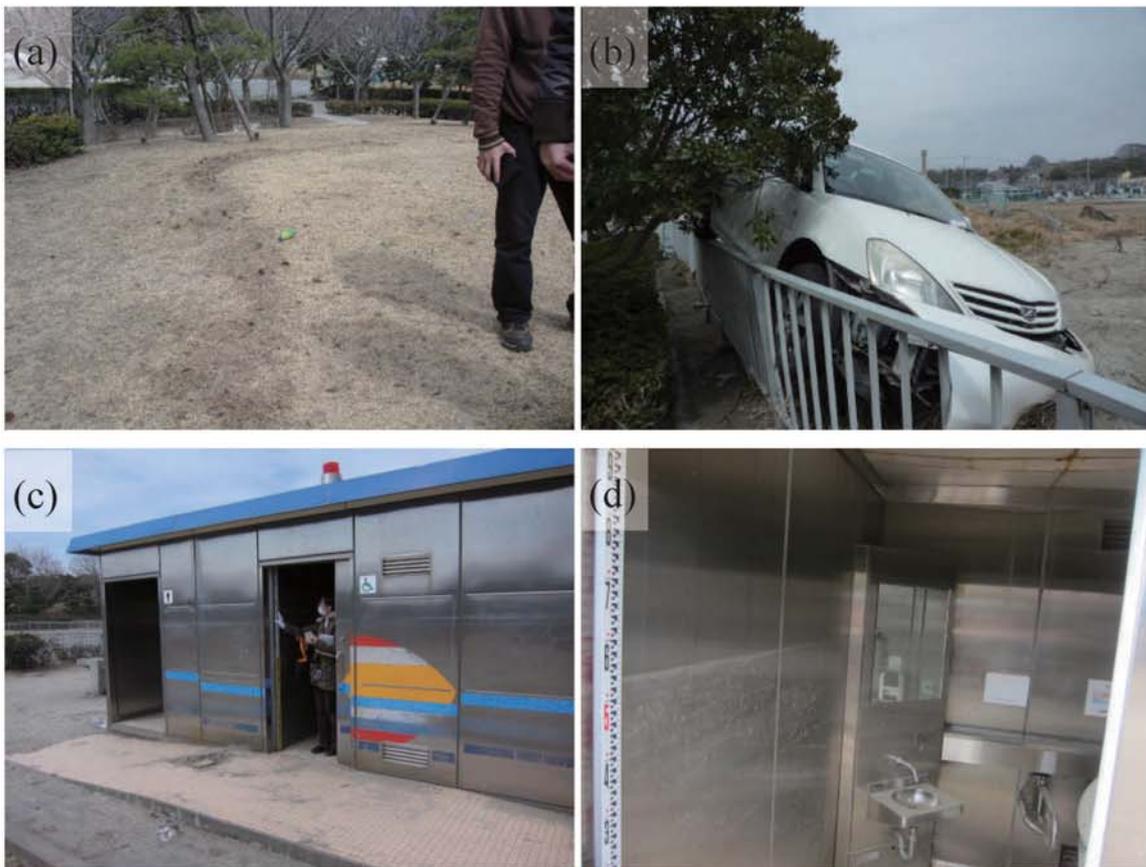
Fig. A274. (a) Trace of tsunami inundation limit on a hill at Nagisa Park. (b) Drifted car that crashed against a fence at Nagisa Park. (c) Public lavatory in Nagisa Park (tsunami trace survey point). (d) Watermark on an inner wall of the public lavatory (1.52 m above ground level, B25).

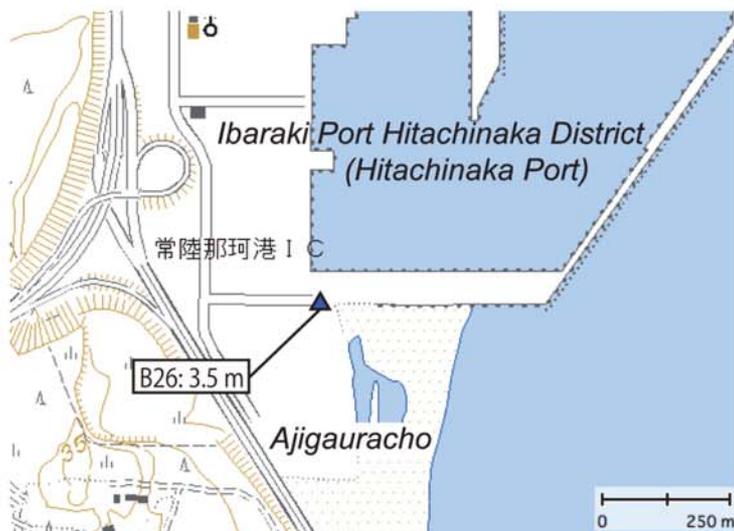
Fig. A275. Tsunami height at Ajigauracho (Ibaraki Port Hitachinaka District), Hitachinaka City, Ibaraki Prefecture (added with a digital topographic map at a scale of 1/25,000 from the Geospatial Information Authority of Japan). The symbol and its meaning are the same as in Fig. 5.

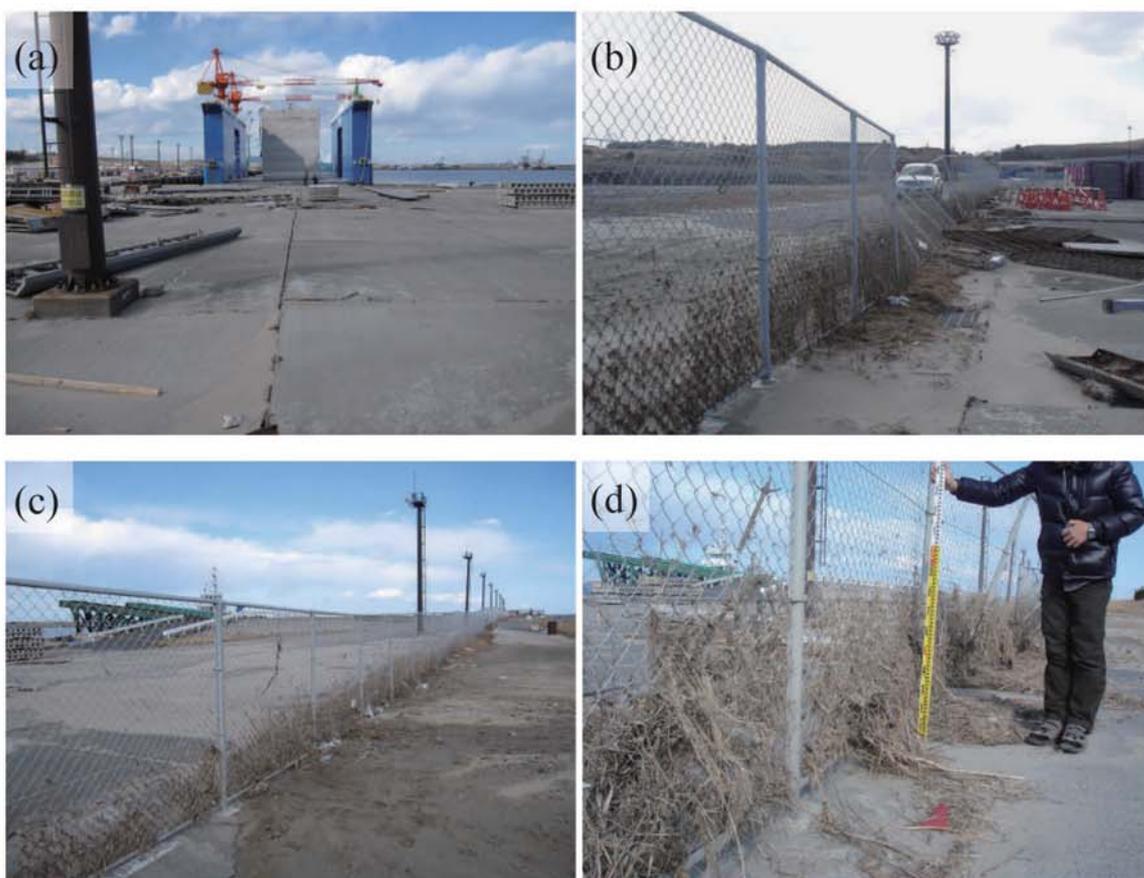
Fig. A276. (a) Ibaraki Port Hitachinaka District (Hitachinaka Port). (b) Damage at Hitachinaka Port. (c) Dry grass on a fence at the port. (d) Measuring height of average upper end of dry grass caught on the fence as the tsunami inundation height (1.03 m above ground level, B26).

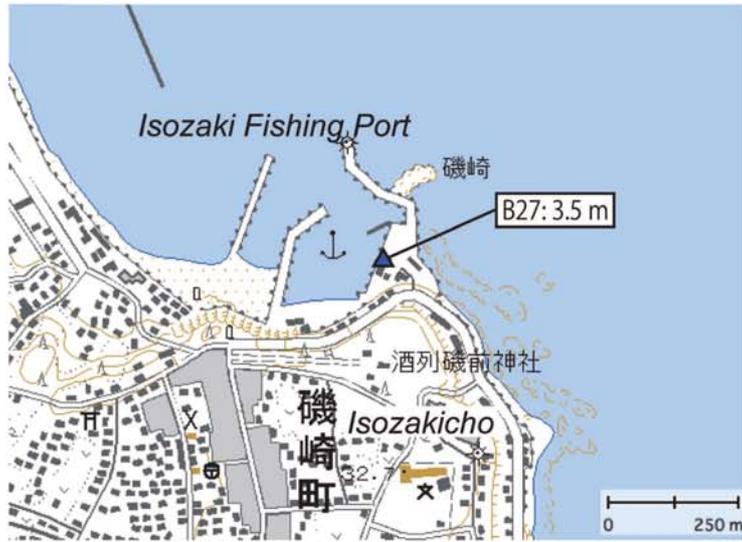
Fig. A277. Tsunami height at Isozakicho (Isozaki Fishing Port), Hitachinaka City, Ibaraki Prefecture (added with a digital topographic map at a scale of 1/25,000 from the Geospatial Information Authority of Japan). The symbol and its meaning are the same as in Fig. 5.

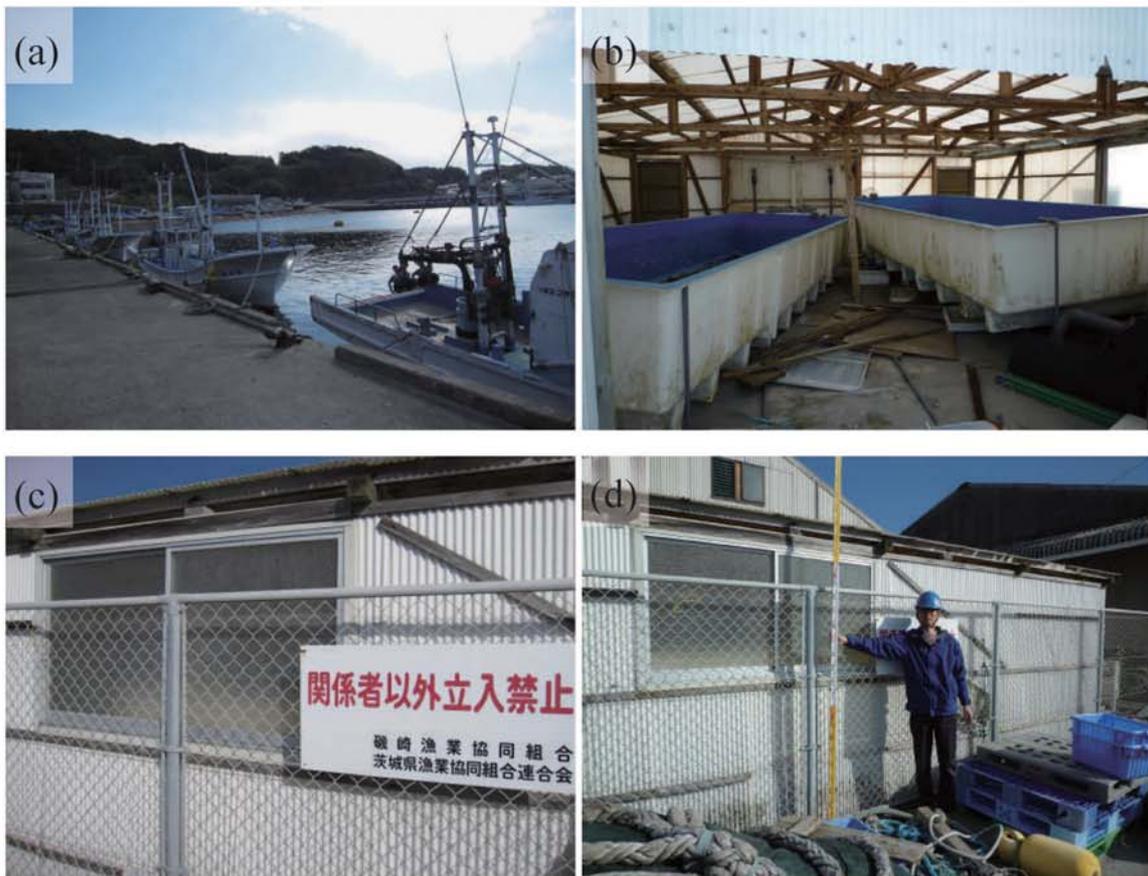
Fig. A278. (a) Isozaki Fishing Port. (b) Damage to shed in Isozaki Fishing Port. (c)-(d) Watermark on windowpanes of shed at the port (1.76 m above ground level, B27).

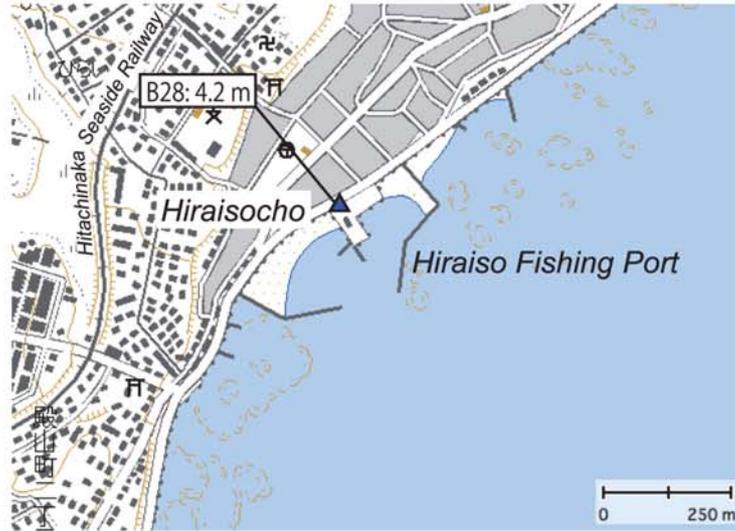
Fig. A279. Tsunami height at Hiraisocho (Hiraiso Fishing Port), Hitachinaka City, Ibaraki Prefecture (added with a digital topographic map at a scale of 1/25,000 from the Geospatial Information Authority of Japan). The symbol and its meaning are the same as in Fig. 5.

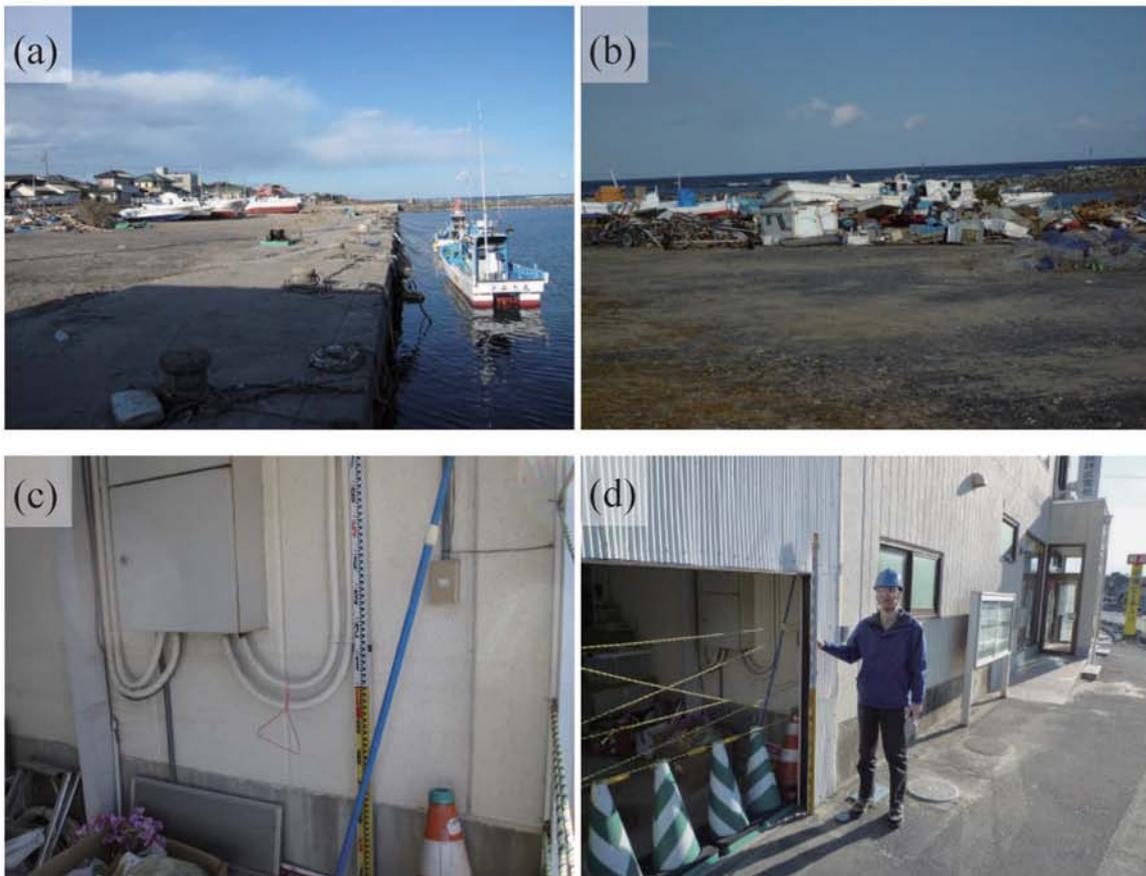
Fig. A280. (a)-(b) Damage at Hiraiso Fishing Port. (c)-(d) Watermark on a wall of a building behind the port (1.085 m above ground level, B28).

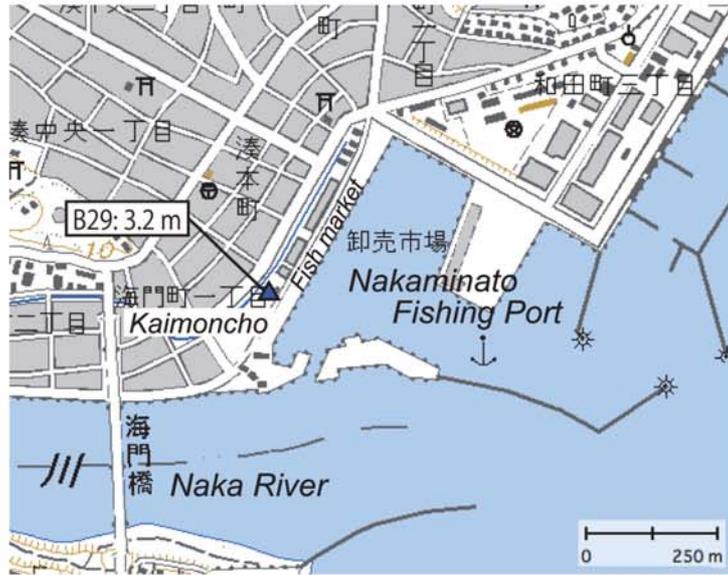
Fig. A281. Tsunami height at Kaimoncho (Nakaminato Fishing Port), Hitachinaka City, Ibaraki Prefecture (added with a digital topographic map at a scale of 1/25,000 from the Geospatial Information Authority of Japan). The symbol and its meaning are the same as in Fig. 5.

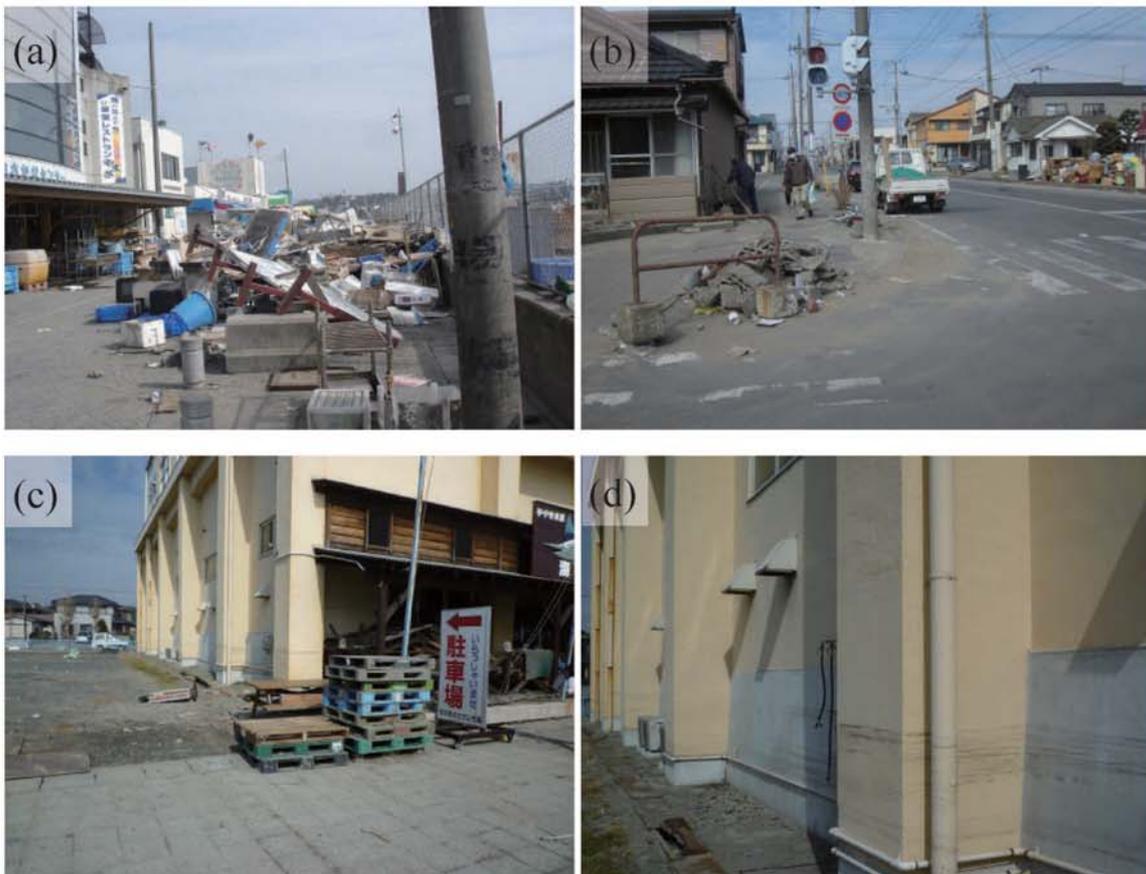
Fig. A282. (a)-(b) Damage at Kaimoncho (Nakaminato Fishing Port). (c) Building of fish market in the port (tsunami trace survey point). (d) Watermark on a wall of the market building (1.19 m above ground level, B29).

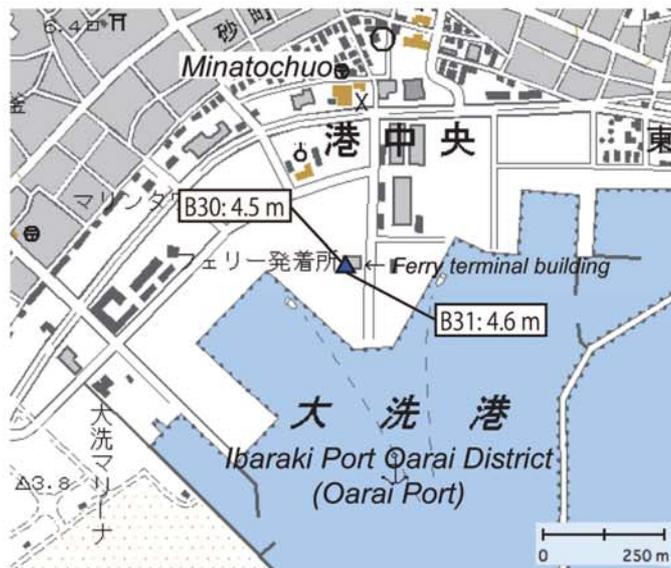
Fig. A283. Tsunami heights at Minatocho (Ibaraki Port Oarai District), Oarai Town, Ibaraki Prefecture (added with a digital topographic map at a scale of 1/25,000 from the Geospatial Information Authority of Japan). The symbols and their meanings are the same as in Fig. 5.

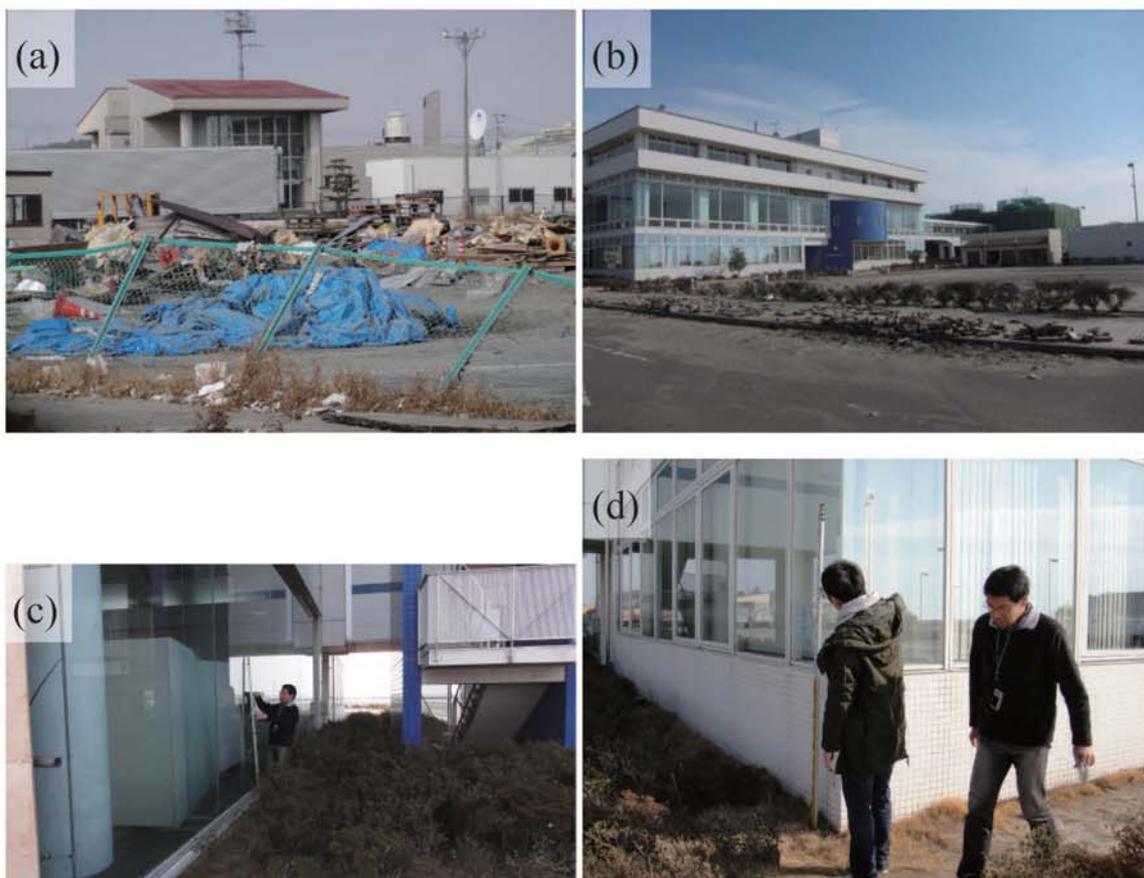
Fig. A284. (a) Damage at Minatocho (Ibaraki Port, Oarai District). (b) Ferry terminal building at Oarai Port. (c) Watermark on windowpanes of ferry terminal building (1.575 m above ground level, B30). (d) Another watermark on windowpanes of the ferry terminal building (1.65 m above ground level, B31).

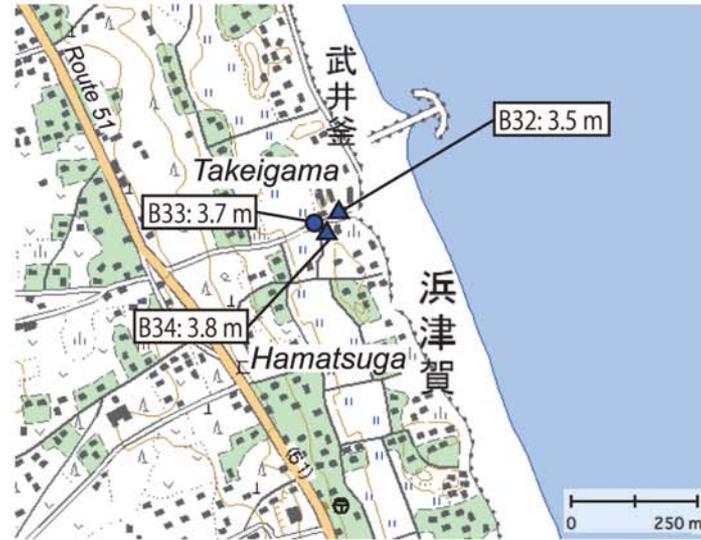
Fig. A285. Tsunami heights at Takeigama (B32 and B33) and Hamatsuga (B34), Kashima City, Ibaraki Prefecture (added with a digital topographic map at a scale of 1/25,000 from the Geospatial Information Authority of Japan). The symbols and their meanings are the same as in Fig. 5.

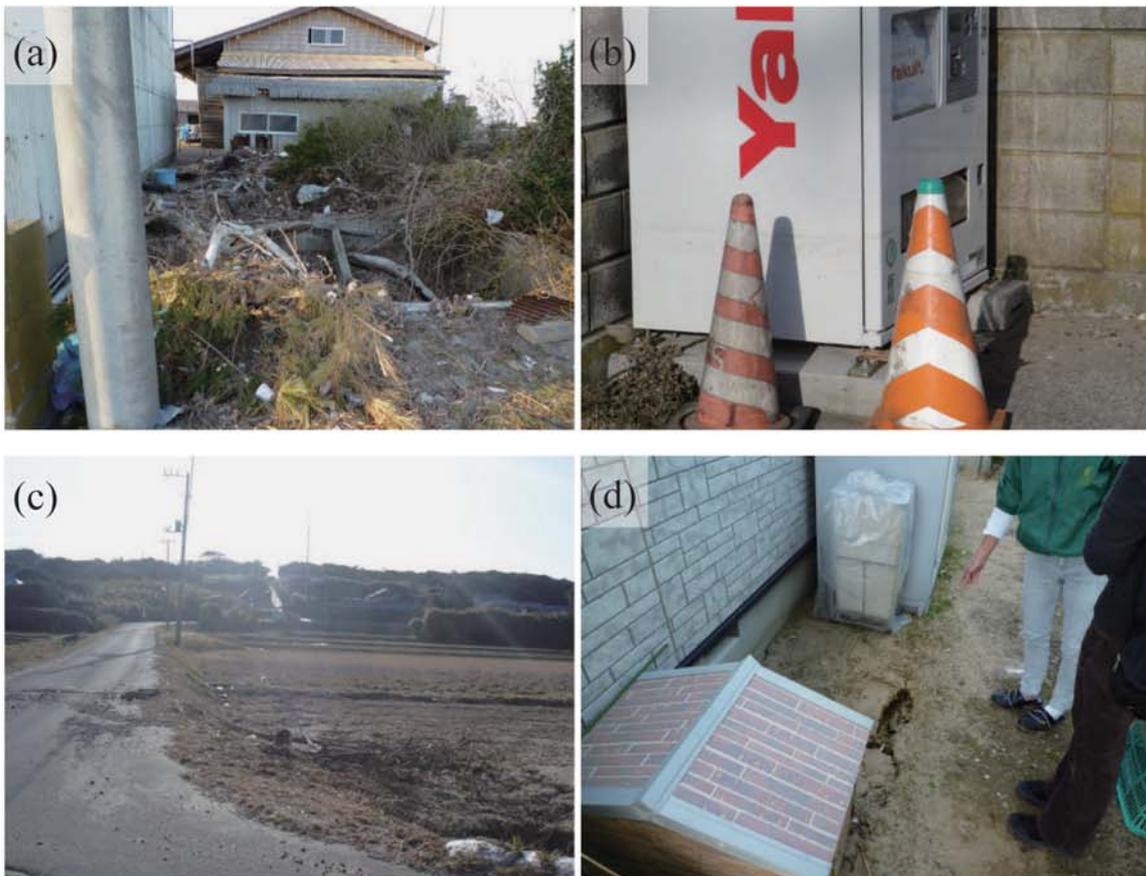
Fig. A286. (a) Debris carried by the tsunami in Takeigama. (b) Watermark on a side of a vending machine beside the fisheries processing factory (0.495 m above ground level, B32). (c) Tsunami inundation limit on a road in Takeigama (B33). (d) Watermark on a side of a foundation of Mr. Kudo's house in Hamatsuga (0.08 m above ground level, B34).

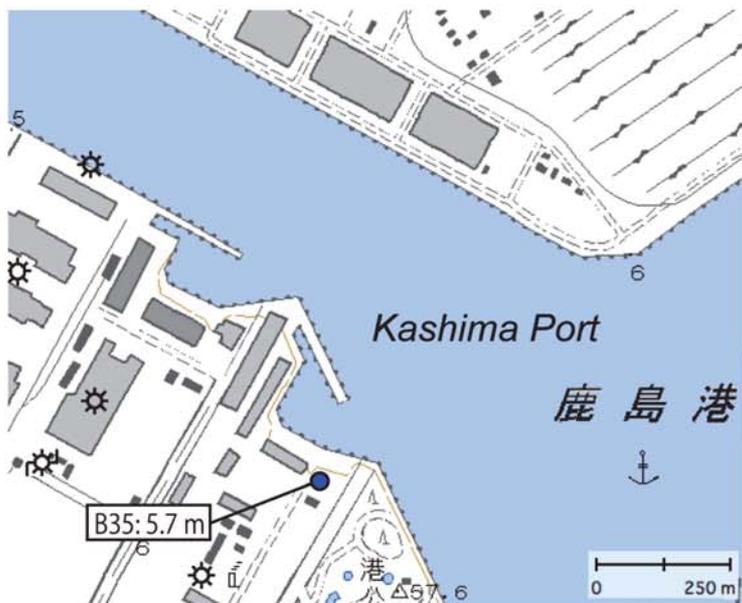
Fig. A287. Tsunami height at Higashifukashiba (Kashima Port), Kamisu City, Ibaraki Prefecture (added with a digital topographic map at a scale of 1/25,000 from the Geospatial Information Authority of Japan). The symbol and its meaning are the same as in Fig. 5.

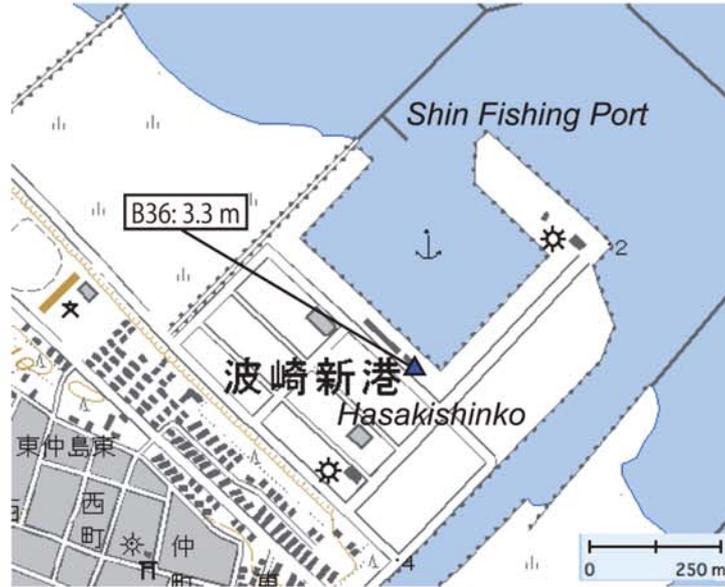
Fig. A289. Tsunami height at Hasakishinko (Shin Fishing Port), Kamisu City, Ibaraki Prefecture (added with a digital topographic map at a scale of 1/25,000 from the Geospatial Information Authority of Japan). The symbol and its meaning are the same as in Fig. 5.

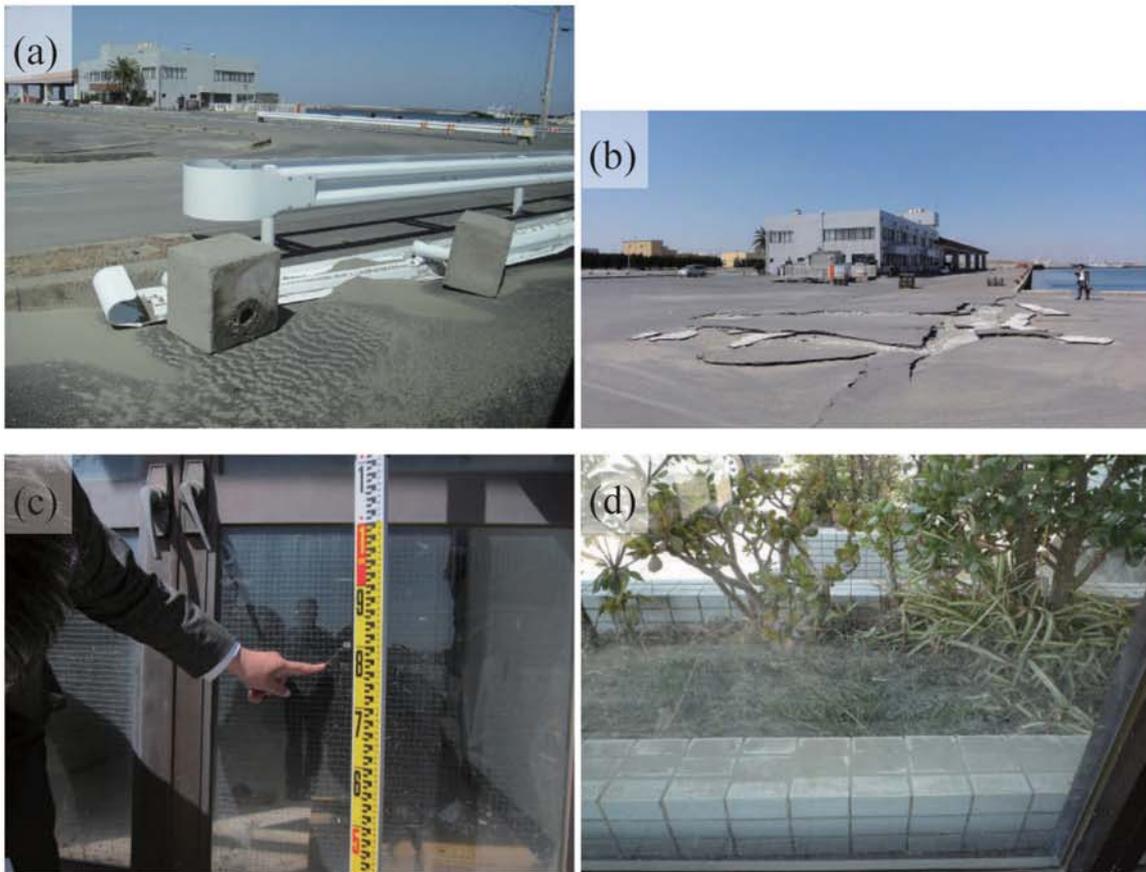
Fig. A290. (a)-(b) Damage around the fishery association building in Shin Fishing Port. (c) Watermark on the entrance doors of the fishery association building (0.898 m above ground level; B36). (d) Watermark on a windowpane of the fishery association building.

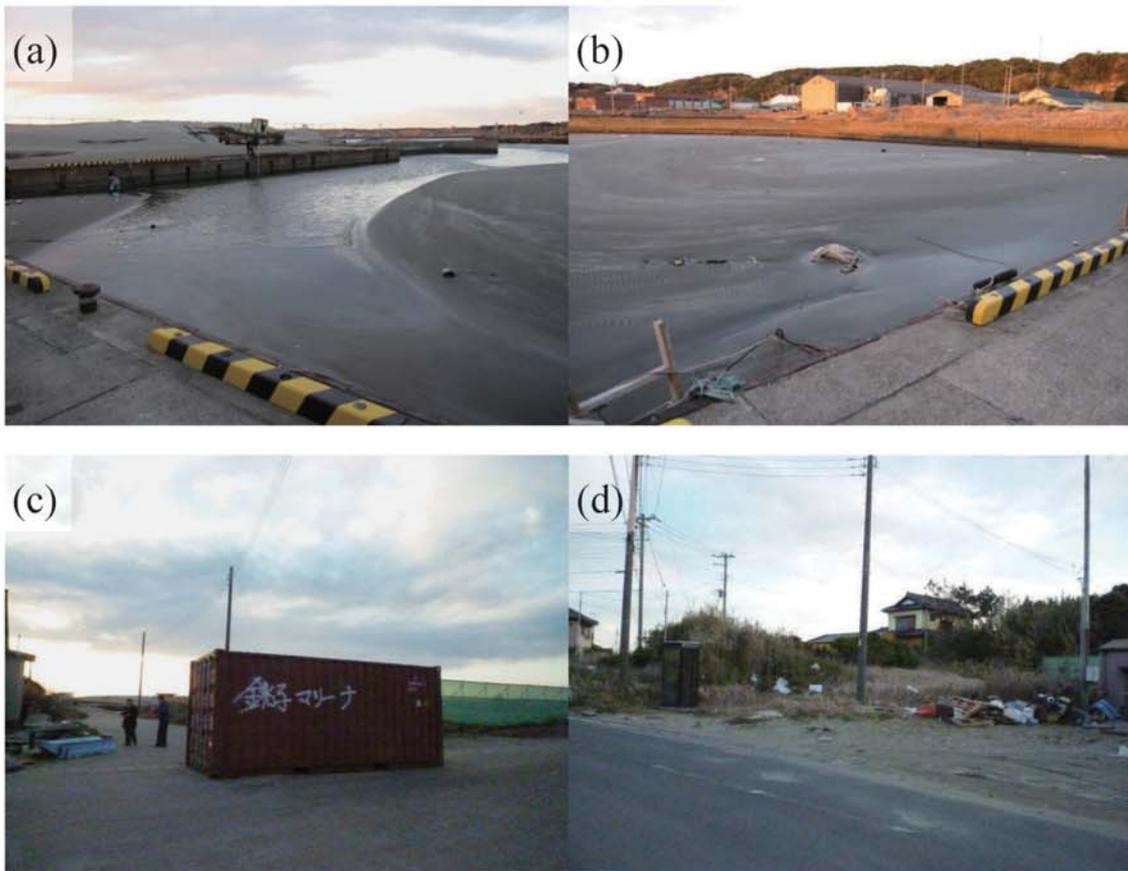
Fig. A294. (a)-(c) Inuwaka Fishing Port. (d) Watermark on a telephone box near Inuwaka Fishing Port (1.365 m above ground level; C2).

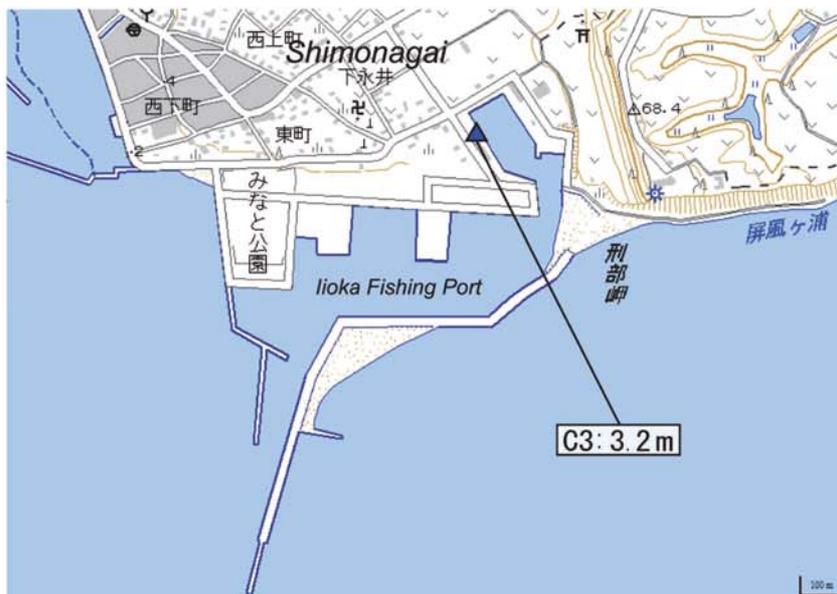
Fig. A295. Tsunami height at Shimonagai (Iioka Fishing Port), Asahi City, Chiba Prefecture (added with a digital topographic map at a scale of 1/25,000 from the Geospatial Information Authority of Japan). The symbol and its meaning are the same as in Fig. 6.

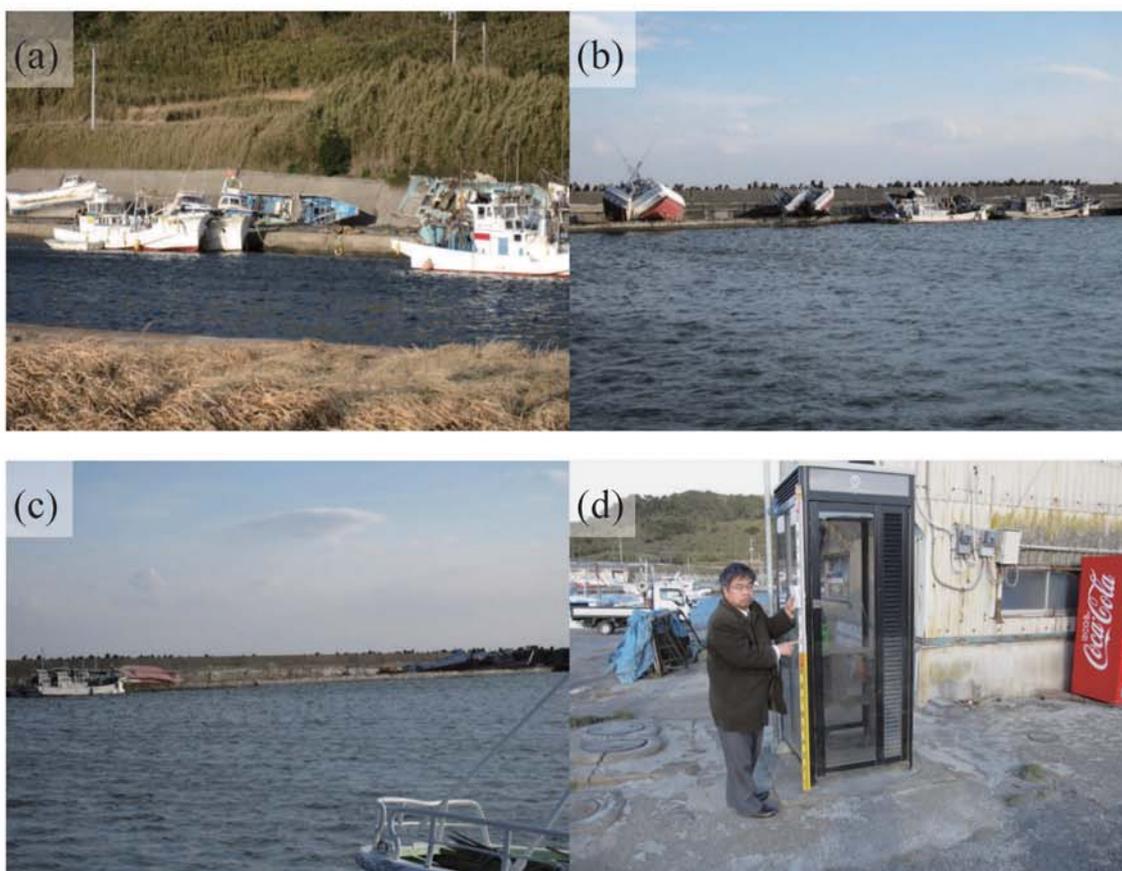
Fig. A296. (a)-(c) Damage at Iioka Fishing Port. (d) Watermark on the wall of a telephone box in Iioka Fishing Port (1.07 m above ground level; C3).
