2011年東北地方太平洋沖地震の津波高調査

Field Surveys of Tsunami Heights from the 2011 off the Pacific Coast of Tohoku, Japan Earthquake

We report the results of field surveys conducted by the Earthquake Research Institute, to measure tsunami heights from the 2011 off the Pacific coast of Tohoku, Japan Earthquake (M 9.0), on March 11. Measurements were taken at 296 points on the Sanriku coasts of Aomori, Iwate, and Miyagi Prefectures, and the Pacific coasts of Ibaraki and Chiba Prefectures. The data are included in the results of the 2011 Tohoku Earthquake Tsunami Joint Survey Group. We did not cover the Sendai plain in the southern Miyagi Prefecture because other parties extensively measure there, nor Fukushima Prefecture because of the accident of the Fukushima Dai-ichi nuclear power plant. The twelve surveys first sought traces indicating tsunami runup or inundation heights. Reliability was classified into A (most reliable based on clear physical evidence and eyewitness accounts), B (mostly based on natural traces), and C (least reliable based on equivocal evidence). Most physical evidence obtained after June was not significant; therefore, reliance was mostly placed on eyewitness accounts. Loc

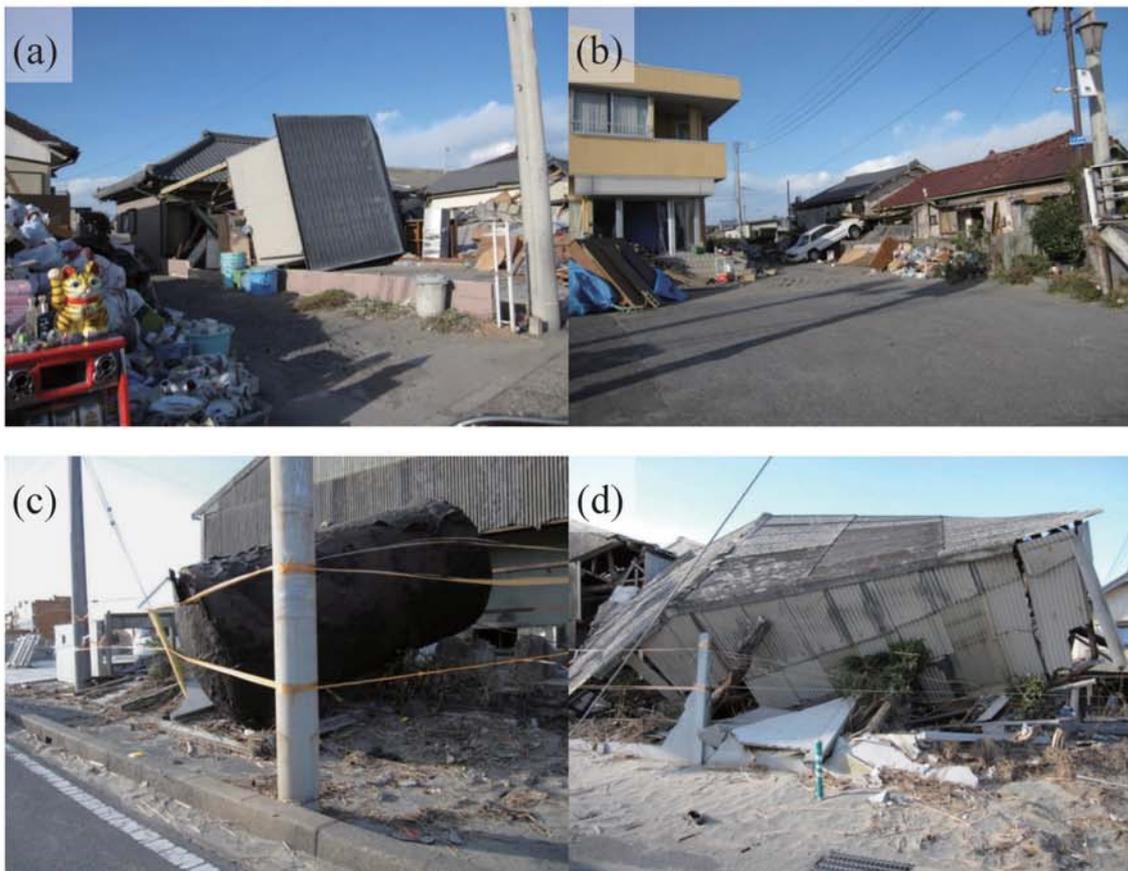
Fig. A298. (a)-(j) Damage at Hiramatsu.

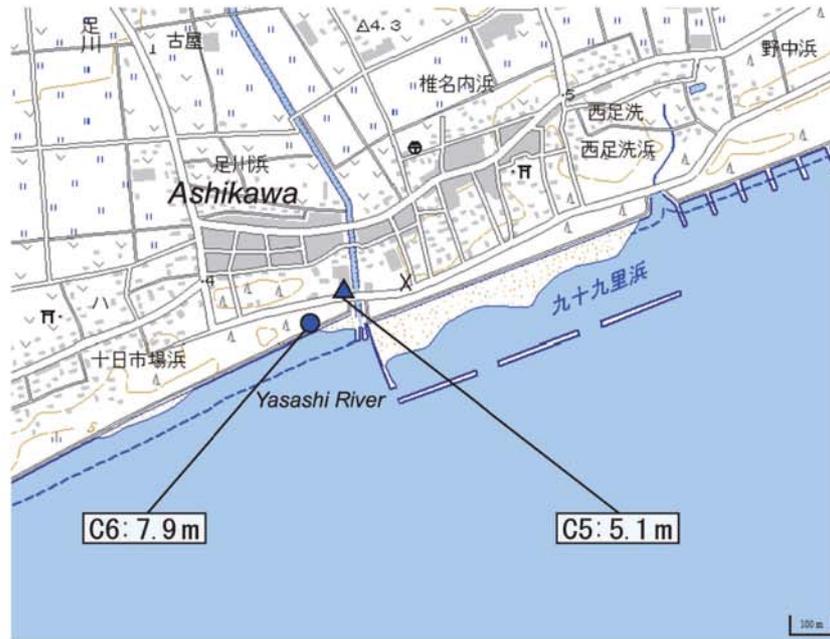
Fig. A299. Tsunami heights at Ashikawa, Asahi City, Chiba Prefecture (added with a digital topographic map at a scale of 1/25,000 from the Geospatial Information Authority of Japan). The symbols and their meanings are the same as in Fig. 6.

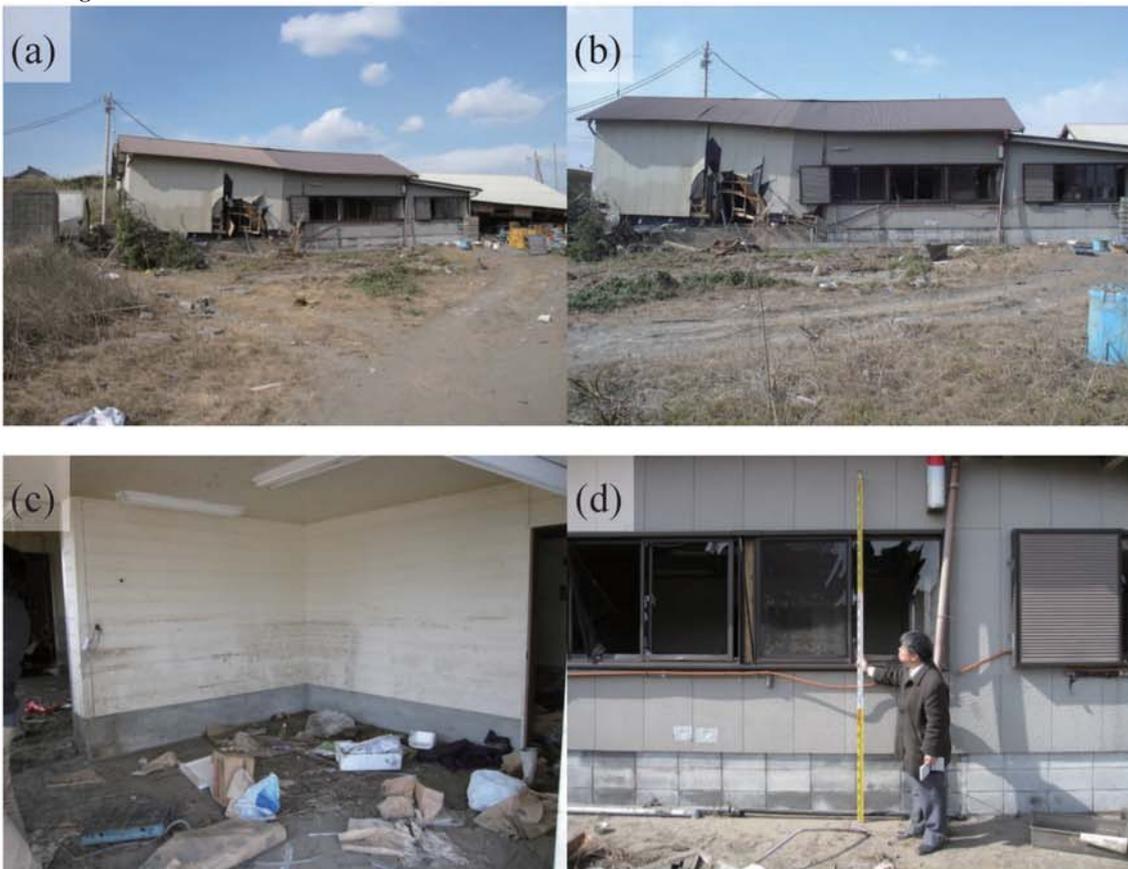
Fig. A302. (a)-(b) The building of a marine product-processing factory destroyed by the tsunami. (c)-(d) Watermark on a wall of a marine product-processing factory (1.94 m above ground level; C7).

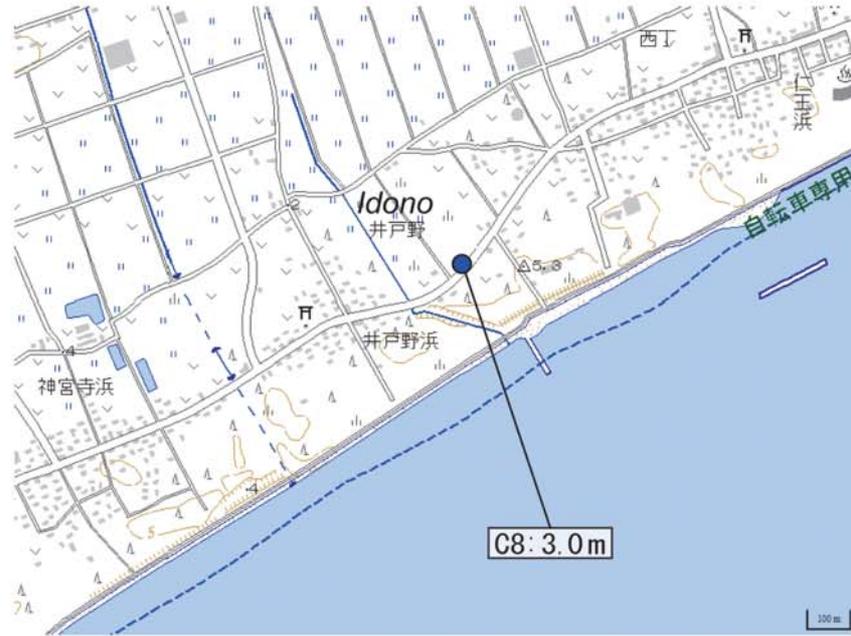
Fig. A303. Tsunami height at Idono, Asahi City, Chiba Prefecture (added with a digital topographic map at a scale of 1/25,000 from the Geospatial Information Authority of Japan). The symbol and its meaning are the same as in Fig. 6.

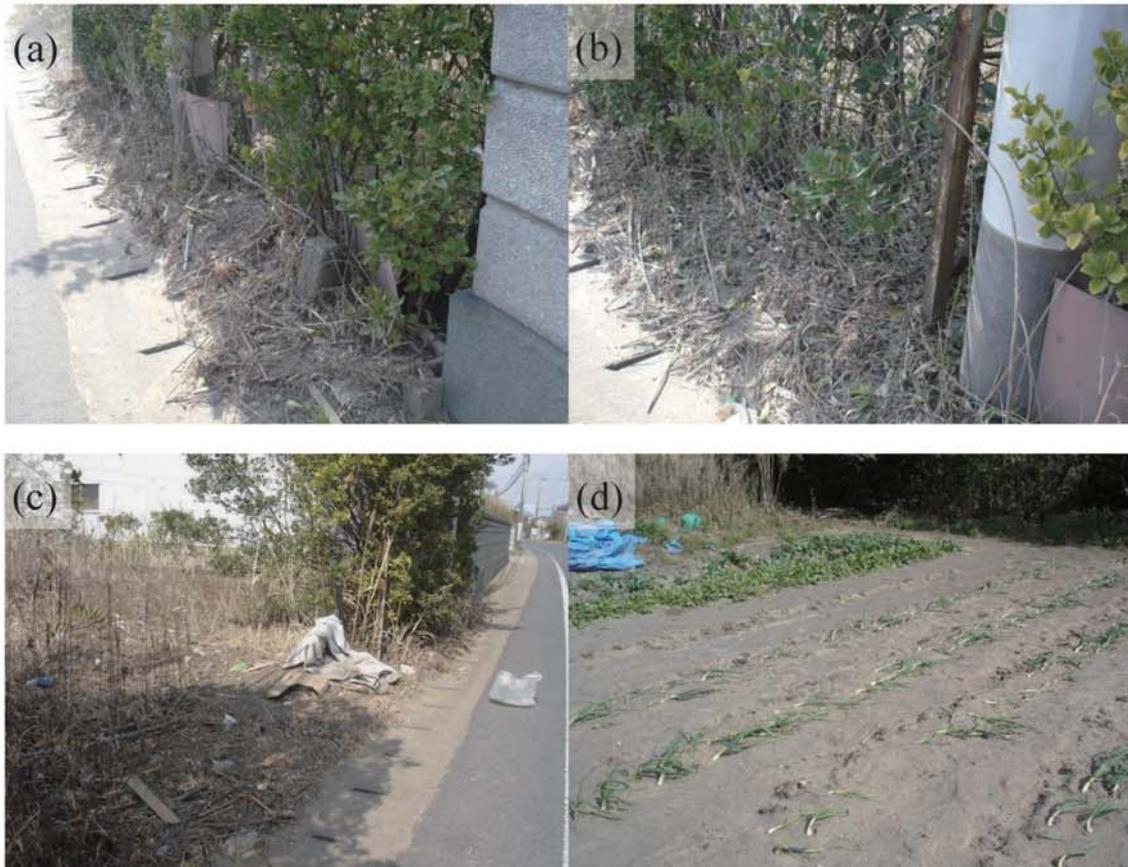
Fig. A304. (a)-(c) Tsunami trace survey point at a drift by the roadside (C8). (d) Leeks laid flat by backwash tsunami.

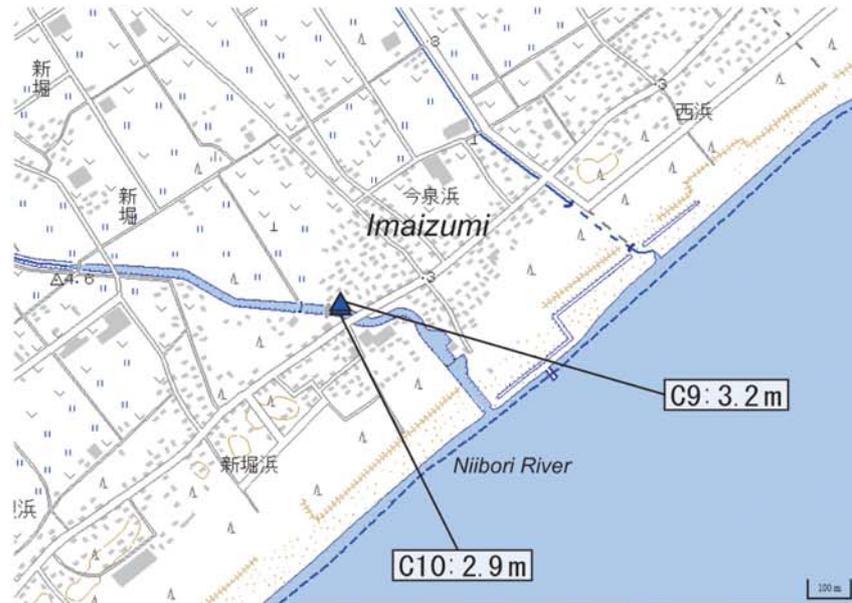
Fig. A305. Tsunami heights at Imaizumi, Sosa City, Chiba Prefecture (added with a digital topographic map at a scale of 1/25,000 from the Geospatial Information Authority of Japan). The symbols and their meanings are the same as in Fig. 6.

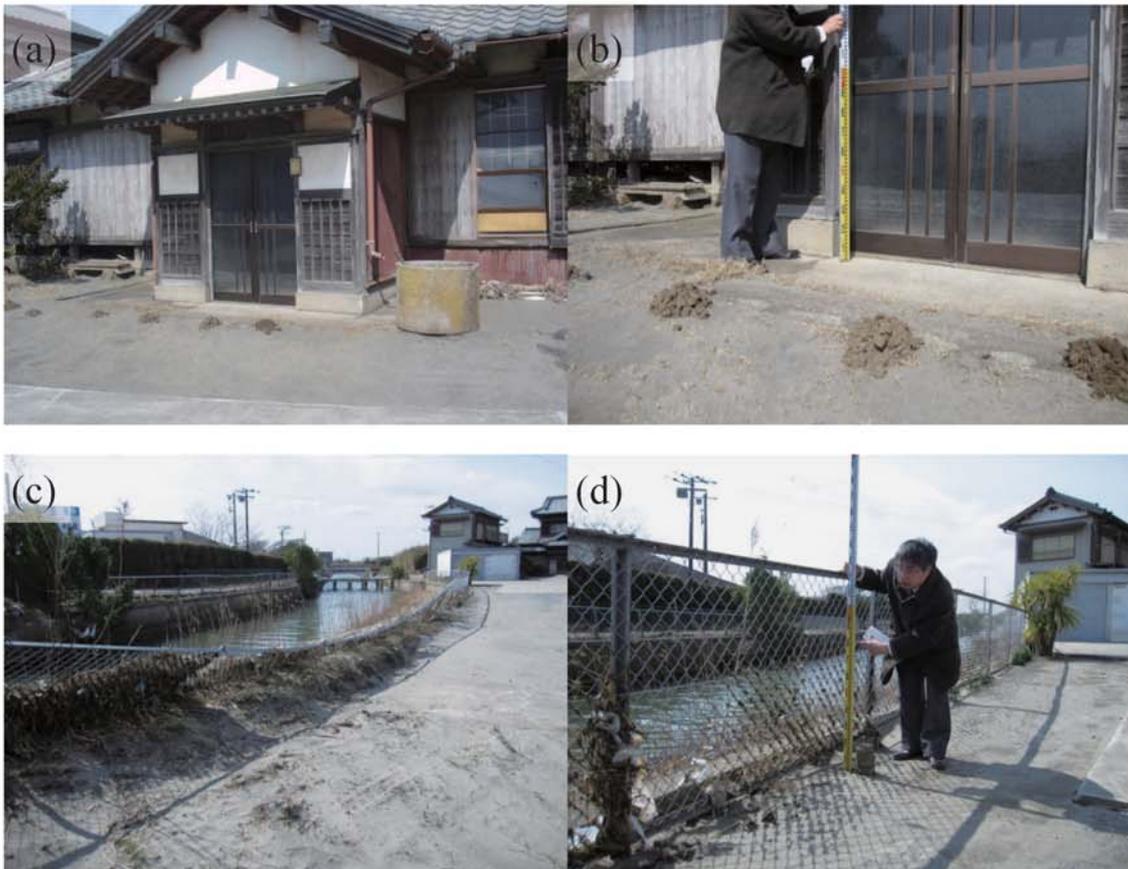
Fig. A306. (a)-(b) Watermark on the entrance sliding doors of Mr. Ui's house near the Niibori River (0.37 m above ground level; C9). (c)-(d) Glass and see glass attached to a fence along the Niibori River (0.76 m above ground level; C10).

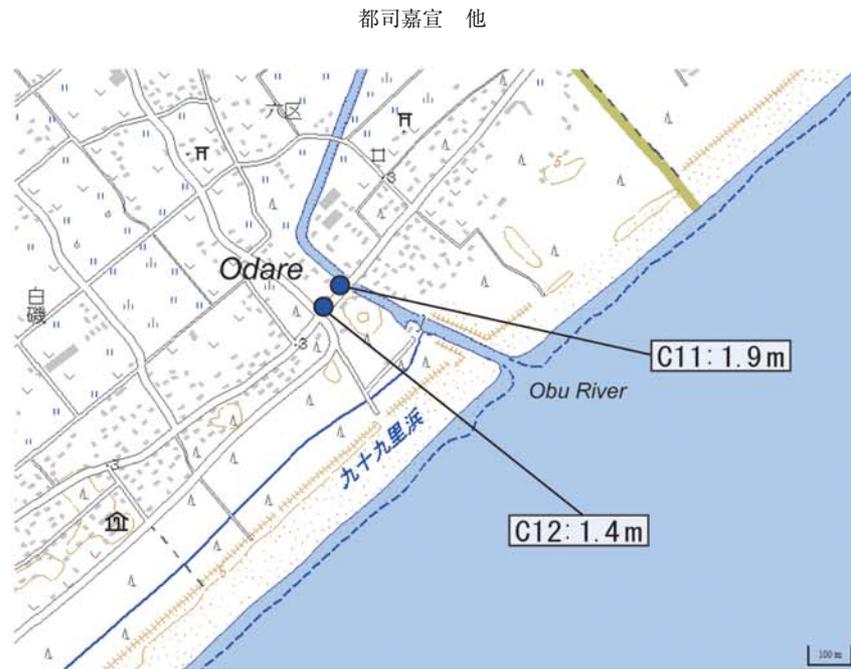
Fig. A307. Tsunami heights at Odare, Yokoshibahikari Town, Chiba Prefecture (added with a digital topographic map at a scale of 1/25,000 from the Geospatial Information Authority of Japan). The symbols and their meanings are the same as in Fig. 6.

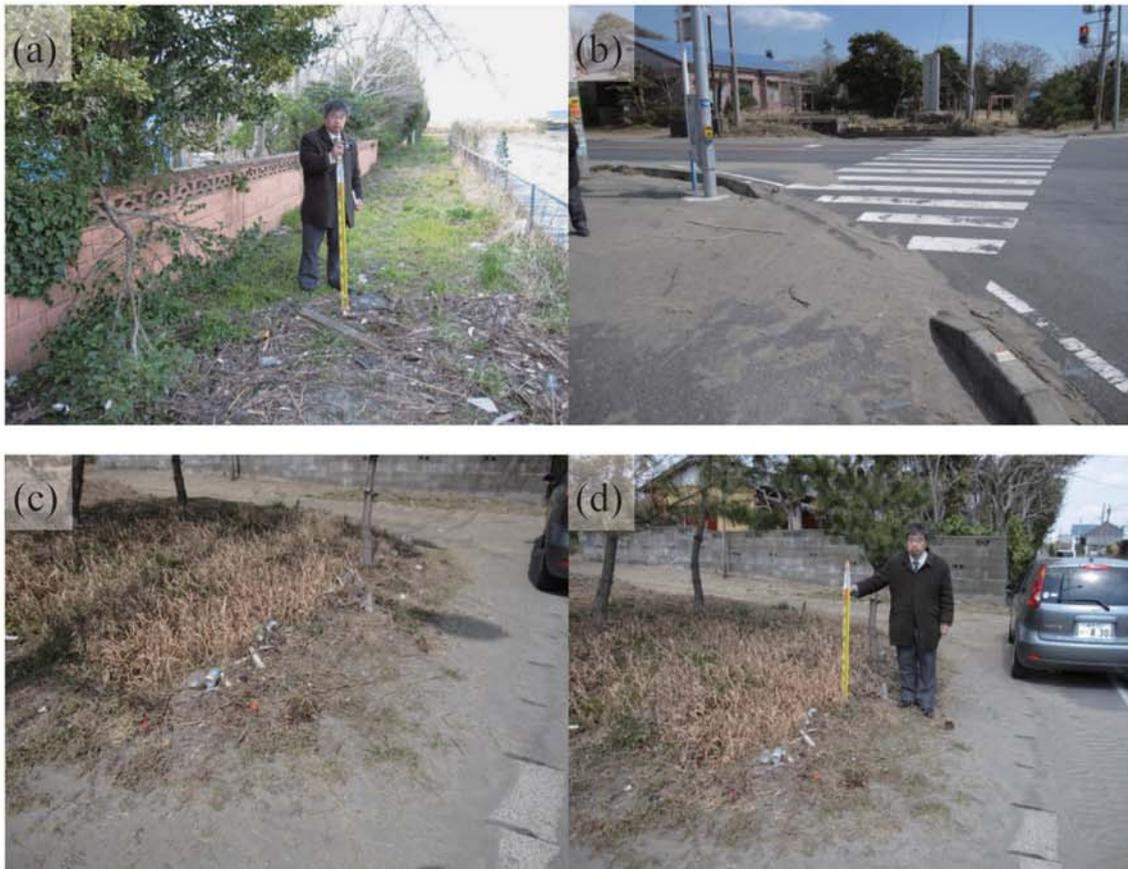
Fig. A308. (a) Tsunami trace survey point at a drift along the Obu river (C11). (b)-(d) Tsunami trace survey point at a drift by the roadside (C12).

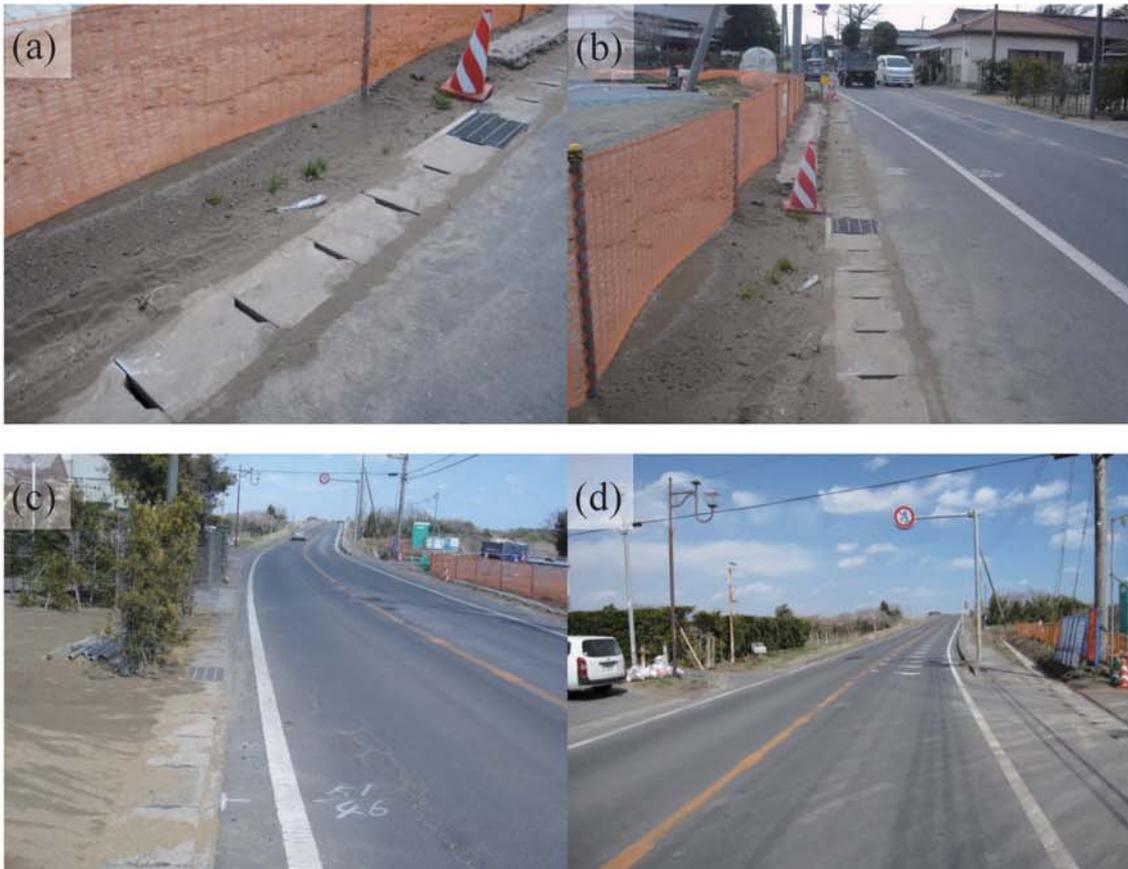
Fig. A310. (a)-(d) Tsunami trace survey point at a drift along a road (C13).

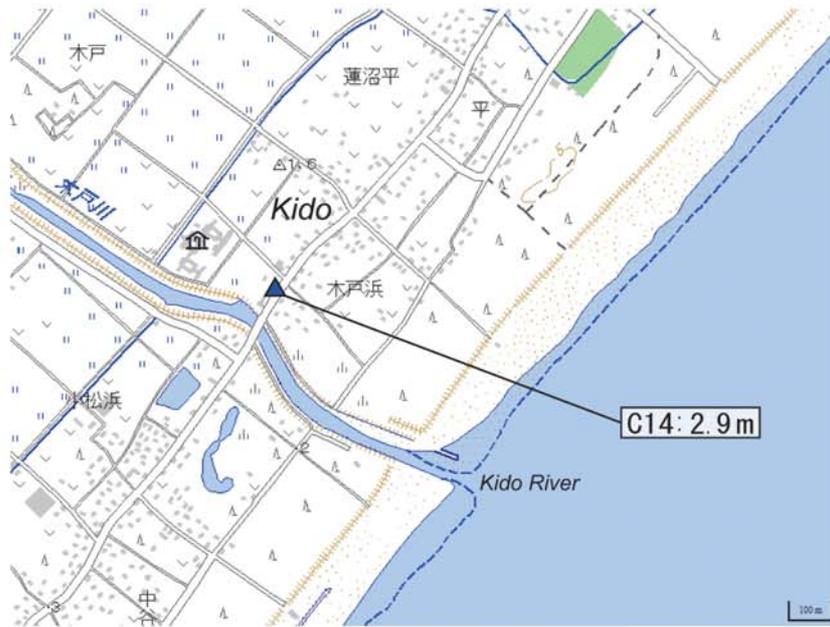
Fig. A311. Tsunami height at Kido, Sammu City, Chiba Prefecture (added with a digital topographic map at a scale of 1/25,000 from the Geospatial Information Authority of Japan). The symbol and its meaning are the same as in Fig. 6.

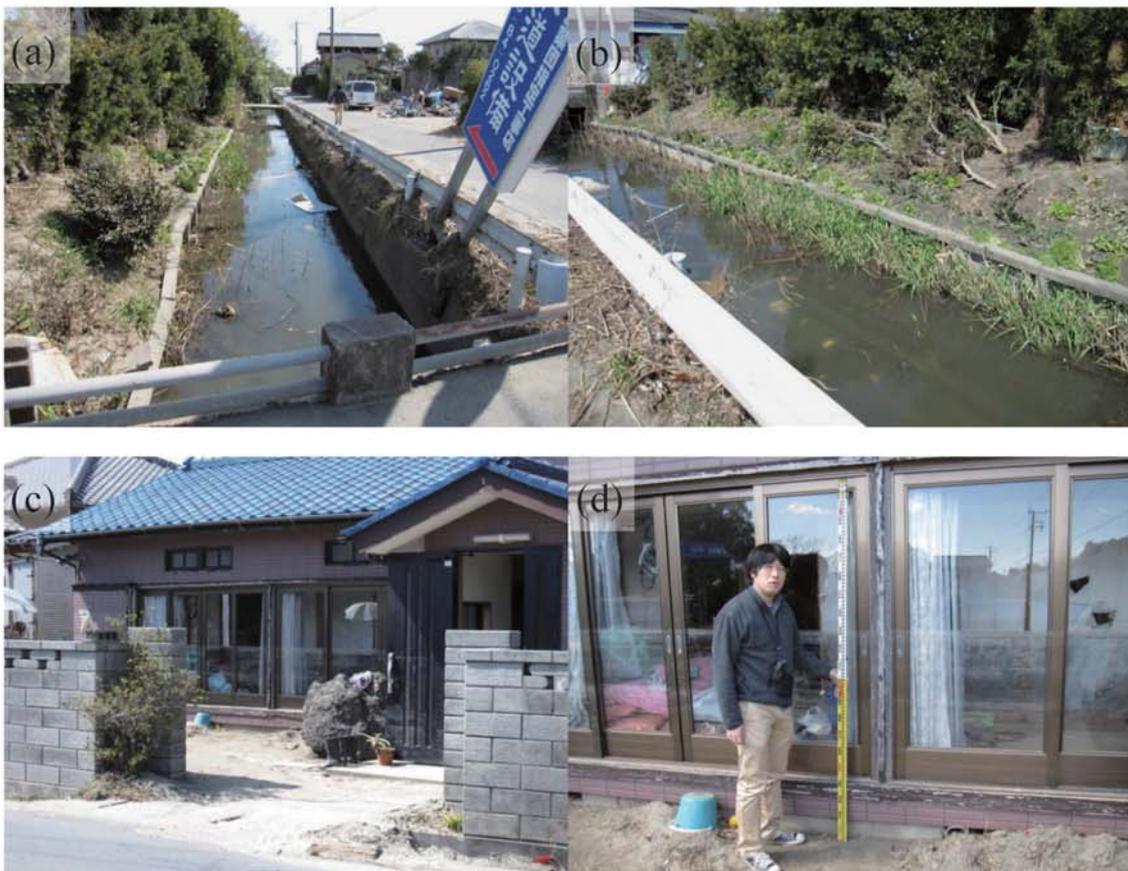
Fig. A312. (a)-(b) Damage due to tsunami run-up through the flume. (c)-(d) Watermark on windowpanes of Mr. Uchida's house (1.27 m above ground level; C14).

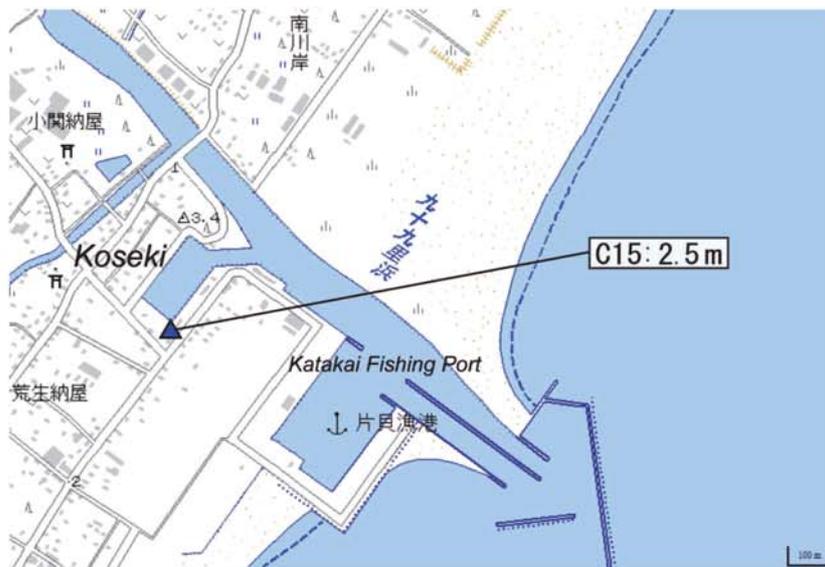
Fig. A313. Tsunami height at Koseki (Katakai Fishing Port), Kujukuri Town, Chiba Prefecture (added with a digital topographic map at a scale of 1/25,000 from the Geospatial Information Authority of Japan). The symbol and its meaning are the same as in Fig. 6.

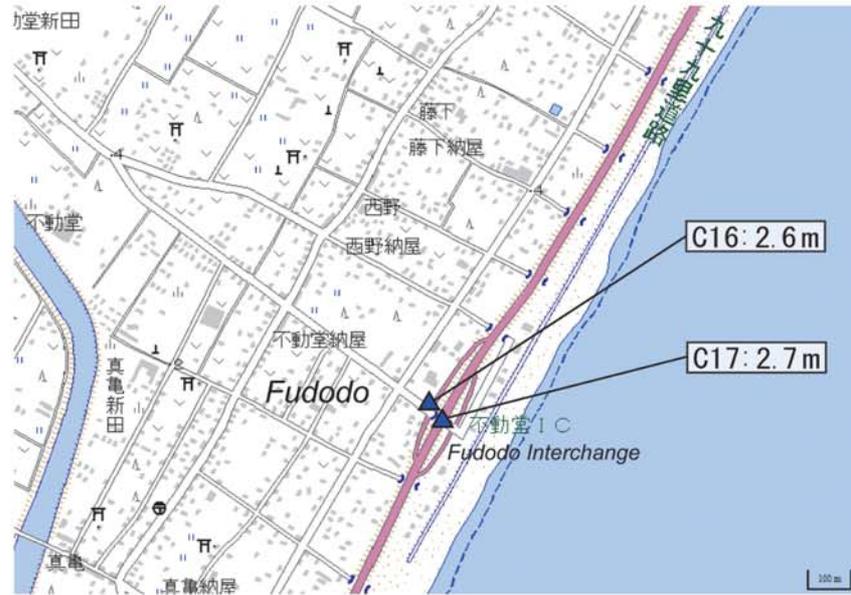
Fig. A315. Tsunami heights at Fudodo, Kujukuri Town, Chiba Prefecture (added with a digital topographic map at a scale of 1/25,000 from the Geospatial Information Authority of Japan). The symbols and their meanings are the same as in Fig. 6.

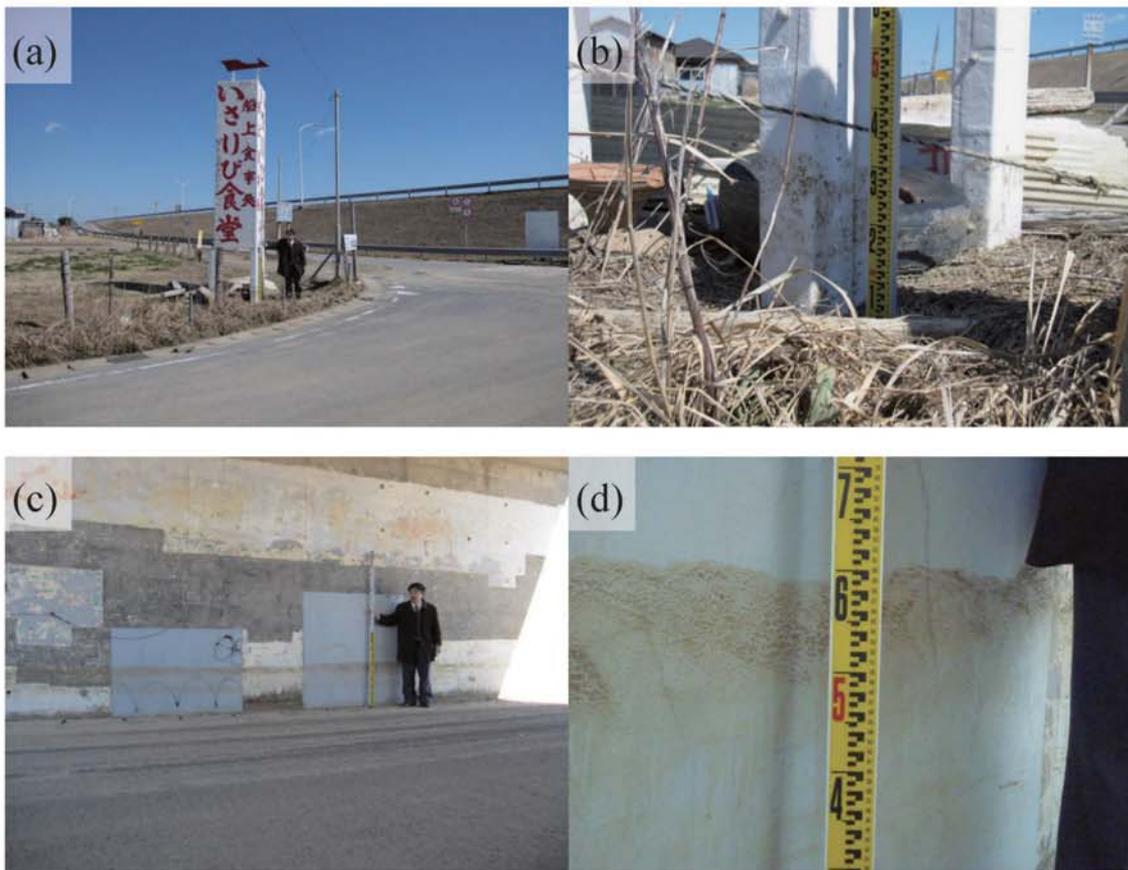
Fig. A316. (a)-(b) Watermark on the prop of a signboard (0.29 m above ground level; C16). (c)-(d) Watermark in a tunnel under Kujukuri tollway (0.56 m above ground level; C17).

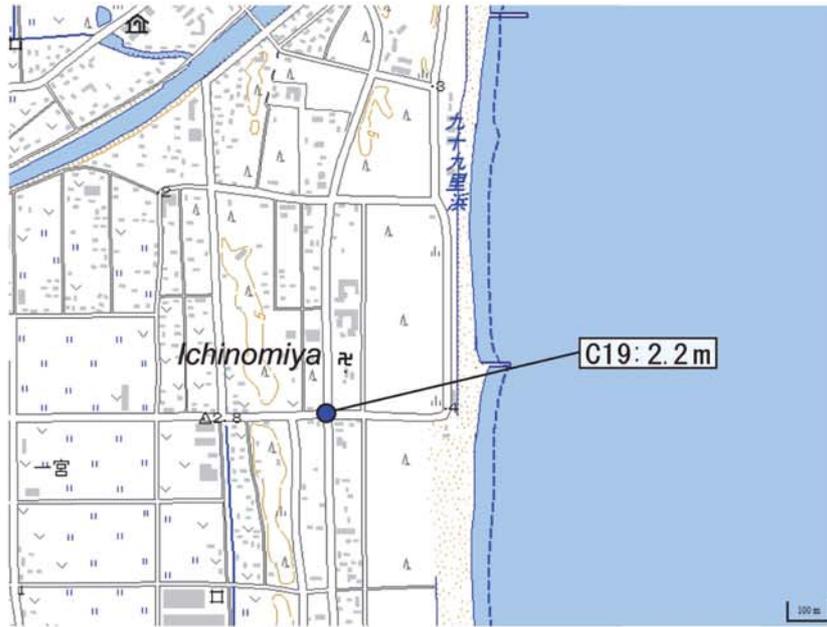
Fig. A319. Tsunami height at Ichinomiya, Ichinomiya Town, Chiba Prefecture (added with a digital topographic map at a scale of 1/25,000 from the Geospatial Information Authority of Japan). The symbol and its meaning are the same as in Fig. 6.

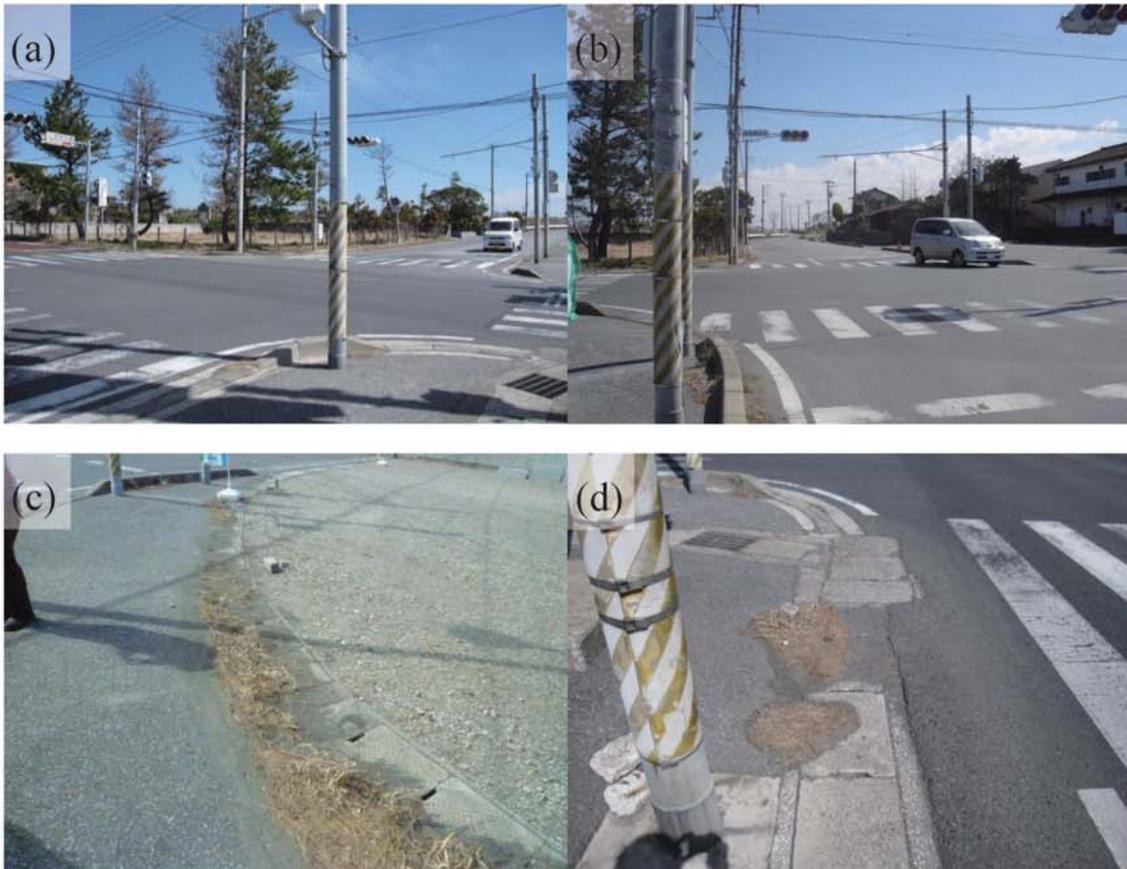
Fig. A320. (a)-(b) Crossroads inundated by the tsunami at Ichinomiya. (c)-(d) Tsunami trace survey point at a drift close to the crossroads (C19).

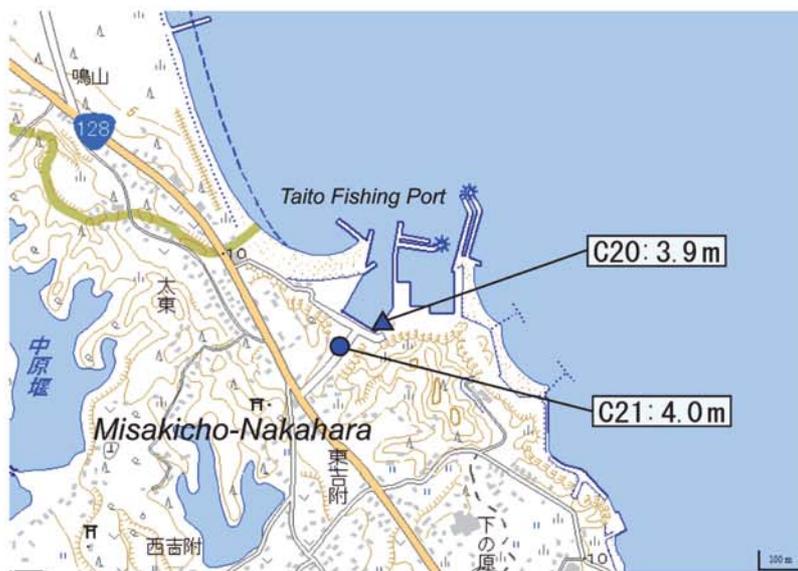
Fig. A321. Tsunami heights at Misakicho-Nakahara (Taito Fishing Port), Isumi City, Chiba Prefecture (added with a digital topographic map at a scale of 1/25,000 from the Geospatial Information Authority of Japan). The symbols and their meanings are the same as in Fig. 6.

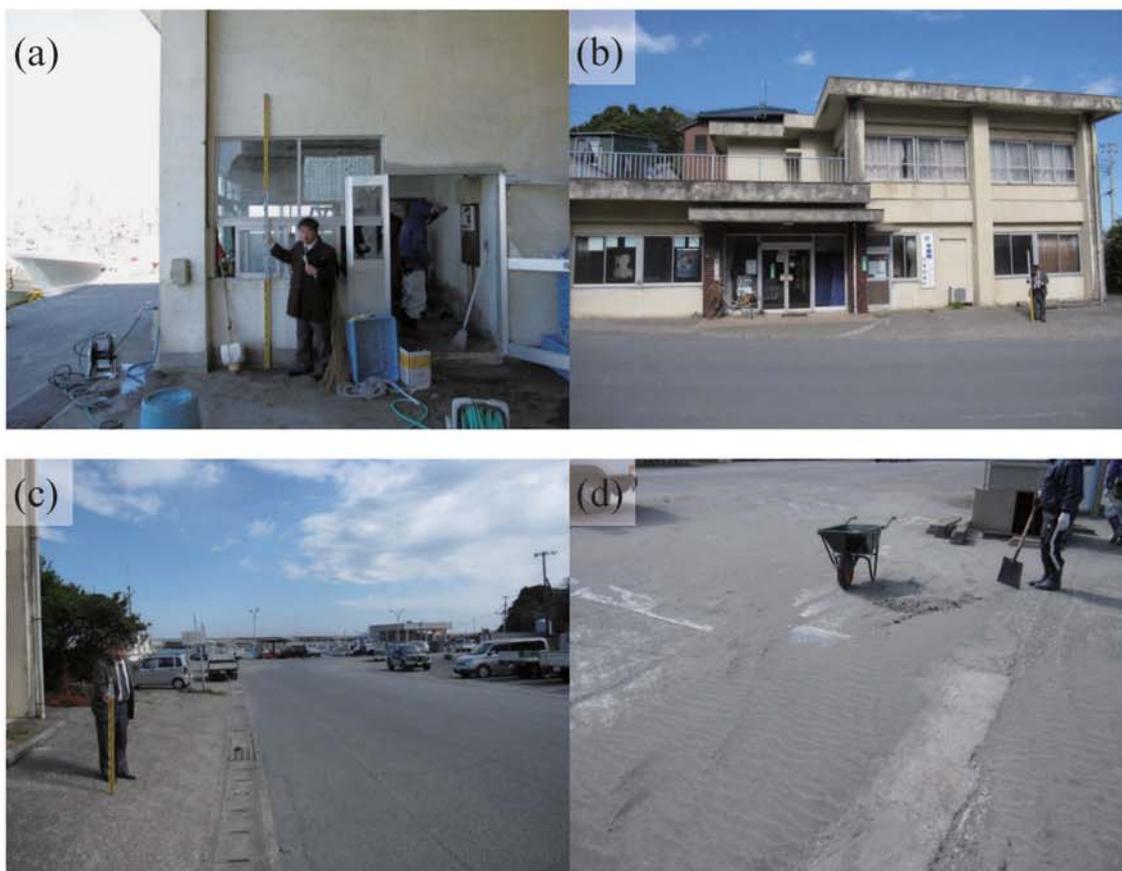
Fig. A322. (a) Watermark on windowpanes of fishery market office building (2.15m above ground level; C20) (b)-(c) Tsunami inundation limit at a slope in front of the Isumitobu fishery association building (Taito affiliate)(C21). (d) Sand deposit carried by the tsunami in Taito Fishing Port.

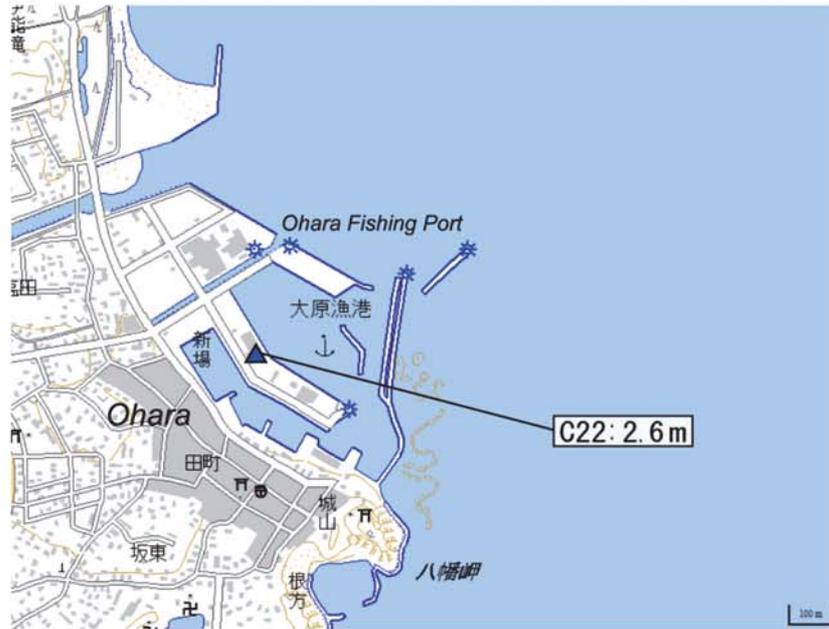
Fig. A323. Tsunami height at Ohara (Ohara Fishing Port), Isumi City, Chiba Prefecture (added with a digital topographic map at a scale of 1/25,000 from the Geospatial Information Authority of Japan). The symbol and its meaning are the same as in Fig. 6.

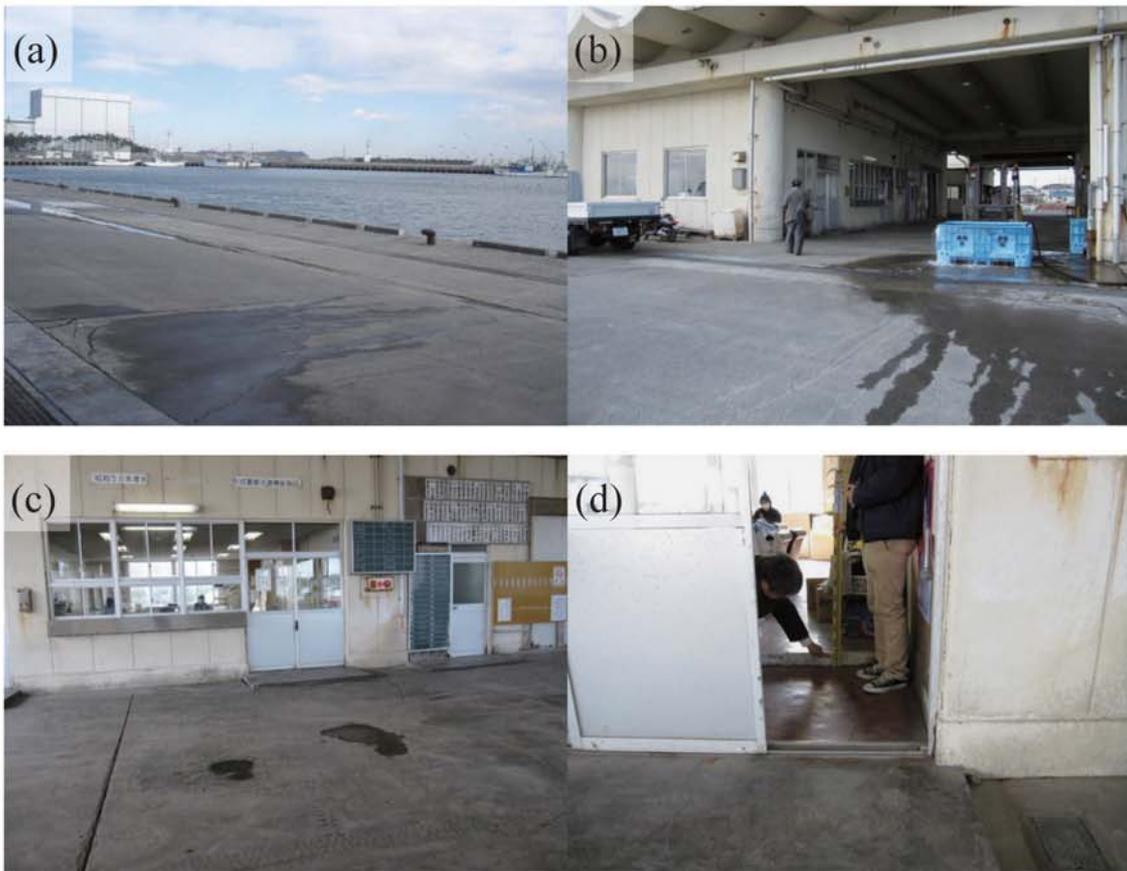
Fig. A324. (a)-(c) Ohara Fishing Port. (d) Tsunami trace survey point at the entrance of Isumitobu fishery association office (C22).

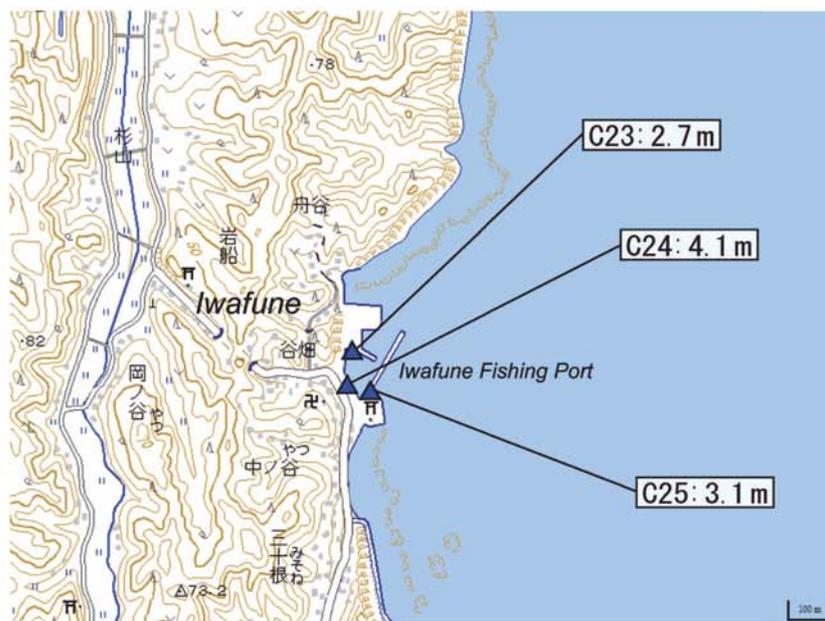
Fig. A325. Tsunami heights at Iwafune (Iwafune Fishing Port), Isumi City, Chiba Prefecture (added with a digital topographic map at a scale of 1/25,000 from the Geospatial Information Authority of Japan). The symbols and their meanings are the same as in Fig. 6.

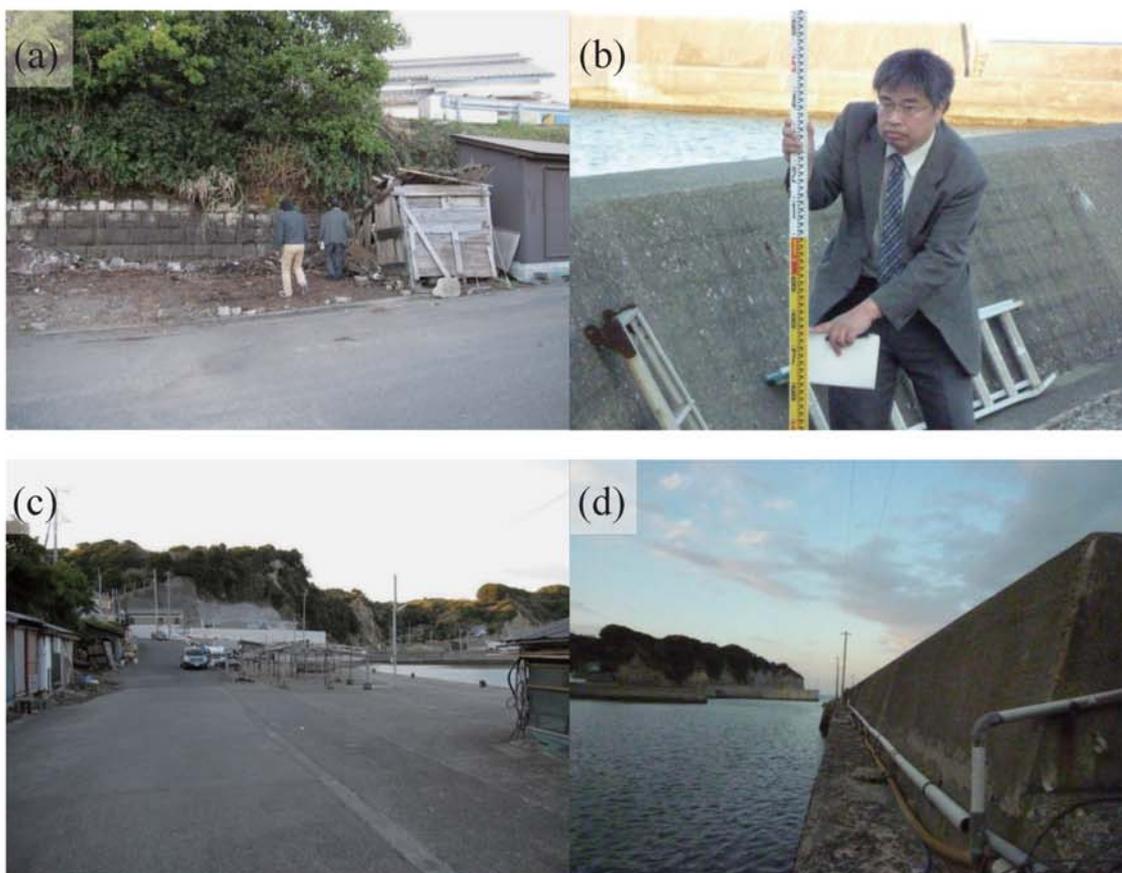
Fig. A326. (a) Damage at Iwafune Fishing Port. (b) Aluminum ladder inundated by the tsunami (C23). (c) Framework of shack inundated by the tsunami (C24). (d) Pipe completely inundated by the tsunami (C25).

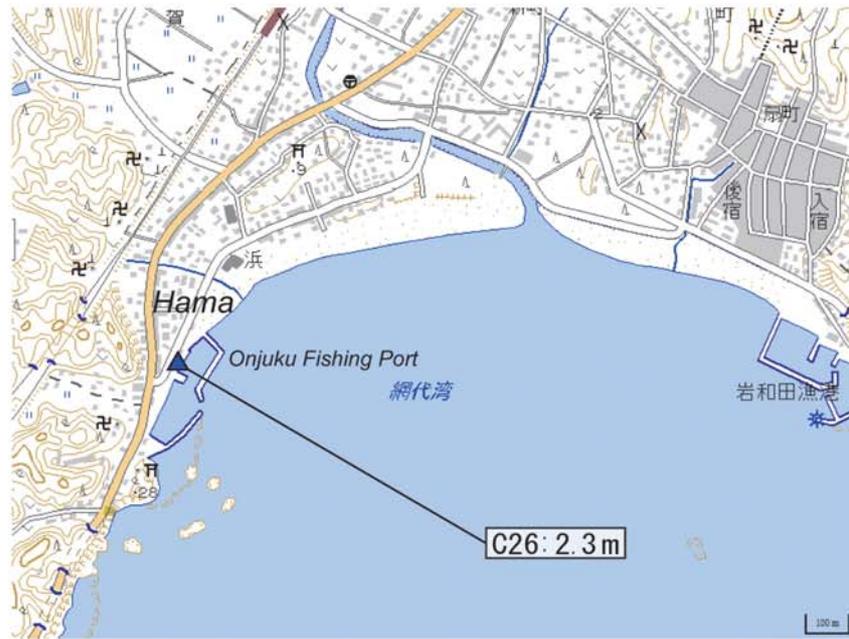
Fig. A327. Tsunami height at Hama (Onjuku Fishing Port), Onjuku Town, Chiba Prefecture (added with a digital topographic map at a scale of 1/25,000 from the Geospatial Information Authority of Japan). The symbol and its meaning are the same as in Fig. 3.

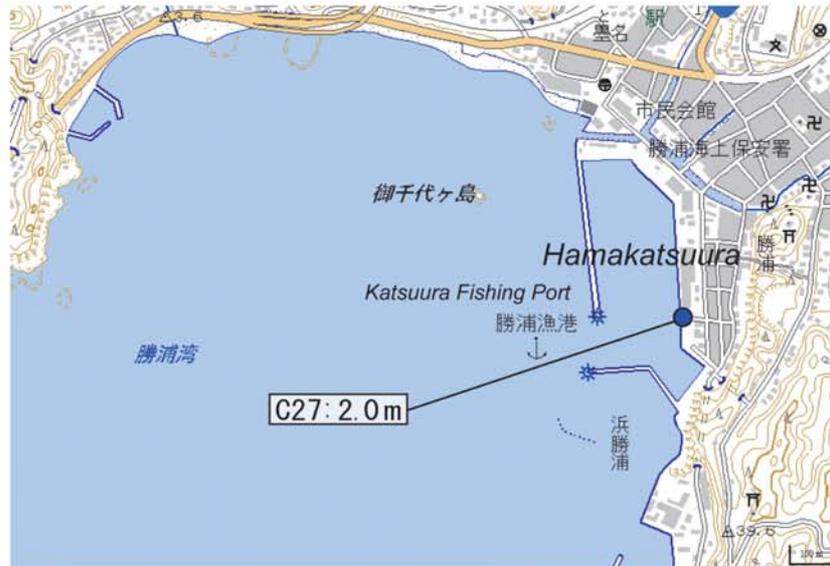
Fig. A329. Tsunami height at Hamakatsuura (Katsuura Fishing Port), Katsuura City, Chiba Prefecture (added with a digital topographic map at a scale of 1/25,000 from the Geospatial Information Authority of Japan). The symbol and its meaning are the same as in Fig. 6.

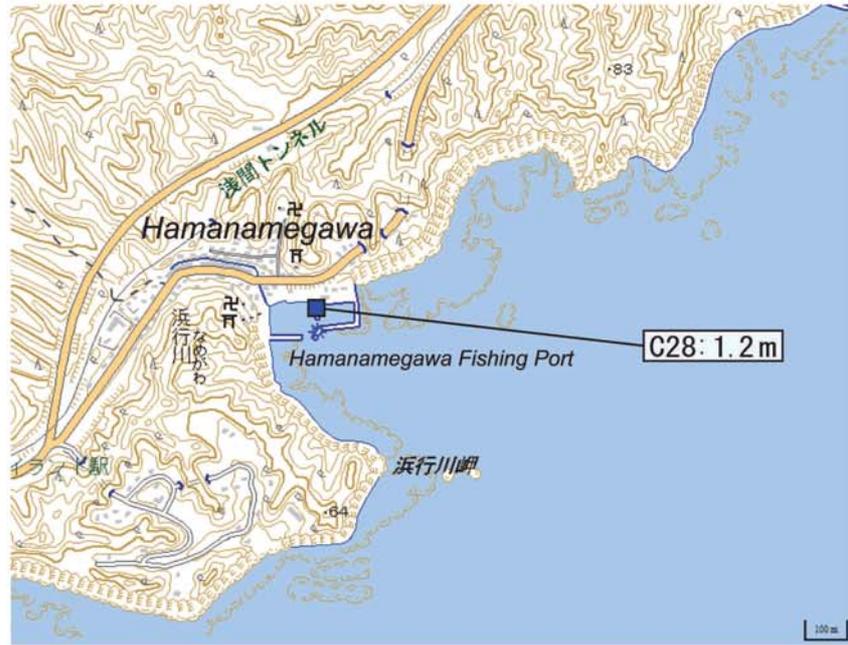
Fig. A331. Tsunami height at Hamanamegawa (Hamanamegawa Fishing Port), Katsuura City, Chiba Prefecture (added with a digital topographic map at a scale of 1/25,000 from the Geospatial Information Authority of Japan). The symbol and its meaning are the same as in Fig. 6.

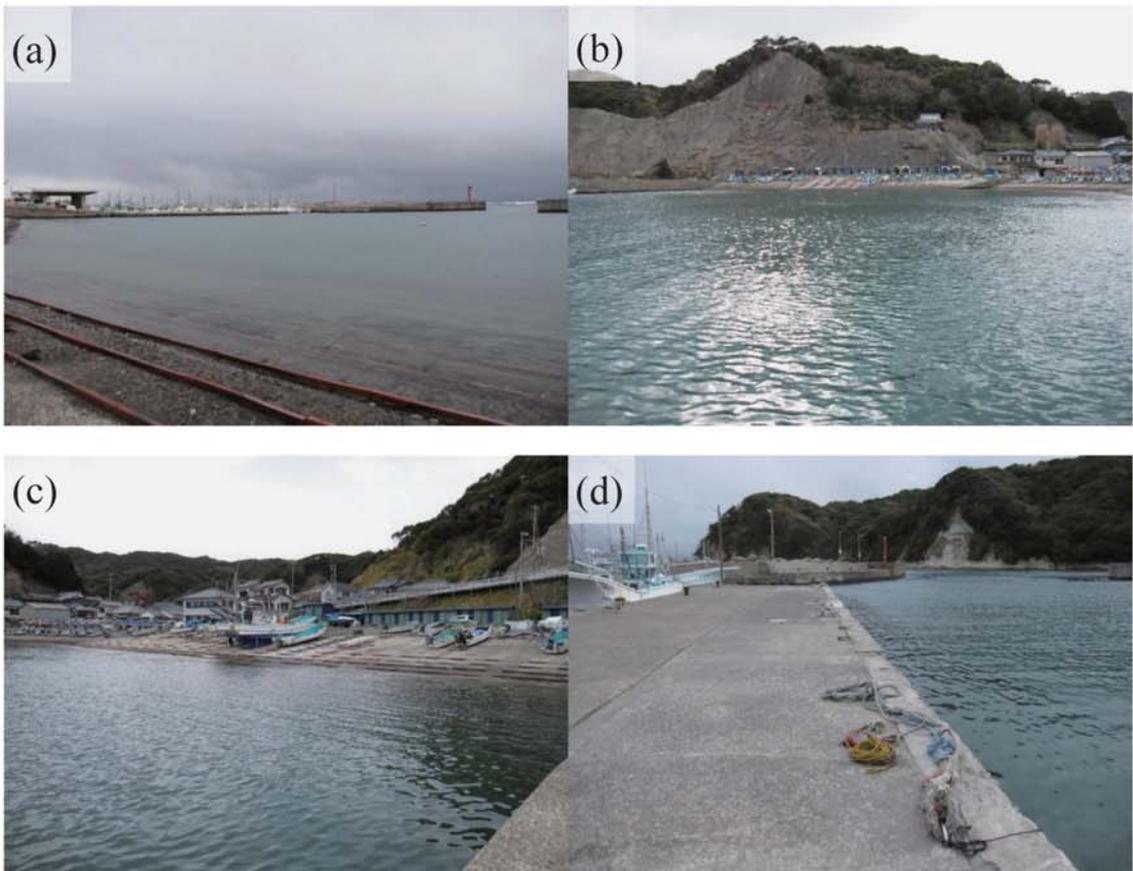
Fig. A332. (a)-(c) Hamanamegawa Fishing Port. (d) Tsunami trace survey point at the top of a quay (C28).

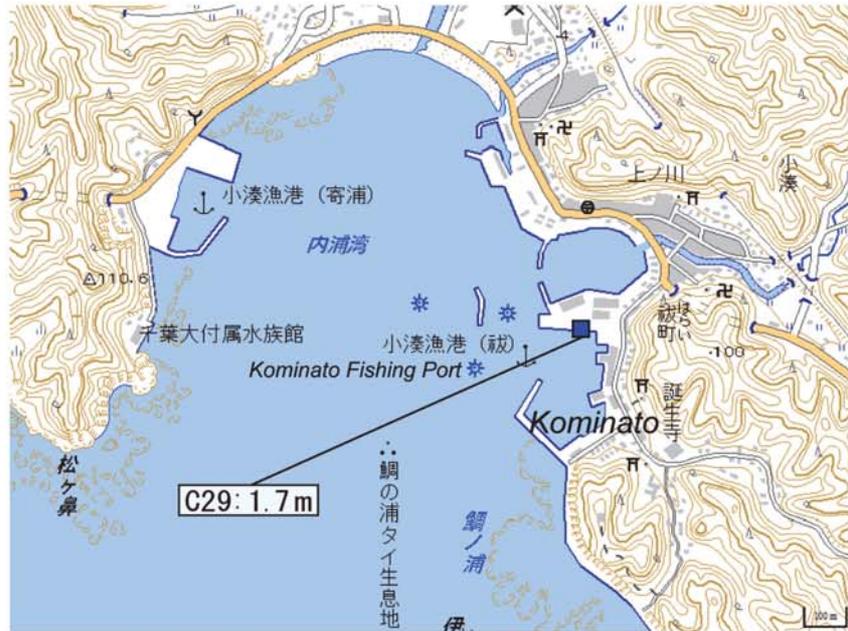
Fig. A333. Tsunami height at Kominato (Kominato Fishing Port), Kamogawa City, Chiba Prefecture (added with a digital topographic map at a scale of 1/25,000 from the Geospatial Information Authority of Japan). The symbol and its meaning are the same as in Fig. 6.

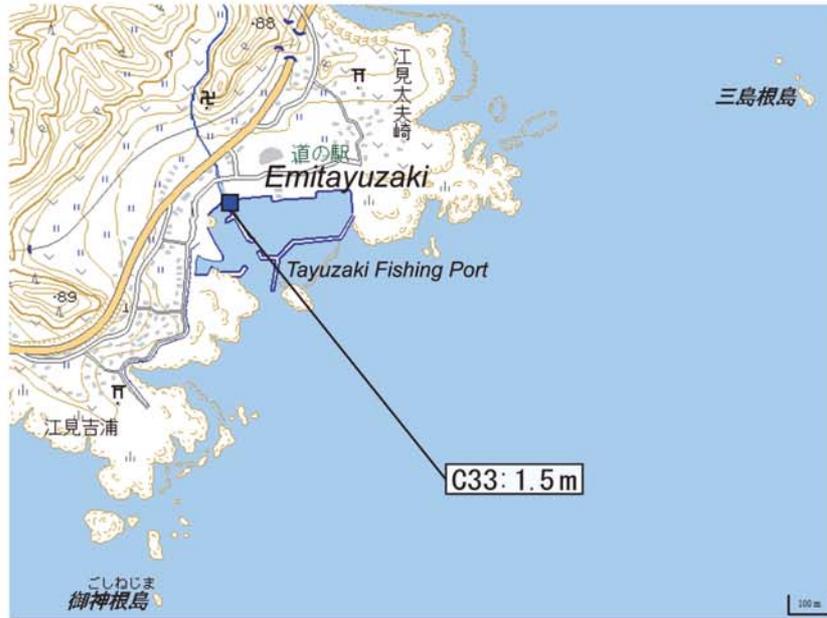
Fig. A339. Tsunami height at Emitayuzaki (Tayuzaki Fishing Port), Kamogawa City, Chiba Prefecture (added with a digital topographic map at a scale of 1/25,000 from the Geospatial Information Authority of Japan). The symbol and its meaning are the same as in Fig. 6.
