2011年東北地方太平洋沖地震の津波高調査

Field Surveys of Tsunami Heights from the 2011 off the Pacific Coast of Tohoku, Japan Earthquake

We report the results of field surveys conducted by the Earthquake Research Institute, to measure tsunami heights from the 2011 off the Pacific coast of Tohoku, Japan Earthquake (M 9.0), on March 11. Measurements were taken at 296 points on the Sanriku coasts of Aomori, Iwate, and Miyagi Prefectures, and the Pacific coasts of Ibaraki and Chiba Prefectures. The data are included in the results of the 2011 Tohoku Earthquake Tsunami Joint Survey Group. We did not cover the Sendai plain in the southern Miyagi Prefecture because other parties extensively measure there, nor Fukushima Prefecture because of the accident of the Fukushima Dai-ichi nuclear power plant. The twelve surveys first sought traces indicating tsunami runup or inundation heights. Reliability was classified into A (most reliable based on clear physical evidence and eyewitness accounts), B (mostly based on natural traces), and C (least reliable based on equivocal evidence). Most physical evidence obtained after June was not significant; therefore, reliance was mostly placed on eyewitness accounts. Loc

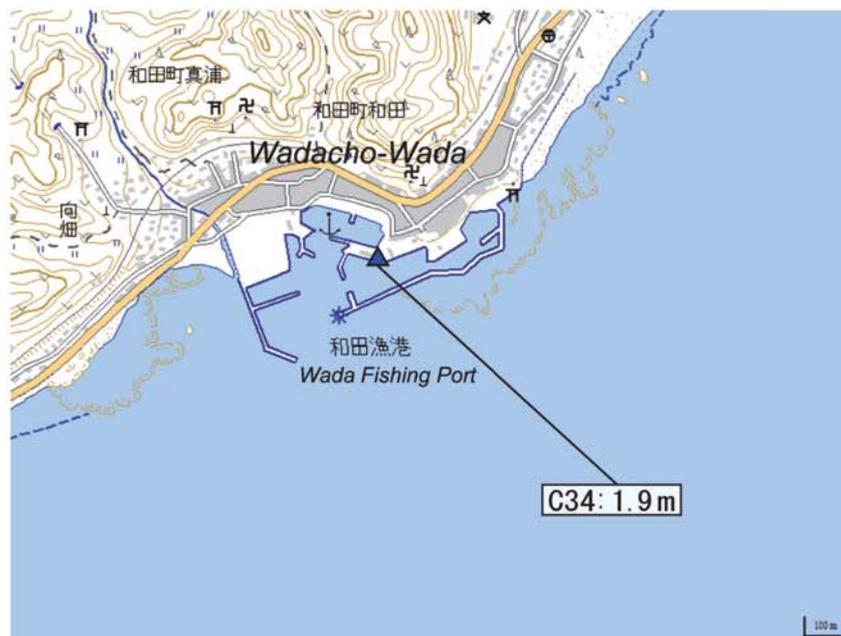
Fig. A341. Tsunami height at Wadacho-Wada (Wada Fishing Port), Minamiboso City, Chiba Prefecture (added with a digital topographic map at a scale of 1/25,000 from the Geospatial Information Authority of Japan). The symbol and its meaning are the same as in Fig. 6.

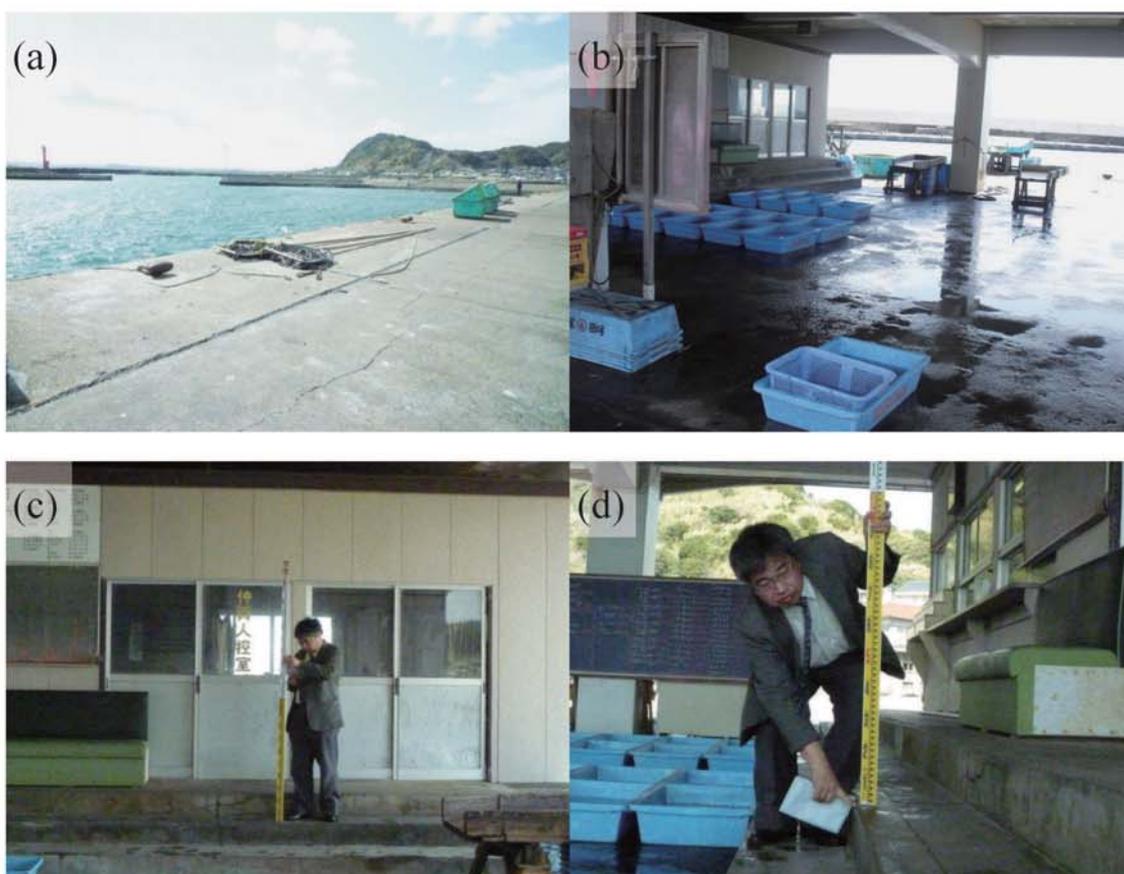
Fig. A342. (a) Wada Fishing Port. (b)-(d) Tsunami trace survey point at the second step of stairs in front of Wada Fishing Port office (C34).

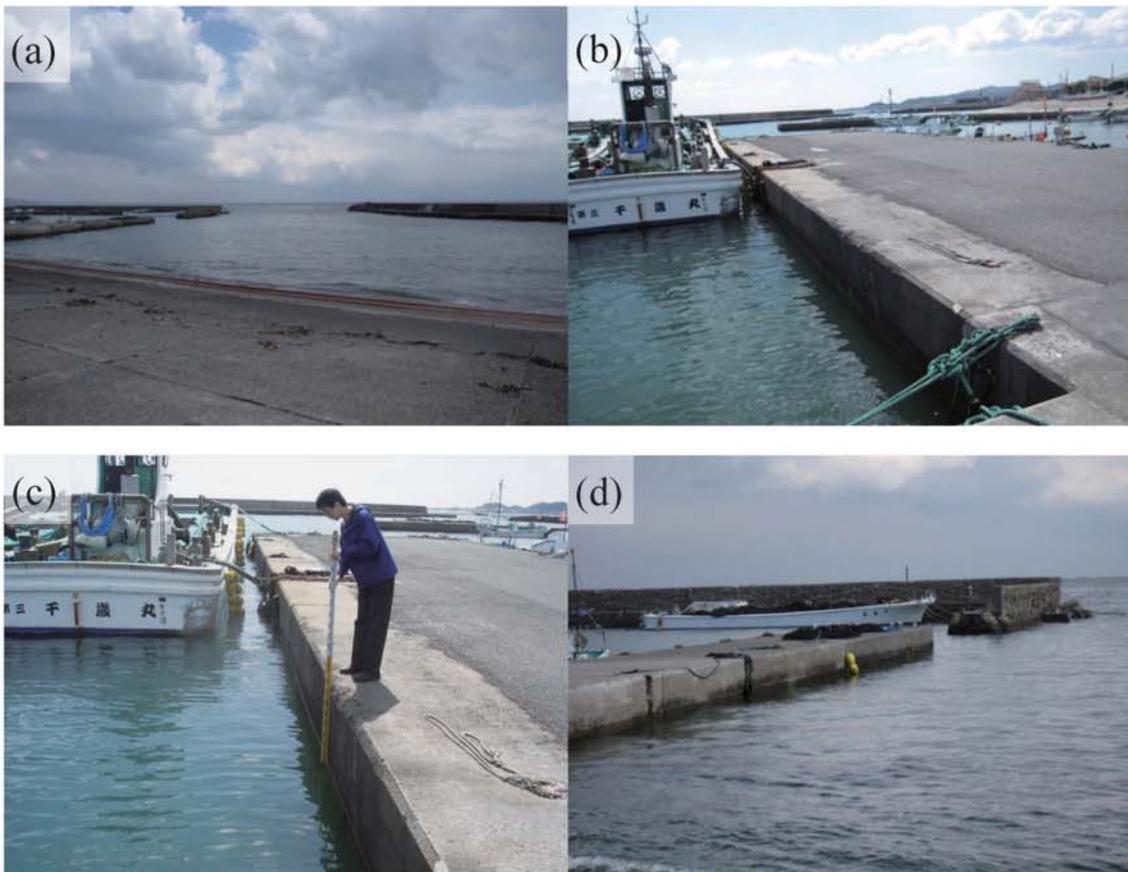
Fig. A344. (a) The Shirako Fishing Port. (b)-(c) Tsunami trace survey point at the top of a quay (C35). (d) The yellow buoys show the upper limit of the Tsunami height at the port (C36).

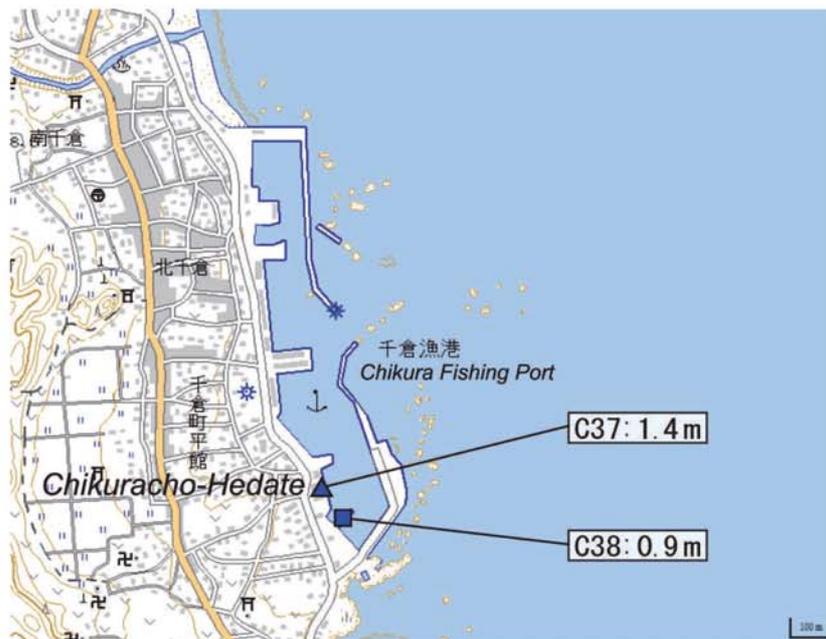
Fig. A345. Tsunami heights at Chikuracho-Hedate (Chikura Fishing Port), Minamiboso City, Chiba Prefecture (added with a digital topographic map at a scale of 1/25,000 from the Geospatial Information Authority of Japan). The symbols and their meanings are the same as in Fig. 6.

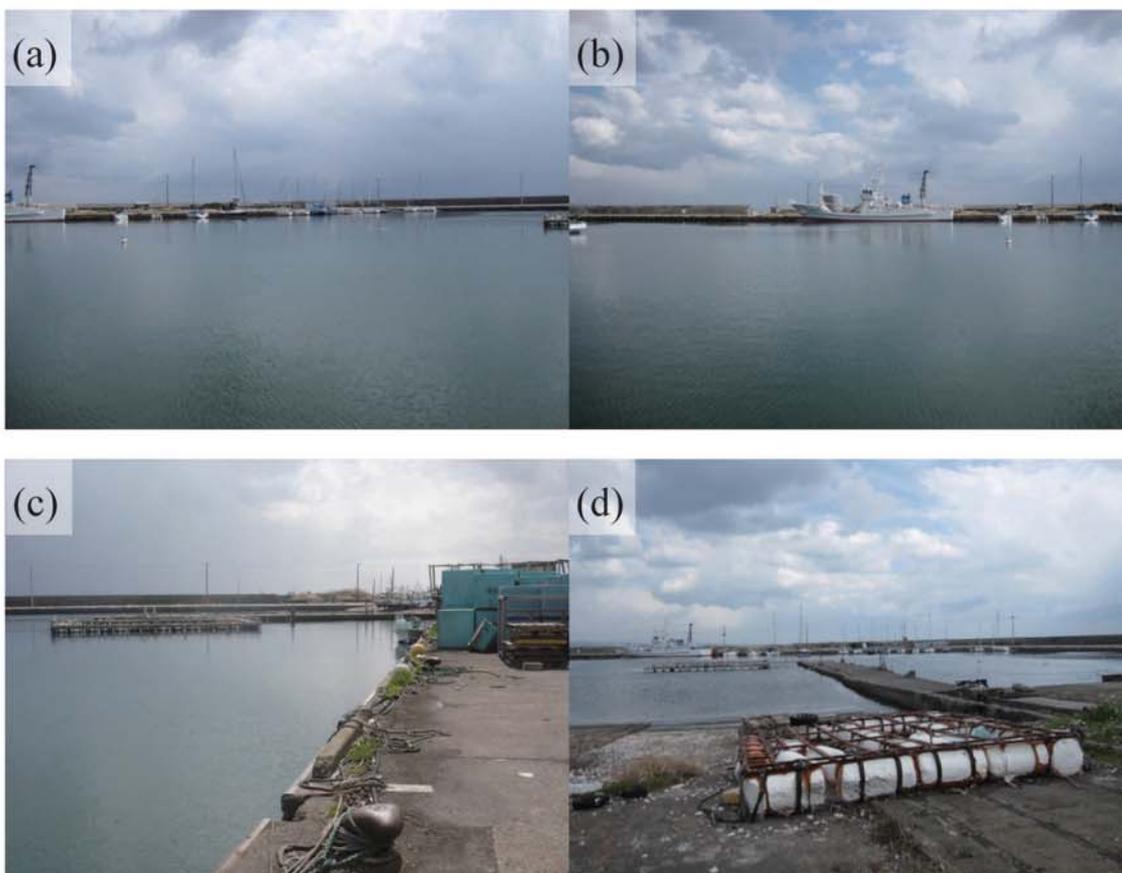
Fig. A346. (a)-(b) Chikura Fishing Port. (c) Quay inundated by the tsunami to a small depth (C37). (d) The other quay with a height equivalent to the Tsunami height at the port (C38).

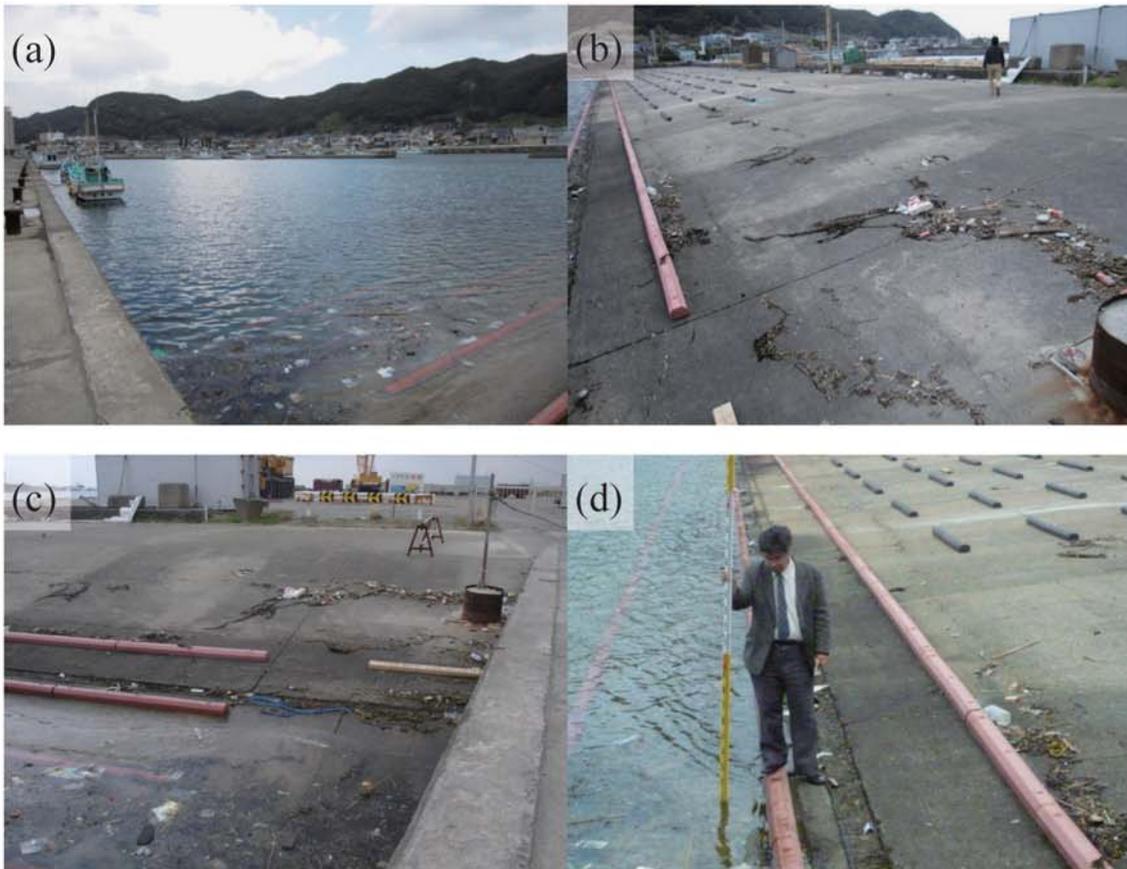
Fig. A348. (a) The Otohama Fishing Port. (b)-(d) Debris on a slope carried by the tsunami (C39).

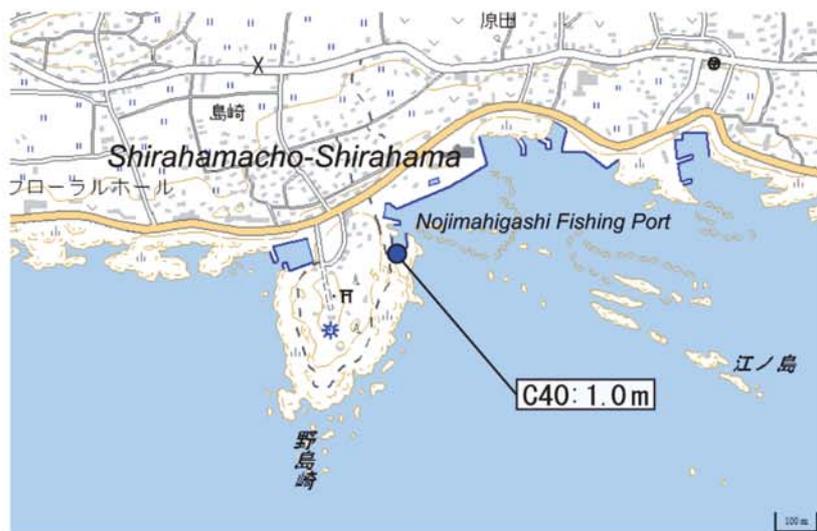
Fig. A349. Tsunami height at Shirahamacho-Shirahama (Nojimahigashi Fishing Port), Minamiboso City, Chiba Prefecture (added with a digital topographic map at a scale of 1/25,000 from the Geospatial Information Authority of Japan). The symbol and its meaning are the same as in Fig. 6.

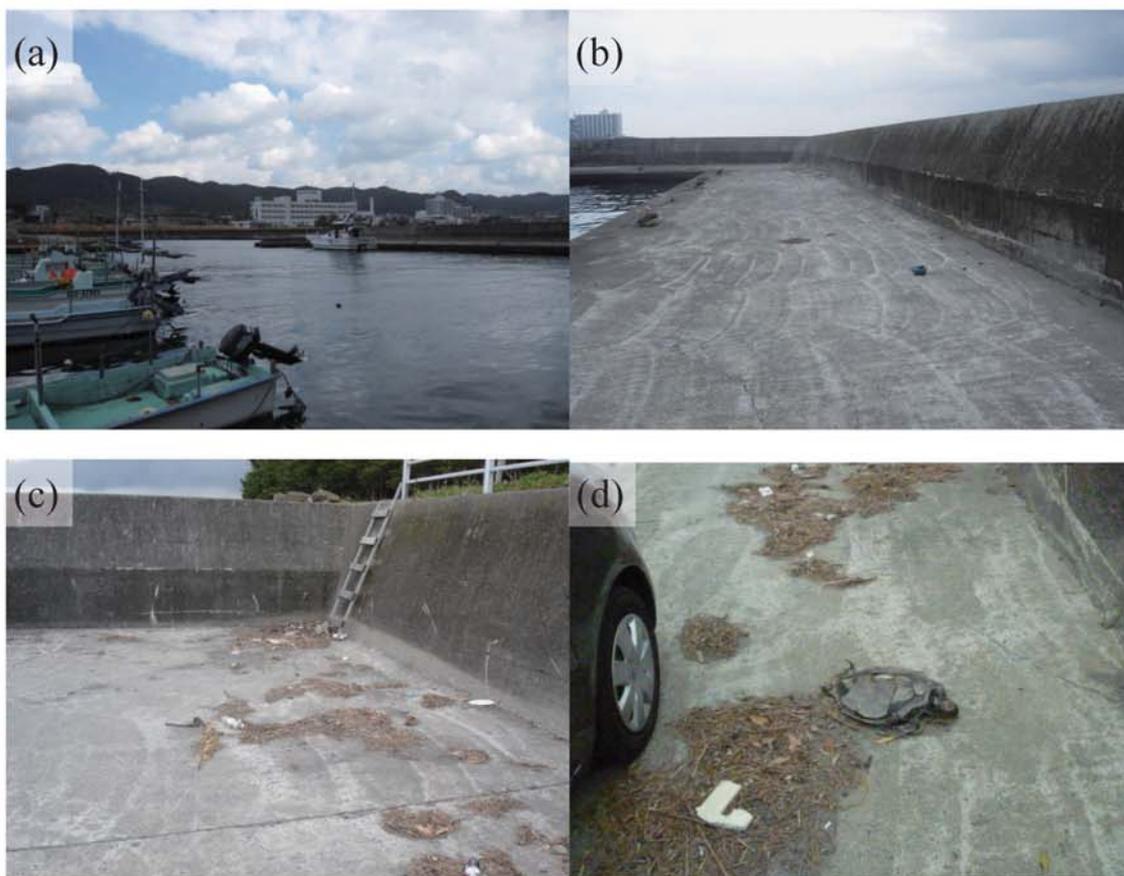
Fig. A350. (a) Nojimahigashi Fishing Port. (b)-(d) Garbage and carcasses including a turtle on the quay carried by the tsunami (C40).

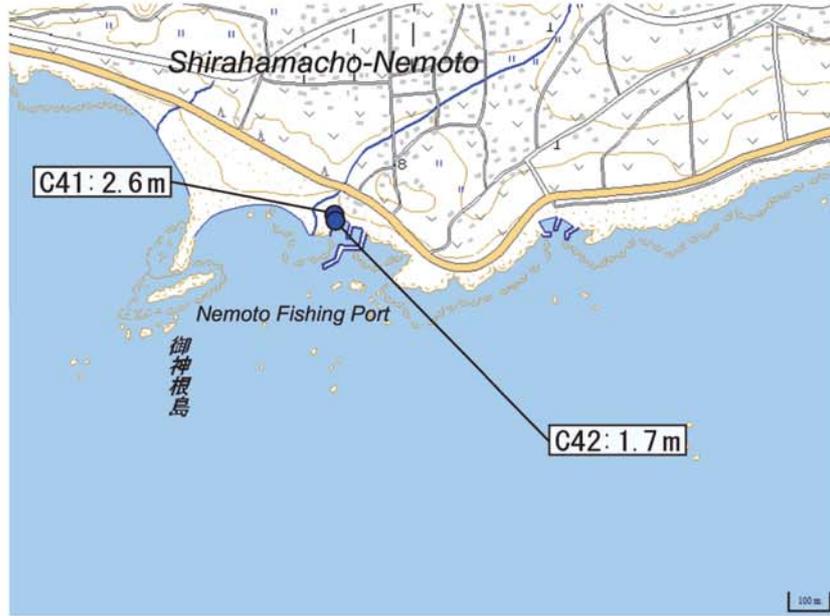
Fig. A351. Tsunami heights at Shirahamacho-Nemoto (Nemoto Fishing Port), Minamiboso City, Chiba Prefecture (added with a digital topographic map at a scale of 1/25,000 from the Geospatial Information Authority of Japan). The symbols and their meanings are the same as in Fig. 6.

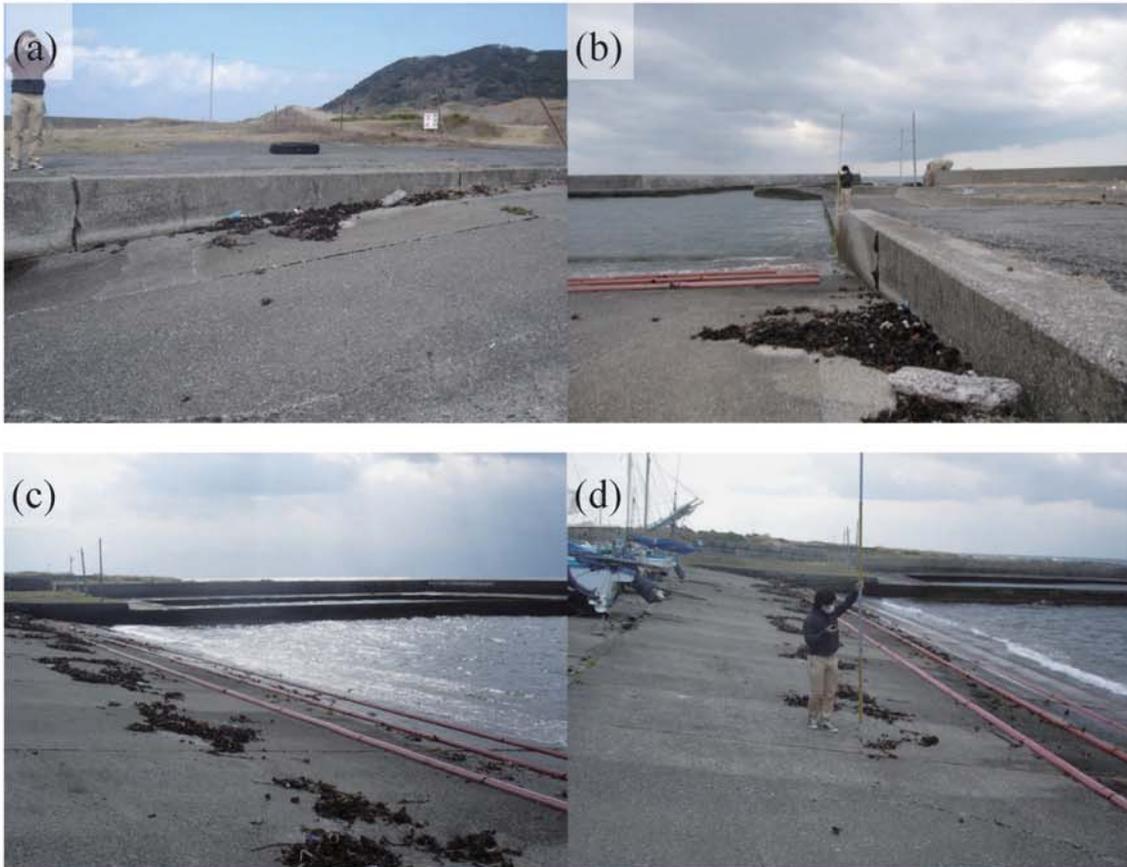
Fig. A352. (a)-(b) Upper limit of garbage and sea glass on a slope in Nemoto Fishing Port (C41). (c)-(d) Garbage and sea glass on a slope in Nemoto Fishing Port (C42).

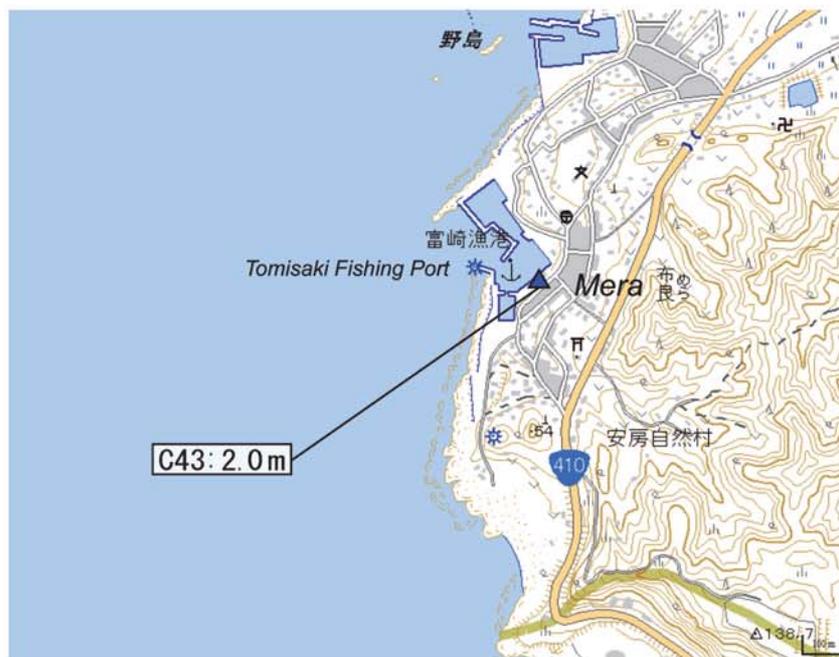
Fig. A353. Tsunami height at Mera (Tomisaki Fishing Port), Tateyama City, Chiba Prefecture (added with a digital topographic map at a scale of 1/25,000 from the Geospatial Information Authority of Japan). The symbol and its meaning are the same as in Fig. 6.

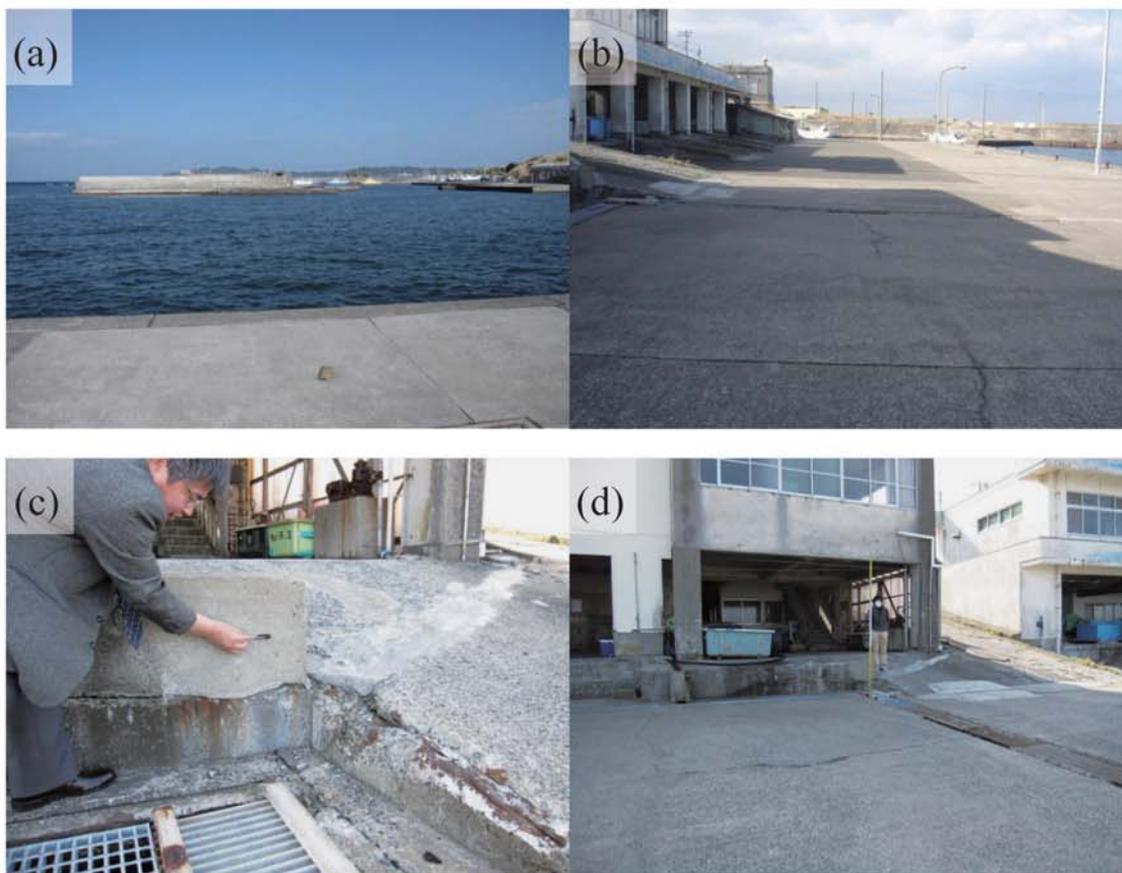
Fig. A354. (a) Tomisaki Fishing Port. (b)-(d) Tsunami trace survey point at the middle of a concrete wall in front of a building (C43).
