捐斐川橋震害圖
 ELEVATION AND PLAN
 OF
 IBIGAWA BRIDGE.

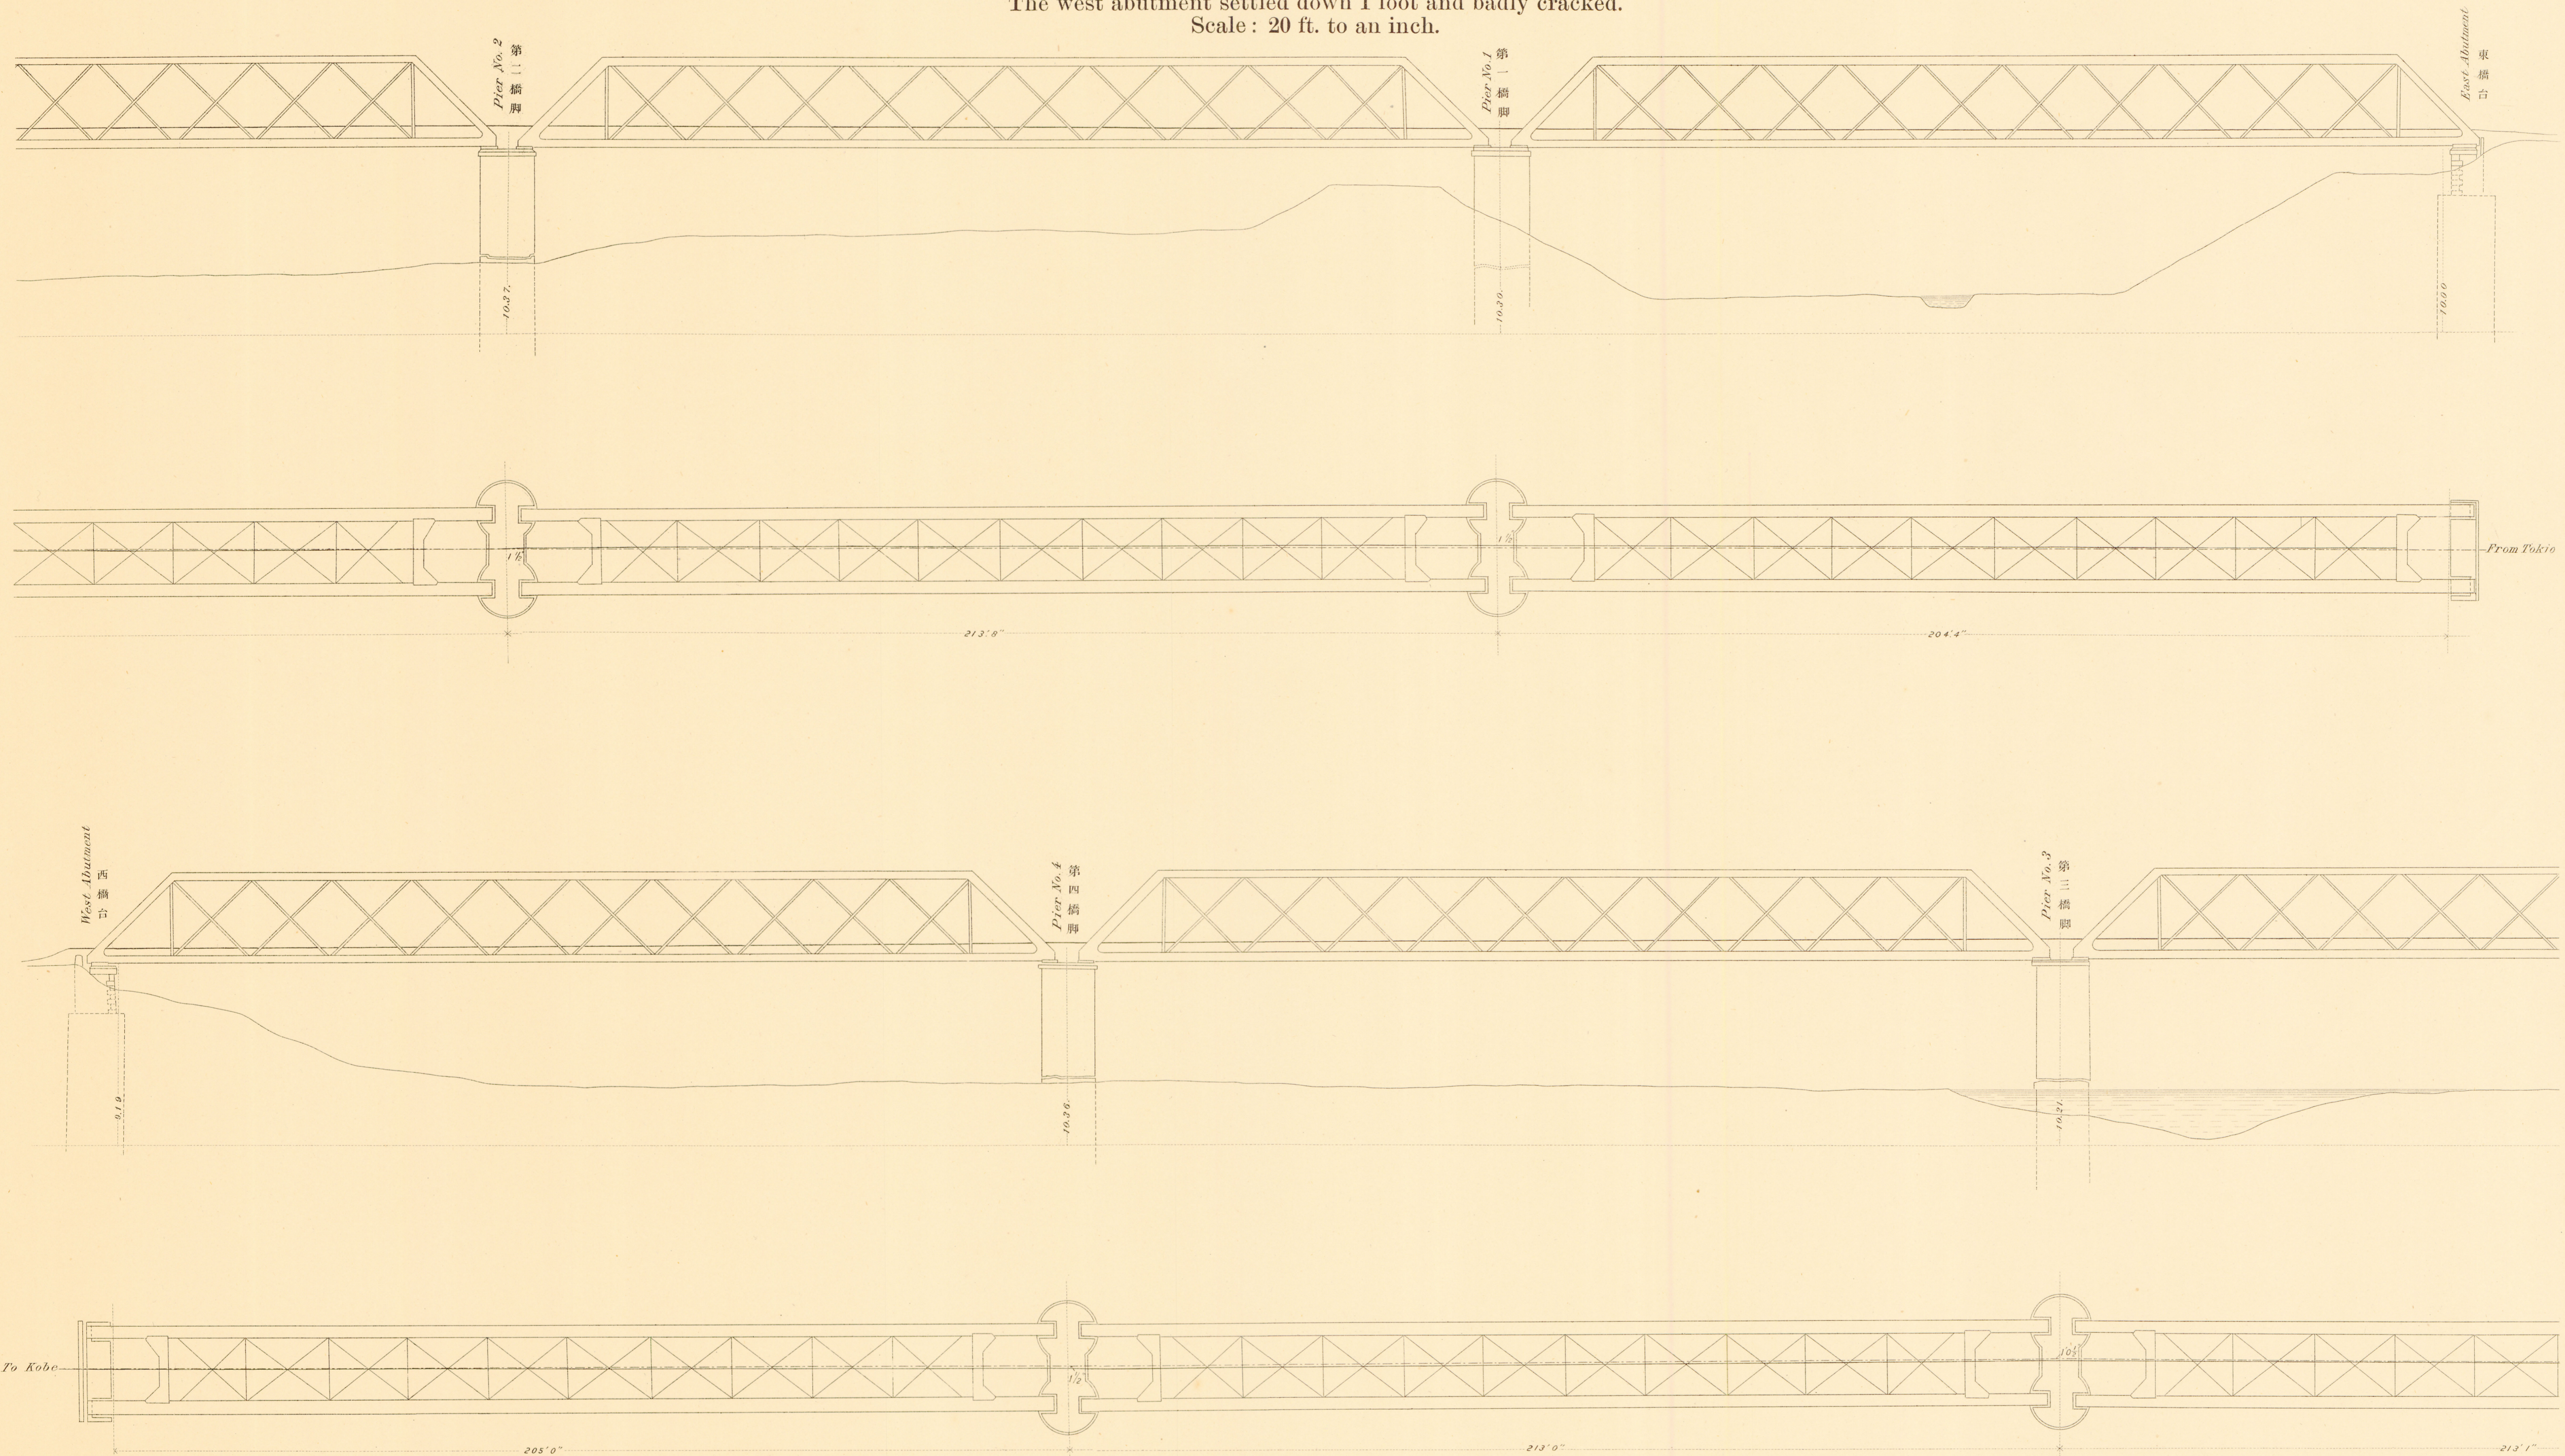
Showing the condition after the earthquake disaster of Oct. 28th, 1891.
 All the piers, each consisting of a pair of brick columns, 12' in diameter, broken a few feet above low water level and displaced a few inches in various directions.
 The west abutment settled down 1 foot and badly cracked.
 Scale: 20 ft. to an inch.
