橋震害圖

木曾川橋震害圖(其二)

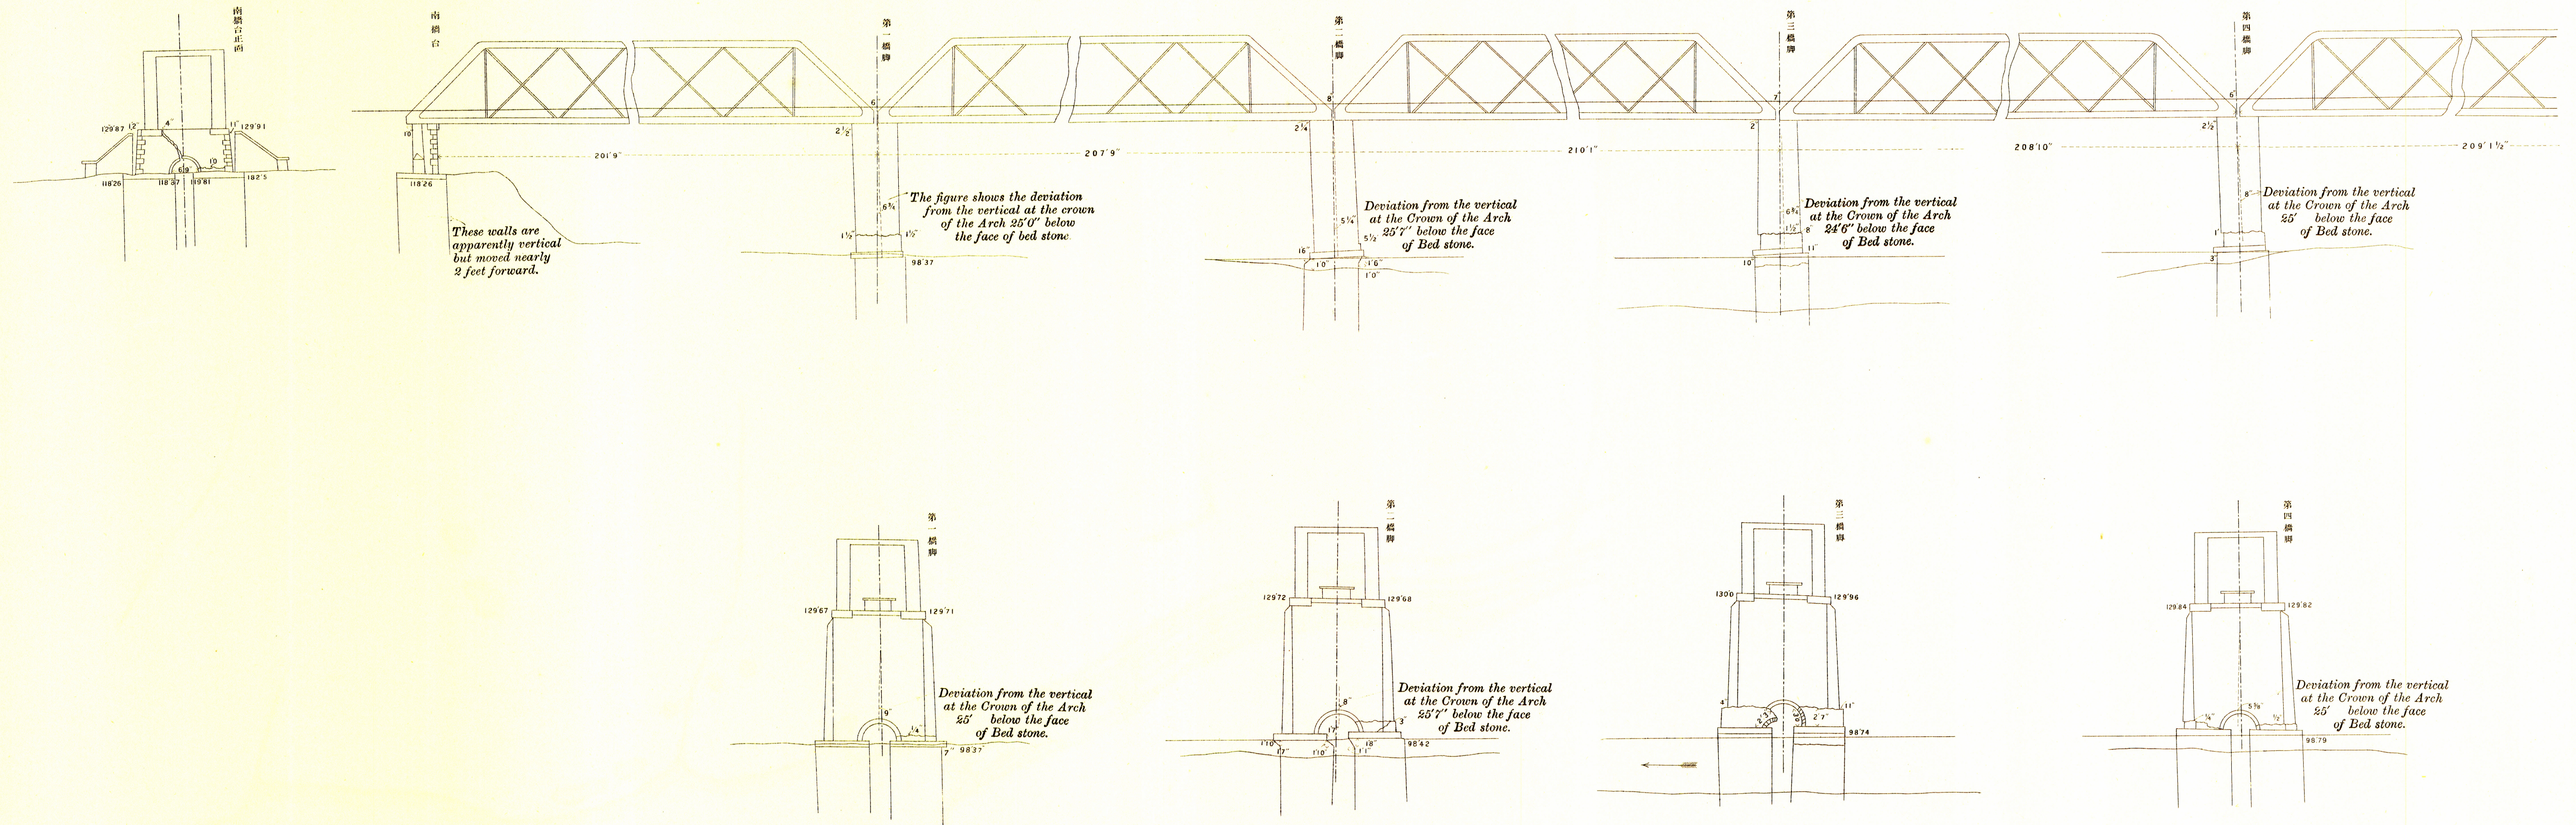
Showing the condition after the earth
All piers and abutments cracked at a few feet ab
less displaced in var
Scale: 20 ft. to
