# Strain Induced in Cracked Utility Poles and Damage to Dwellings from the Dec 26, 2003, Bam Earthquake

## Abstract

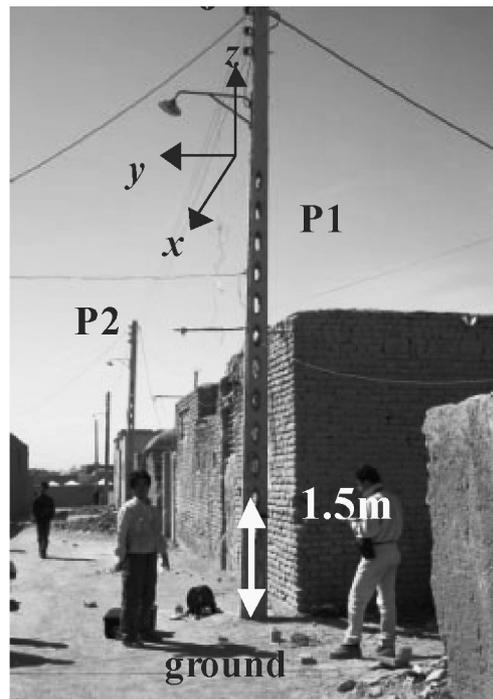
(b) Poles P-1 and P-2.

To examine the dynamic features of this type of pole, microtremors were measured at two poles (Fig. 4 (b)). Their characteristics are summarized in Table 1. Bottom holes on P-2 pole were filled in to prevent theft.
