Seismic Behavior of Local Soil and Foundations in Bam City During the 2003 Bam Earthquake in Iran

Abstract

Key words: site investigation, sounding, masonry, earthquake

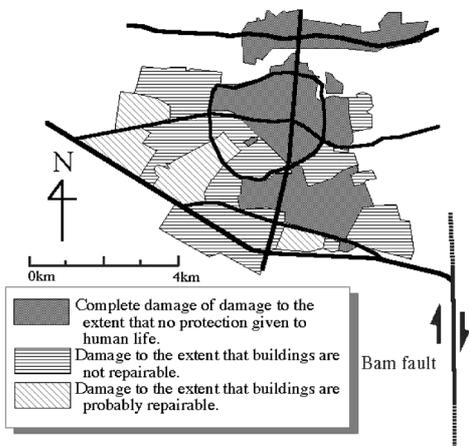
Fig. 2. Variations in damage to houses in different parts of Bam (investigation by Tehran University).

In the earliest phase of the present investigation, it was found that damage was substantial in Bam city, where most houses and buildings were destroyed. In contrast, many buildings and houses, although they suffered slight damage, withstood the earthquake in the southern and western parts of the city (Fig. 2). Thus, it was assumed that subsurface soil conditions might have affected the intensity of tremors and consequently damage. This hypothesis seemed to be supported by the existence of the Posht

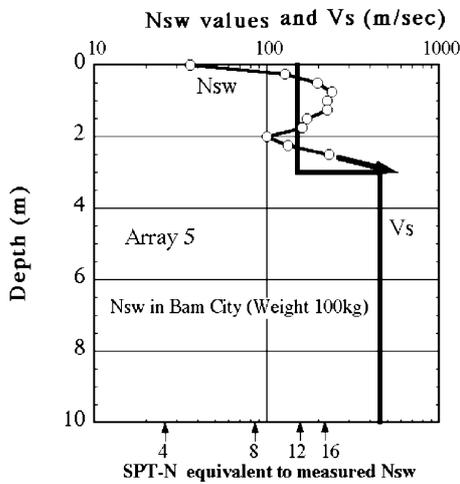
Fig. 6. Comparison of Swedish weight sounding and seismic reflection survey at IIEES array 5.

Figure 6 compares the results of N_{sw} , the number of half rotations needed for 1-meter penetration, against the average velocity profile obtained by

IIEES. As stated before, Swedish sounding provides detailed soil conditions at a single location, while the seismic profile in contrast provides more global information but less detail on soil conditions. Moreover, the exact surface elevations in these studies are not identical. Despite these issues, there is good consistency between the 2 results; harder soils lie below 3 meters in depth. Note that the soil properties seen in Fig. 6 do not imply soft soil conditions that may cause many seismic problems as often encountered in Japanese alluvial planes.

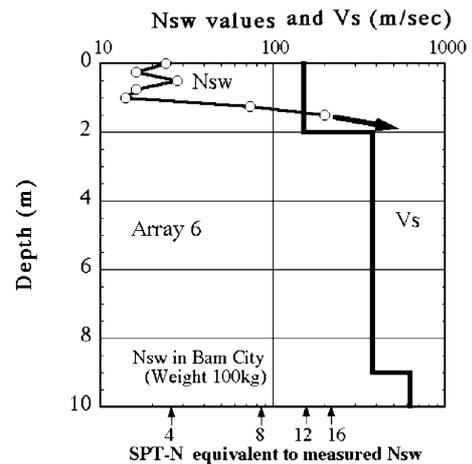
Fig. 7. Comparison of Swedish weight sounding and seismic reflection survey at IIEES array 6.

5). Upon visiting this house, its owner said that it had been built by a local contractor who was renowned for the good quality of construction. Fig. 7 compares

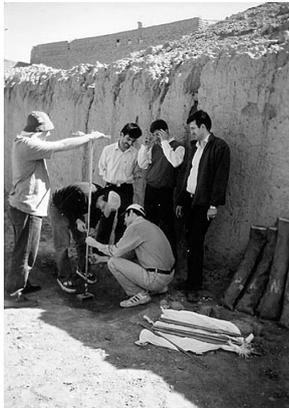
(a) View of excavation of excavation.

less significant (Photo 6) than in the north and central parts of the city, as demonstrated above. Swedish sounding at this site was conducted in a large excavated pit (Photo 7 a), which was approximately 3 meters deep. It was expected that this decision would save time needed to penetrate the top hard soil and more efficiently study subsoil conditions.

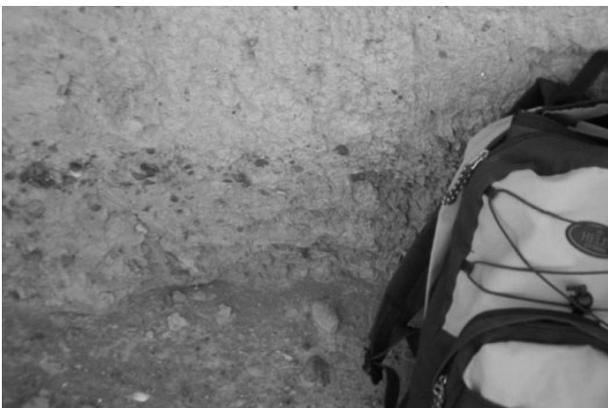
Photo 7. Excavation where Swedish sounding was conducted (array 7 site).

(b) Gravel layer at bottom.

An important feature of this site is the gravel deposit observed at the bottom of the pit (Photo 7 b). For this reason the Swedish sounding device could not penetrate deep into the subsoil. Accordingly, the results of Swedish sounding and IIEES seismic profiling are consistent with each other (see Fig. 8), revealing hard soil conditions at this site.

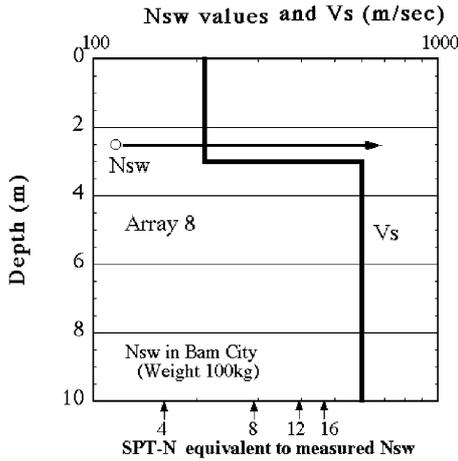
Fig. 9. Comparison of Swedish weight sounding and seismic reflection survey at IIEES array 8.

This site is located to the south of the city, where urbanization has occurred in more recent times, and the density of buildings is not as high as at the city center. Swedish sounding was carried out at the bottom of a shallow excavation (2.5 meters deep) again to save time (Photo 8). Because the bottom soil was also gravel, penetration of the device was terminated immediately. Fig. 9 compares test results to show clearly that soil conditions are hard here.

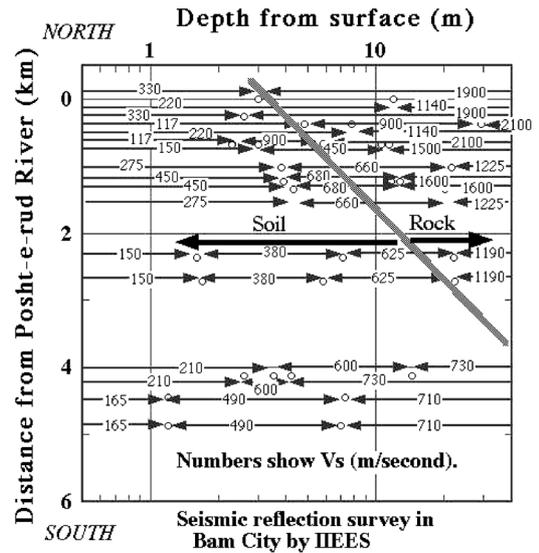
Fig. 10. Assemblage of nine IIEES seismic profiles in Bam city.

for sand (Japan Road Association, 2002). Accordingly, the surface cohesionless soil in Bam has SPT-N values of 20 or more, which means hard soil. Therefore, the soil condition in Bam was not the major cause of building damage.

the city is judged to be reasonable, and is assembled in a single diagram, Fig. 10. The horizontal axis in this figure designates the depth of strata, while the distance from the north edge of the city is plotted on the vertical axis. From this diagram, the following points can be made.

- 1) The elevation of the hardest soil or rock becomes deeper in the southern part of the city. In contrast, the hard material occurs at the ground surface in the northern part of the city as is typically exemplified by the hill of Arg-e-Bam (Photo 1). Therefore, the surface geology is inclined slightly towards the south.
- 2) The angle of base inclination, however, is typically 1%, which is not significant.
- 3) The S-wave velocity (V_s) a few meters below the surface soil ranges from 220 to 900 m/sec. This
