Building Damage around Bam Seismological Observatory Following the Bam, Iran Earthquake of Dec. 26, 2003

Yasushi Sanada^{1)*}, Ali Niousha²⁾, Masaki Maeda³⁾, Toshimi Kabeyasawa¹⁾ and Mohammad Reza Ghayamghamian⁴⁾

Abstract

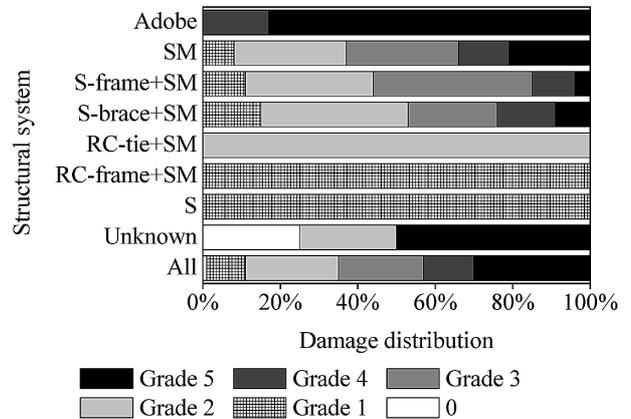
Figure 5 shows the damage distribution of each structural system. All Adobe buildings were classified into Grade 4 and Grade 5. The sum of the ratio of Grade 4 and Grade 5 in SM buildings exceeded 30%, which was much smaller than that of the Adobe buildings. The damage ratios of S-frame+SM and S-brace+SM buildings were expected to be much less than that of the SM buildings, however, there were no major differences among them. This was caused by brittle fractures of poorly welded connections in a few S-frame+SM and S-brace+SM build-

Fig. 5. Damage Distribution of each structural system.

ings. On the other hand, the damage to RC-tie+SM and RC-frame+SM buildings was quite slight because the connections in these buildings were constructed monolithically with other elements. These results, however, were derived from only one case in each system. The damage level of the only S building, which was a gymnasium structure, was Grade 1.

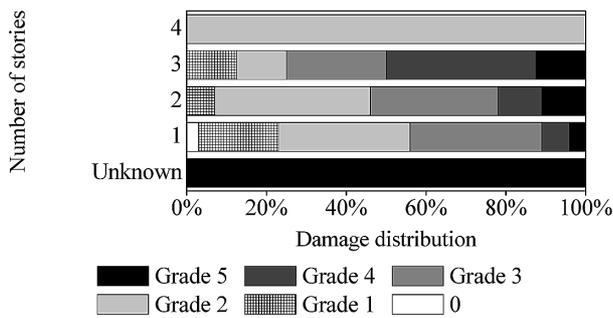
location were investigated. Adobe buildings, however, were excluded from the statistical data, because Fig. 5 obviously showed the low seismic performance of these buildings, which were usually single-story residences constructed before 1987. The effect of the number of stories on damage distribution is investigated in Fig. 6. The ratios of Grade 5 and Grade 4 were larger in the case of higher buildings except the only 4-story building. Fig. 7 shows the damage distribution before the establishment of National Standard code No. 2800 in 1987, from 1987 until the revision in 1999, and after 1999. No major differences were observed among these distributions; however, these results were derived from about half of the buildings. This was caused by the technical and social background in Iran. These results reveal that the seismic performance of Iranian buildings

Fig. 6. Effect of number of stories on damage distributions.

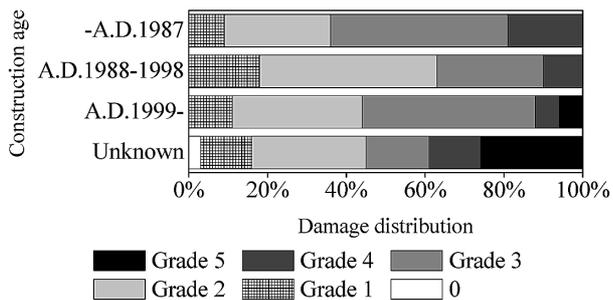
were strongly affected by partial weak points, especially jack arch slab and poorly welded connections, and that the seismic code might have not been diffused to local areas. To investigate the effects of input directivity (EW components > NS components in the records) on building damage, the damage distributions of buildings along the N-S and E-W streets are shown in Fig. 8. The building damage along E-W street is estimated to be larger than that along N-S street, considering the horizontal irregularity due to the arrangement of openings in buildings along the streets, whereas the statistics do not show significant directivity of building damage.

Fig. 7. Effect of construction age on damage distributions.

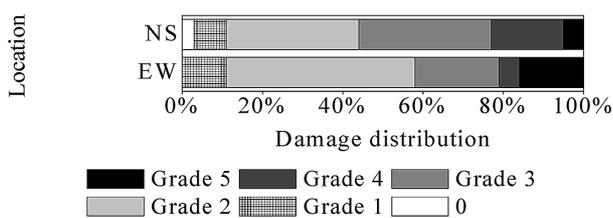
Fig. 8. Damage Distributions along the N-S and E-W streets.

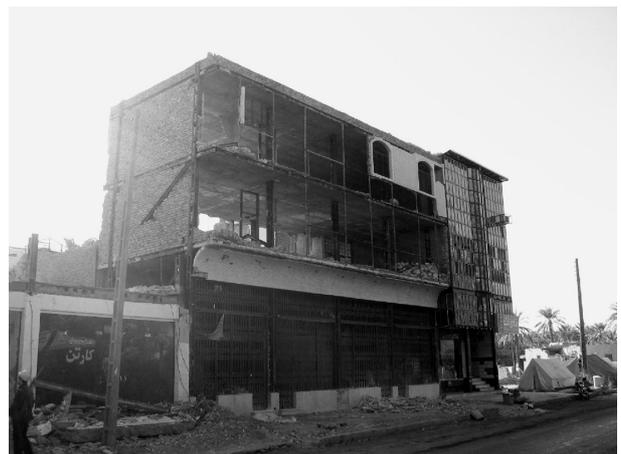
The building under construction (Photo 7) is located a few hundred meters south of the Governor's Building. The structural system of this building is quite typical of the buildings along the main streets

Photo 7. Residence and store building under construction.

shaped steel columns (Fig. 16). Steel braces (I-shape, 70 mm × 140 mm, 7 mm in thickness) are installed in both exterior frames in the EW direction. Brick walls, which are post-installed in the frame without being confined by the surrounding steel frame, are not expected to contribute to carrying the lateral load. I-shaped steel profiles are also used for girders and beams (Photo 7).

In the first story, fractures of welding joints and buckling of steel braces were observed (Photo 8 and 9). As a result, the brick walls had collapsed. Damage to the brick wall on the second story (Photo 10) was also observed. No remarkable structural damage to the steel columns in NS direction was found, although bricks had fallen off the facade of the building.

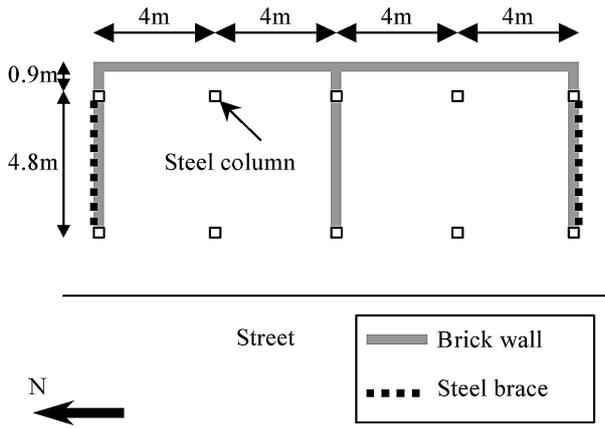
in the downtown area. The 3-story steel structure consists of 4 bays in the NS direction along the street and 1 bay in the transverse direction (EW), as shown in Fig. 15. Columns are erected using coupled I-

Fig. 15. First floor plan.

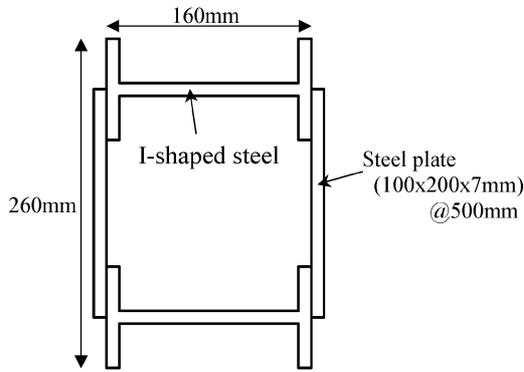
Fig. 16. Section of coupled I-shaped steel column.
